# DACC

Doña Ana Community College

# Facilities Master Plan

**FMP 2023-2030**

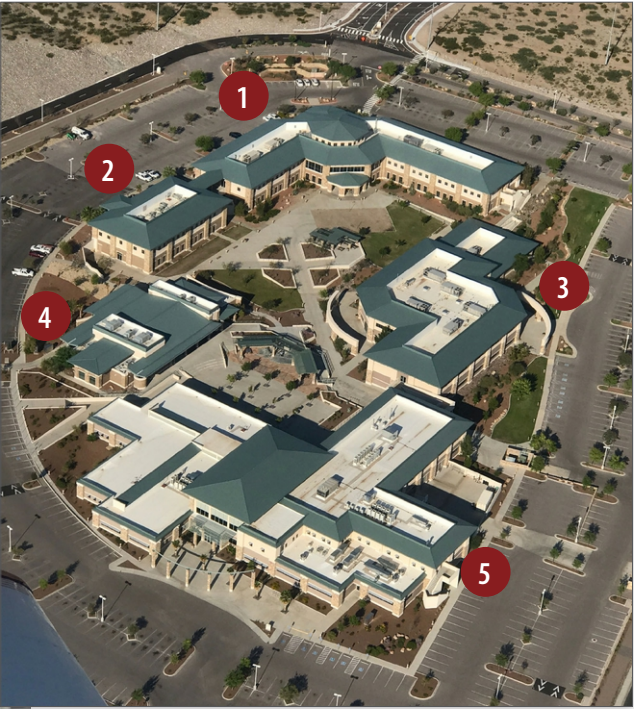
Ex-22: DACC East Mesa Campus Site Plan

View looking southwest

- 1. DAEM – East Mesa
- 2. DADM – Digital Media
- 3. DAAR – Academic Resources
- 4. DAAU – Auditorium
- 5. DASR – Student Resources

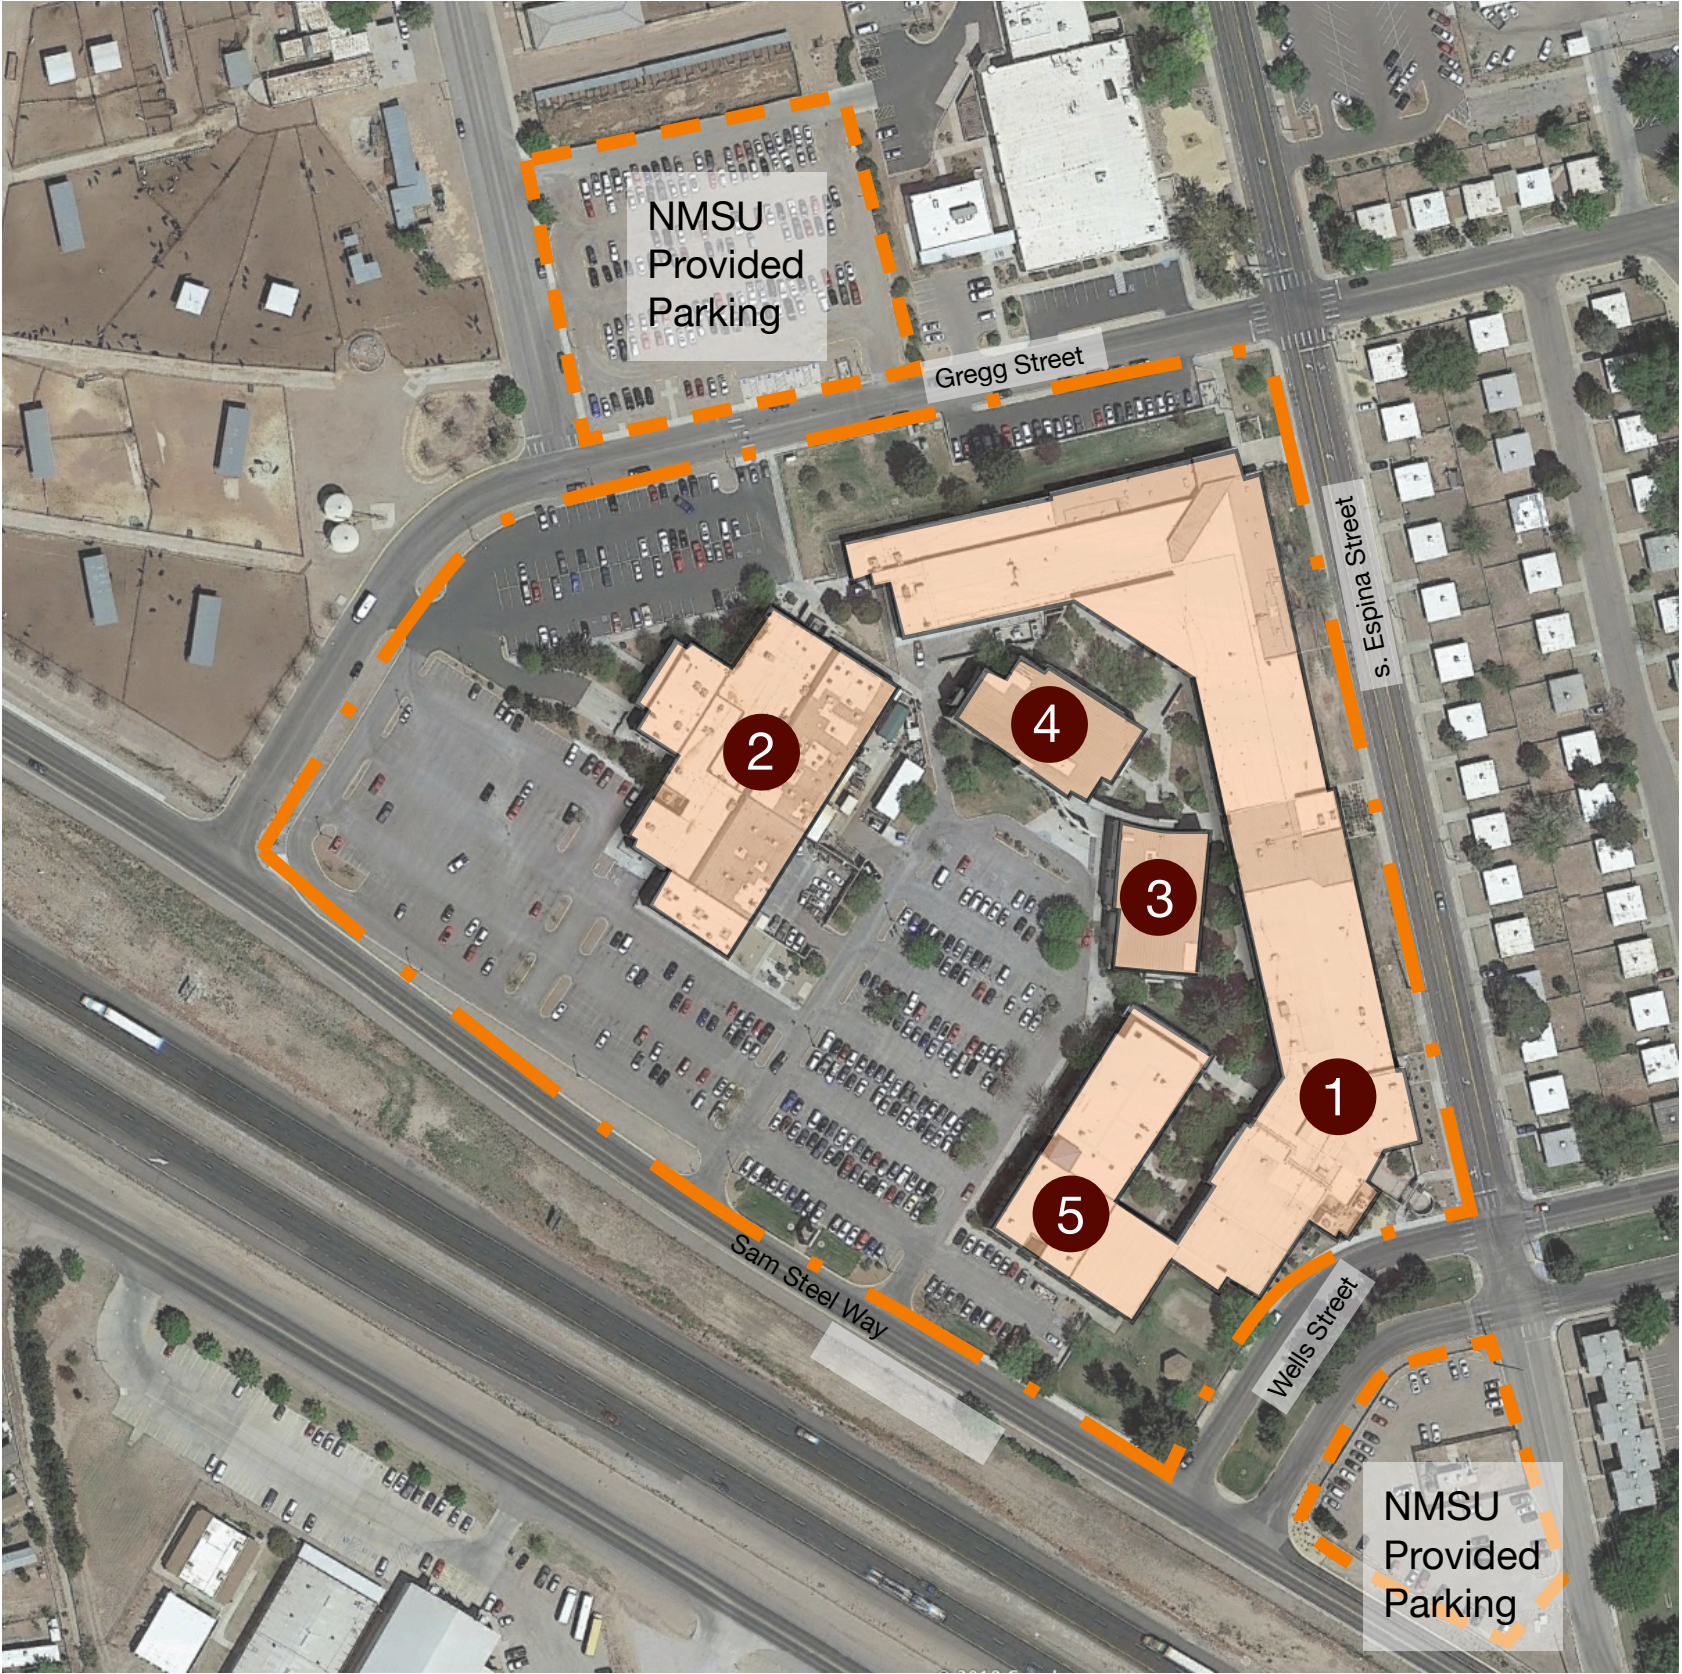
Ex-27: Espina Campus at NMSU

- 1. DAMA /DASH - Alex Sanchez Hall (Main Building)
- 2. DATA – Technical Studies
- 3. DALR – Learning Resources Center
- 4. DACL – Classroom Building
- 5. DAHL – Health and Public Services

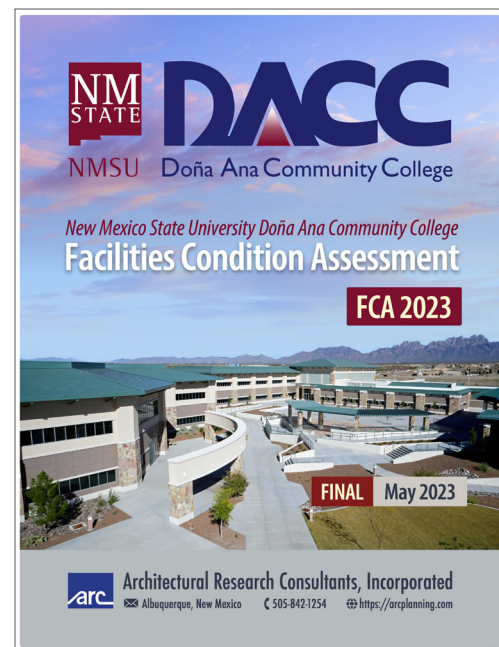
Ex-40: NMSU-DACC FCA Report Excerpts

Site Data				
Site acres:	20.00	No/type of parking spaces:	918 standard, 31 accessible	
Building Data				
Permanent building area:	52864 GSF	Number of floors:	2	
Modular building area:	0 GSF	Modular buildings:	0.0% of GSF	
Construction Dates				
Year Built:	2008	Building age:	14	
Initial Construction Date:		Renovation/Addition 1:		
Renovation/Addition 2:		Renovation/Addition 3:		
FCI Data				
Building Type:	Education	Facility Class:		
Building Height:	Two Story	CRV:	\$14,989,587	
Cost per GSF:	\$283.55	FCI Cost:	\$56,574	
FCI Score:	0.004	FCI:	Good	
FCI Scoring: 0.00-0.050=Good 0.051-0.100=Fair Greater than 0.100=Poor				
Assessment Score for DACC, EAST MESA, ACADEMIC RESOURCES, PH-3&4				
Scoring Category	Possible Points	Actual	Earned	Percent Score (E/A)
The Site		215.0	208.0	<div><div></div></div> 96.7%
Physical Plant Assessment		357.0	289.0	<div><div></div></div> 81.0%
Adequacy and Environment		192.0	169.0	<div><div></div></div> 88.0%

ARC conducted a condition assessment of all the buildings on DACC's six campuses totalling approximately 545,000 GSF [Ex-40].

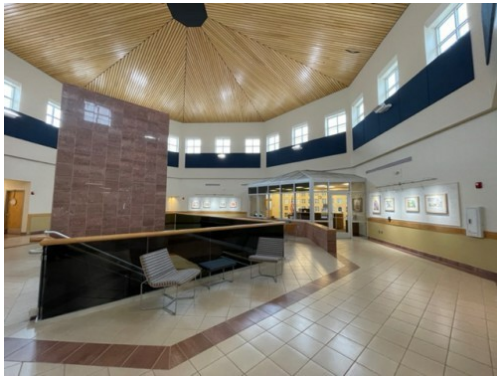
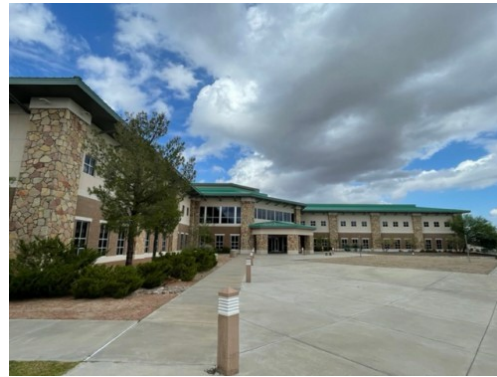
## Building Assessment

The Main Building occupies the southwest corner of the Doña Ana Community College's East Mesa Campus. Upon arrival to the campus from the main vehicle entrance driveway, it is the first building visitors encounter. Its main entrance sits at the corner circular drive, where the west parking lots branch to the north and the south parking lots branch to the east.

The Main Building is a two-story, steel-frame structure with concrete masonry unit (CMU) infill, stucco, and stone facades. The building's main entrance accesses the upper level, which sits at grade level between the parking lots. Its secondary entry, on the building's lower level, sits at grade level on the southwest corner of the central courtyard. The building contains a central space and two classroom/office corridor wings. The west wing branches to the north, and the south wing to the east. The building's primary and secondary entries occupy opposite corners of the central section on the upper and lower levels.

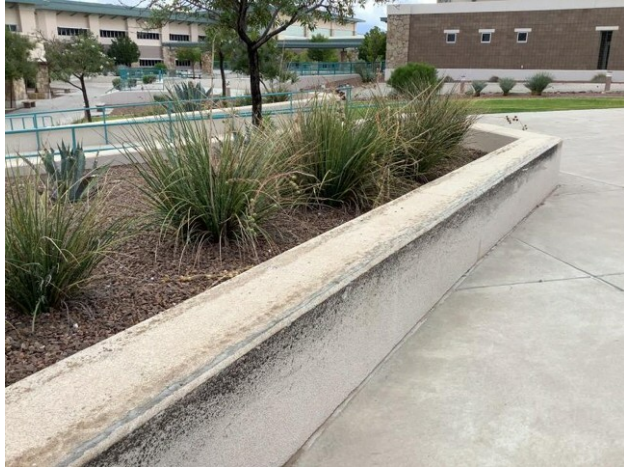
## Project 0591.2001 · Site Improvements

Damaged concrete landscape walls stand throughout the campus courtyard. Metal handrails in the courtyard show damage and chipped paint. Deteriorating xeriscape rocks result in exposed and damaged underlayment paper. A damaged sprinkler head and irrigation control box cause flooding near the west side of the Auditorium Building.

Repair the concrete landscaping walls. Repaint the handrails. Replenish the xeriscape rocks, and replace underlayment paper where required. Repair the sprinkler head and irrigation control box.

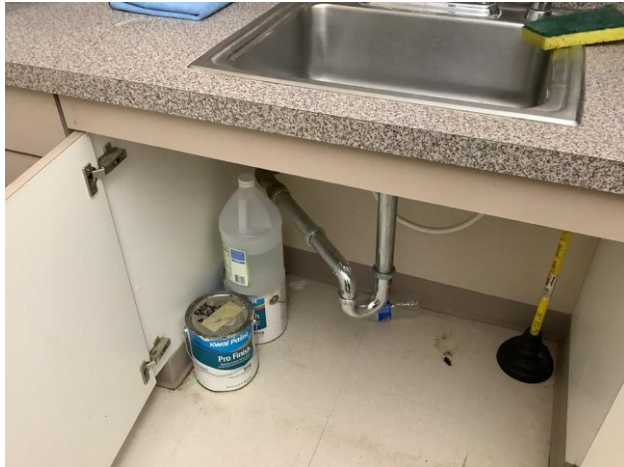
## Project 0591.2002 · ADA Compliance: Interior Improvements

The classroom, break room, and restroom sinks sit in counters that are ADA-noncompliant in height throughout the building, and faucets sit outside of compliant reach ranges. Sinks with knee spaces have uninsulated pipes. Restroom accessories hang at noncompliant heights and are outside of reach ranges above the counters. Vertical grab bars are missing in accessible restroom stalls. Restroom doors offer noncompliant hardware. Stairs lack contrasting colored nosings.

Install counters and sinks at compliant heights in classrooms, break rooms, and restrooms. Move restroom accessories to compliant heights. Insulate pipes. Install vertical grab bars in restrooms. Replace restroom door hardware with compliant handles. Install contrasting colored stair nosings.

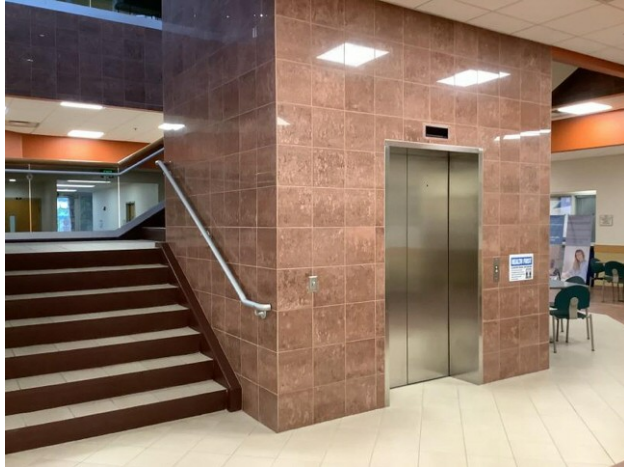
## Project 0591.2003 · Elevator Modernization

The elevator serving the building is original.

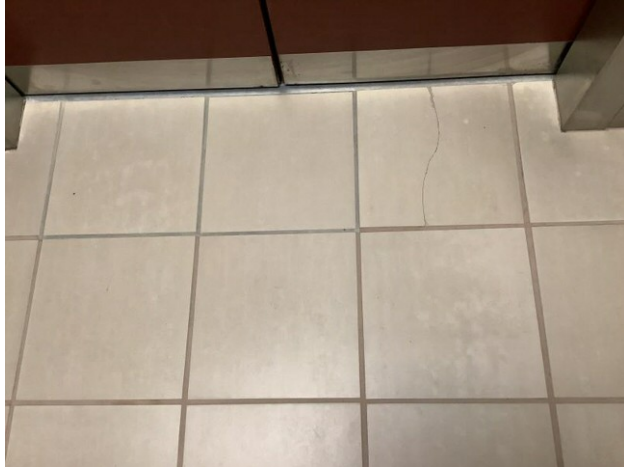
## Project 0591.2004 · Interior Improvements

Finishes throughout the building show wear, stains, and damage. Some office suites have updated finishes.

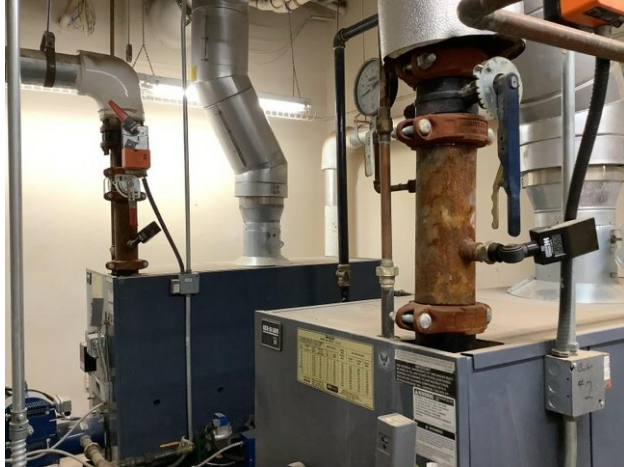
## Project 0591.2005 · Mechanical Study

Poor heat delivery results in the south corridor wing's lower level remaining cold through the winter months. No individual temperature controls serve the building.

Gas-fired boilers and roof-mounted refrigerated units, with variable air volume (VAV) boxes inside the plenums, heat and cool the building. Problems with the delivery of heat cause the lower level to remain cold through the winter months in the south corridor wing. No individual temperature controls serve the building. A network-based system centrally controls temperatures. Plumbing fixtures throughout the building have flush-valve malfunctions and suffer drain backups. The electrical supply is adequate, and the lighting is in good condition.

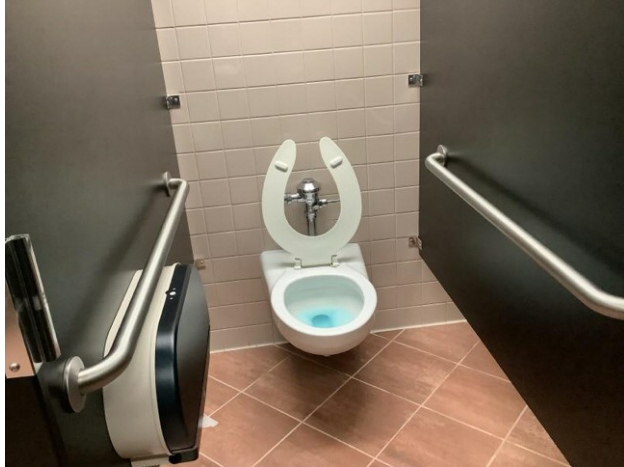
## Project 0591.2006 · Plumbing Study

Plumbing fixtures throughout the building experience flush valve malfunctions and drain backups.

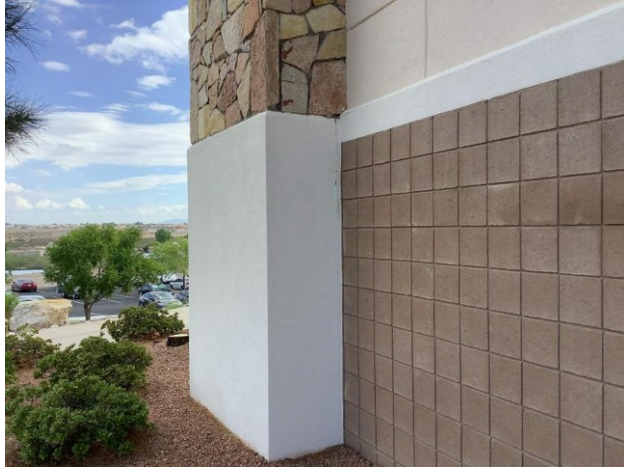
## Project 0591.2007 · Structural Study

Structural cracks show on the walls in upper-level classrooms 216 and 218, in the west corridor wing on the lower level, and on the building's exterior.

Repair cracks and repaint walls. Commission a structural study.

The building's exterior shows high concrete foundation walls covered with stucco. The building facades include CMU-infill sections, stucco, and stone veneers. Notable cracks show on the foundation walls at connection joints and pilasters. The primary and secondary entries sit protected beneath sloped metal roofed porticos supported by stone veneer columns. Sloped metal roofs with wide overhangs and metal panel-covered fascia and soffits protect building entries. Roof drains along the building's west face drain into stone-lined swales. The swales run in xeriscape areas with deteriorating gravel and exposed, damaged paper underlayment. Single-ply roof systems, with some soft spots and water ponding, cover the flat roofs. Active roof leaks are present in the south corridor wing. Windows consist of tinted, fixed, double-glazed units in clear aluminum frames and storefront system units with clear aluminum frames and break-metal sections between tinted safety glazing. Exterior doors are storefront system units with clear aluminum frames and tinted safety glazing.

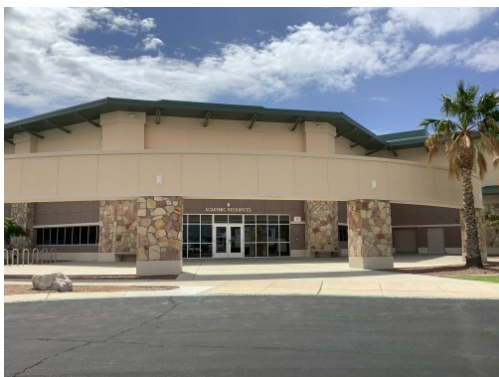
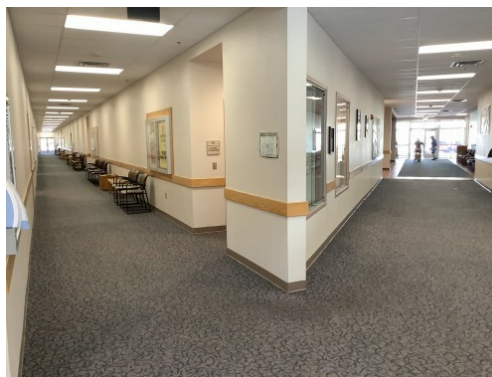
## Building Assessment

The Academic Resources Building occupies the north edge of Doña Ana Community College's East Mesa Campus. The building forms the north border of the protected central courtyard, and its overall form is in the shape of an extended S. The building comprises a center section and two corridor sections that branch to the northeast and the southwest. The main entrances sit at either end of the center section—one on the southeast corner facing the courtyard, and the other on the northwest corner facing the north parking lot. It is a two-story, steel-frame structure with stucco, concrete panel, and stone facades. The upper level covers a portion of the building above the center section, the northeast wing, and part of the southwest wing.

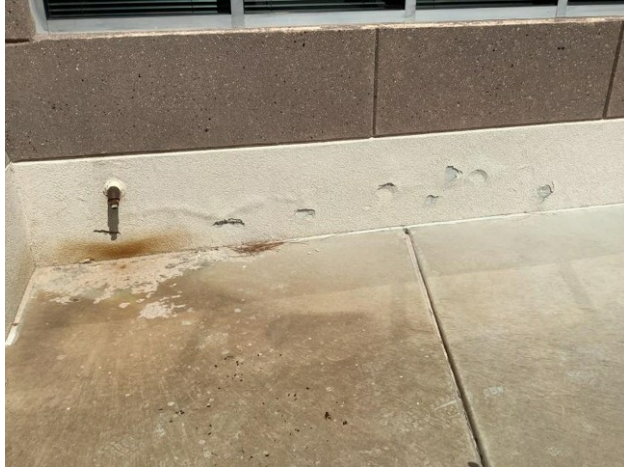
## Project 0622.2001 · Exterior Improvements

Puncture marks and holes in the stucco system exposed the mesh underlayment and the rigid insulation.

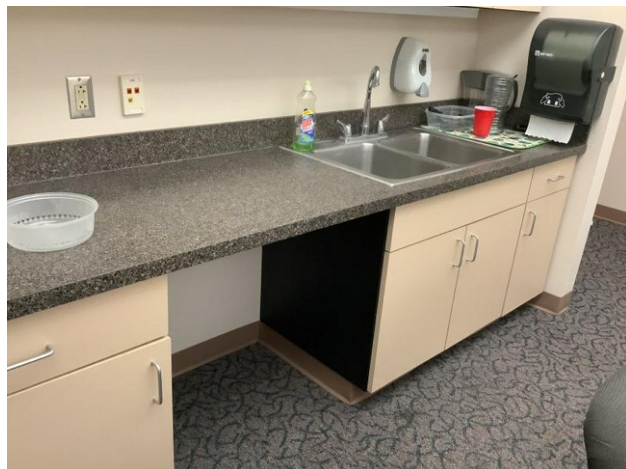
## Project 0622.2002 · ADA Compliance: Interior Improvements

The classroom, break room, and restroom sinks sit in counters that are noncompliant in height throughout the building. Sink faucets sit outside of compliant reach ranges. Sinks with knee spaces have uninsulated pipes. Restroom accessories hang at noncompliant heights and sit outside of reach ranges above the counters. Vertical grab bars are missing in the accessible restroom stalls. Stairs lack contrasting colored nosings.

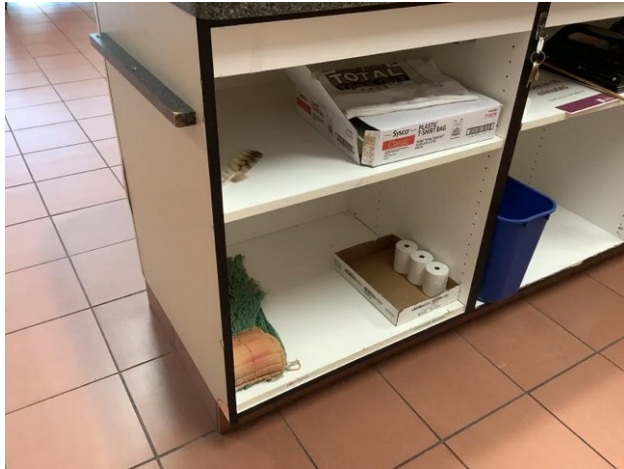
## Project 0622.2003 · Interior Improvements

Finishes throughout the building show wear, stains, and damage. Some office suites have updated finishes.

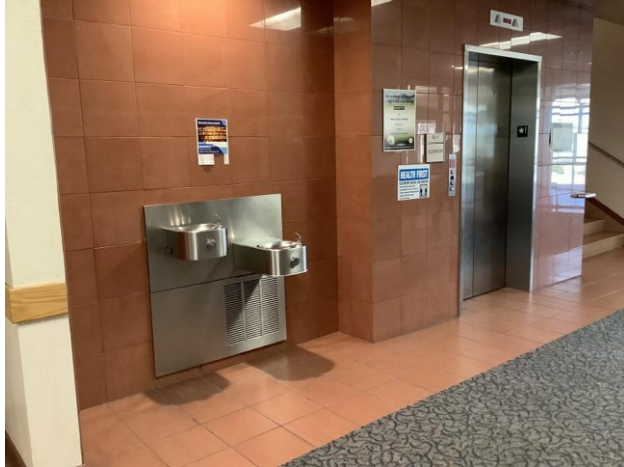
## Project 0622.2004 · Elevator Modernization

The elevator serving the building is original.

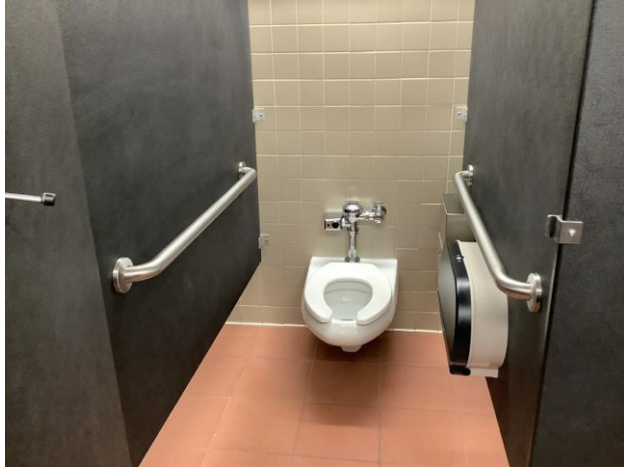
## Project 0622.2005 · Plumbing Upgrades

Plumbing fixtures throughout the building experience flush valve malfunctions and suffer drain backups.

Replace flush valves throughout the building.

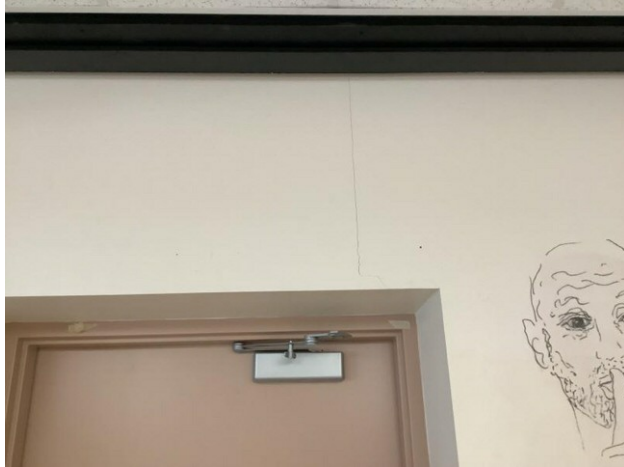
## Project 0622.2006 · Structural Study

Structural cracks show on walls in classrooms 113, 114, 115, and 117 on the lower level; across the ceiling in classroom 112; and on the wall outside of storage room 110 in the southwest wing corridor. Cracks also appear on the computer lab's window wall on the upper level.

Repair cracks and repaint walls. Commission a structural study.

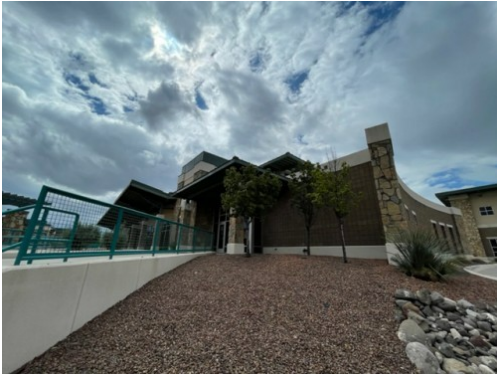
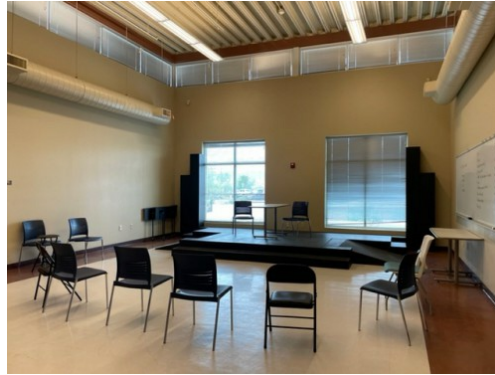
## Building Assessment

The Auditorium Building is a single-story, steel-frame structure with stucco, exposed concrete masonry units (CMU), stone, and aluminum storefront system facades. The building sits on the southeast corner of the East Mesa Campus, between the Digital Arts Building to the west and the Student Resources Building to the northeast.

A concrete slab-on-grade foundation stabilizes the single-story building. Steel posts and beams lie exposed above stone and stucco columns, which support the metal roof's deep overhangs and the covered portico at the main entrance on the south side of the building. The building comprises vertically tiered sections and multiple faceted elevations defined by glass-wall storefront systems, stucco, stone veneer, and smooth-faced CMU. Changes in facade elevation and materials clearly define the entries. Exterior materials are in good condition, free from cracks and wear, show no water damage, and show no structural damage. Building entries are protected beneath column-supported and cantilevered roof overhangs. Entry doors use tinted, tempered storefront system glass with aluminum frames and handles. Windows consist of tinted, insulated storefront system glazing in clear, anodized-aluminum frames. Service doors use painted, solid-metal leaves in painted, metal masonry frames. No operable windows serve the building.

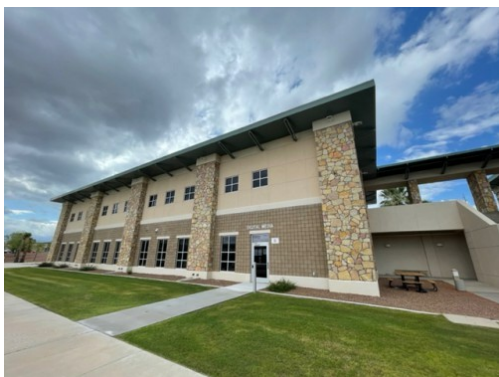
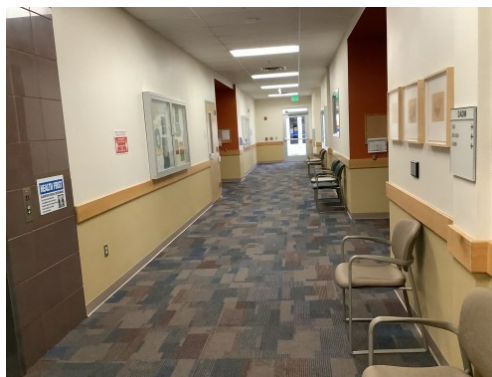
## Building Assessment

The Digital Media Building stands along the south edge of the campus, directly east of the Main Building and west of the Auditorium Building. A covered walkway on the upper and lower levels connects it to the Main Building on the west end. The building acts as a retaining structure. Like the Main Building, the Digital Media Building's upper level sits at a grade level that is adjacent to the parking lots and pedestrian sidewalks to the south. In contrast, the lower level is adjacent to the grade level of the interior courtyard to the north. Exterior concrete stairs connect the two levels.

The building's exterior shows concrete foundation walls covered with stucco. Notable cracks show on the foundation walls at the lower level. Building facades include concrete masonry unit (CMU) infill, stucco, and stone veneers. The primary entrance sits protected beneath a portico, which features a sloped metal roof and is supported by stone veneer columns. The secondary entries at the west end on the upper and lower levels of the building sit beneath covered walkways. The secondary entry on the west end of the building on the lower level stands unprotected, as is the third entry on the building's north side, facing the courtyard. Sloped metal roofs with wide overhangs, metal-panel-covered fascia, and soffits surround the building. Roof drains along the building's north face drain into stone-lined swales. The swales run between xeriscape areas and into grass lawns. Single-ply roof systems, with some soft spots and water ponding, cover the flat-roofed sections in the center of the building. Active roof leaks occur throughout the building, where the flat-roofed sections meet the high parapets that hold the top ridges of the metal roofs. Windows hold tinted, fixed, double-glazed units in clear aluminum frames and storefront system units with clear aluminum frames and tinted glazing. Exterior doors use storefront system units with clear aluminum frames and tinted safety glazing.

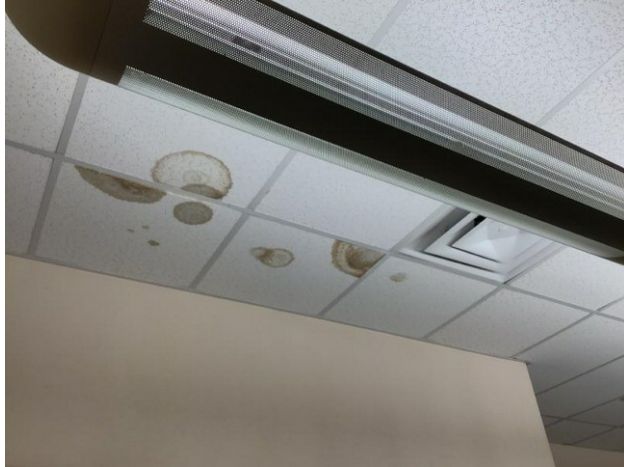
## Project 0606.2001 · Roof Repairs

Active roof leaks show on the ceilings. The ceilings exhibit damaged, stained acoustic tiles and rusted vents.

Repair roof leaks.

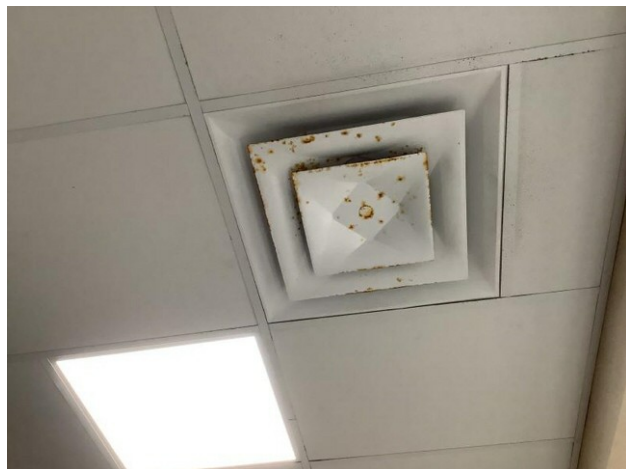
## Project 0606.2002 · Interior Improvements

Building finishes are outdated and worn with cracked concrete floors, stained and worn carpet, structural wall cracks, and bowed and stained acoustic ceiling tiles. No corner guards serve the gypsum-board walls, which exhibit cracks and damage. Plastic laminate cabinets and counters show chipped and damaged material. Painted metal doors and vision-lite frames appear chipped and damaged in many locations. Warped acoustic ceiling tiles show water damage and stains. The metal air-distribution vents on the ceilings have rust stains. Large porcelain tiles on restroom floors are slick and exhibit stained grout. The restrooms have acoustic tile ceilings.

Building finishes are outdated and worn with cracked concrete floors, stained and worn carpet, structural wall cracks, and bowed and stained acoustic ceiling tiles. Damp odors permeate most spaces in the building. No corner guards protect the gypsum-board walls, which exhibit cracks and damage. Plastic laminate cabinets and counters show chipped and damaged material. Painted metal doors and view lite frames appear chipped and damaged in many locations. Warped acoustic ceiling tiles show water damage and stains; many spaces on the upper level show active dripping leaks. Ceilings hold outdated fluorescent lights throughout the building. Metal air-distribution vents on the ceilings show rust stains. Large porcelain tiles on restroom floors are slick and exhibit stained grout. Plastic laminate counters and panels in restrooms hold sinks with ADA-noncompliant reach ranges and mounting heights. No vertical grab bars serve the restrooms, which have acoustic tile ceilings. Wall-mounted toilets have come loose from their connections, and additional reinforcement supports the bowls. In the AT suite and the drafting lab, the sinks mounted in plastic laminate cabinets are noncompliant in height and lack open knee space.

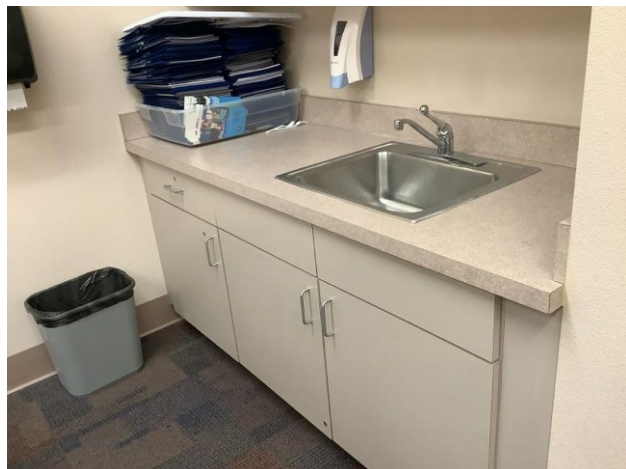
## Project 0606.2003 · ADA Compliance: Interior Improvements

Throughout the building, sinks sit in counters that are ADA-noncompliant in height. Sink faucets sit outside of compliant reach ranges. Sinks offer no knee spaces and have uninsulated pipes. Restroom accessories hang at noncompliant heights and sit outside of reach ranges above the counters. Vertical grab bars are missing in the accessible restroom stalls.

Replace cabinets and sinks with ADA-compliant height units with open knee space and provide pipe insulation. Move restroom accessories within compliant mounting heights. Install vertical grab bars in accessible toilet stalls.

Sinks sit in counters that are noncompliant in height throughout the building. Sink faucets sit outside of compliant reach ranges. Sinks lack knee spaces and pipe insulation. Restroom accessories hang at noncompliant heights and are outside of reach ranges above the counters. Vertical grab bars are missing in accessible restroom stalls. Steel stringer and concrete pan stairs with ceramic tile treads provide access between the floor levels. Aluminum handrails are compliant. The elevator is outdated.

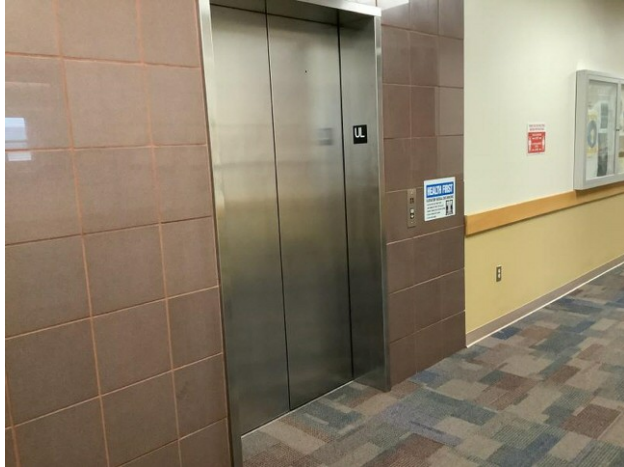
## Project 0606.2004 · Elevator Modernization

The elevator serving the building is original.

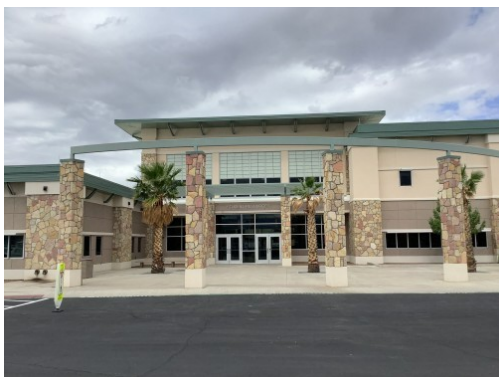
## Building Assessment

The Student Resources Building occupies the northeast corner of Doña Ana Community College's East Mesa Campus. The building forms the northeast corner of the protected central courtyard. The Student Resources Building contains a double-height center section and two corridor sections that branch to the north and the south. The main entrances sit at either end of the center section with one on the west side facing the courtyard and the other on the east side facing the east parking lot. The building is a two-story, steel-frame structure with stucco, concrete panel, and stone facades. The upper level covers a portion of the building above the north section.

The building's exterior shows concrete foundation walls covered with stucco at the base. The lower portion of the building's facade includes concrete panels and stone-veneer pilasters with a stucco edge cap. The upper portion of the facade is a stucco system with control joints and a stucco-covered cornice. The primary entries sit on either side of the building's central portion, facing east and west. The entries are well defined by concrete plazas and have a curved archway, which is supported by stone-veneer columns on the east side. The top wall portion of this curved archway consists of a curved metal beam. Sloped metal roofs with wide overhangs, metal-panel-covered fascia, and soffits surround the building. Single-ply roof systems, with some soft spots and water ponding, cover the flat-roofed sections in the center of the building. Active roof leaks are present throughout the building, where flat roofs meet the high parapets that hold the top ridges of the metal roofs.

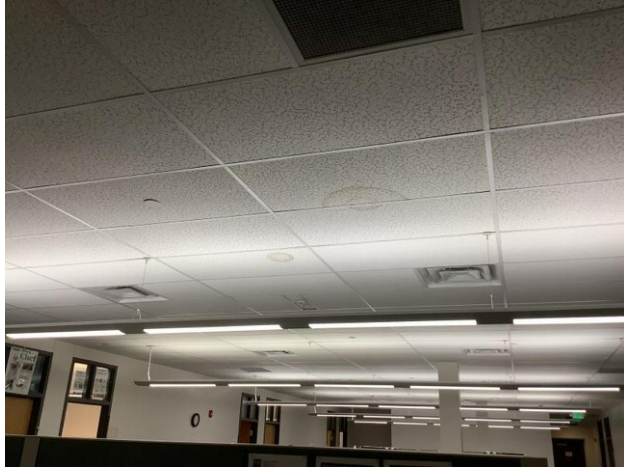
## Project 0639.2001 · Roof Repairs

Active roof leaks in the upper level caused stains and damage on the ceiling tiles.

Repair roof leaks as needed.

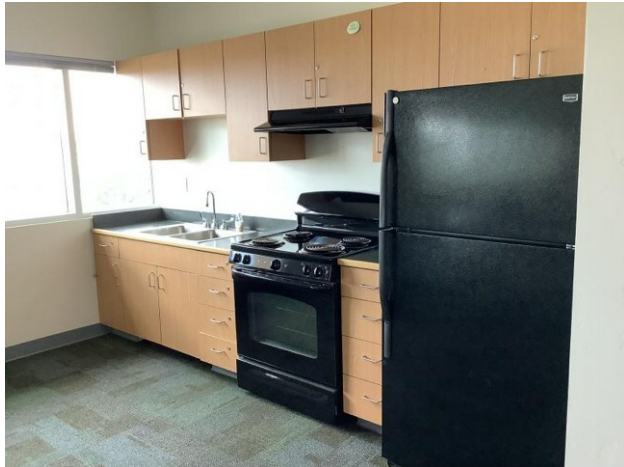
## Project 0639.2002 · ADA Compliance: Interior Improvements

Classroom, break room, and restroom sinks sit in counters that are noncompliant in height throughout the building. Sink faucets sit outside of compliant reach ranges. Sinks with knee spaces have uninsulated pipes. Restroom accessories hang at noncompliant heights and sit outside of reach ranges above the counters.

Restroom sinks sit on counters that are Americans with Disabilities Act (ADA)-noncompliant in height throughout the building, and faucets sit outside of compliant reach ranges. Restroom accessories hang at noncompliant heights and are outside of reach ranges above the counters. Break room sinks sit in counters that are ADA noncompliant in height and lack open knee space. Pipes are uninsulated. Steel stringer and concrete pan stairs with ceramic tile treads provide access between the floor levels. Wood handrails are compliant. The elevator is outdated.

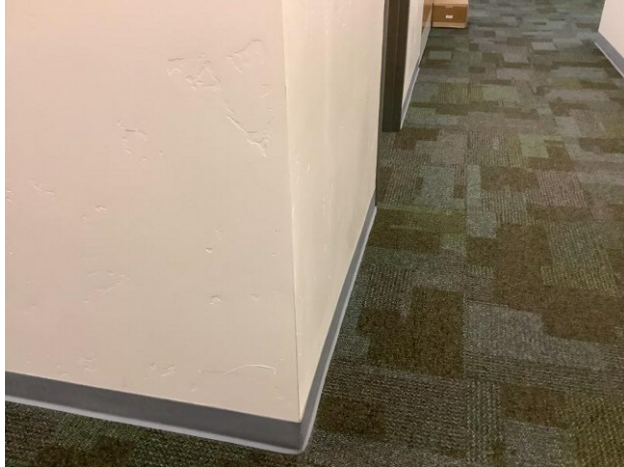
## Project 0639.2003 · Interior Improvements

Finishes throughout the building show wear, stains, and damage. Some office suites have updated finishes.

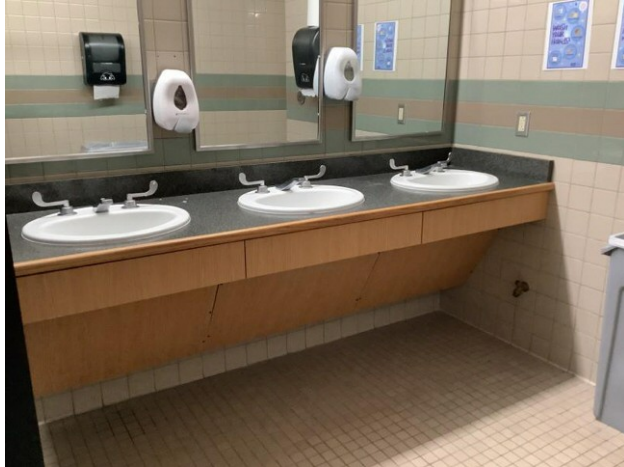
## Project 0639.2004 · Plumbing Study

The plumbing system has crossed supply lines; hot water runs through what should be cold water lines and vice versa.

Commission a plumbing study. An allowance is added for repairs.

Gas-fired boilers and roof-mounted refrigerated units, with variable air volume (VAV) boxes inside the plenums, heat and cool the building. No individual temperature controls serve the building. A network-based system centrally controls temperatures. The maintenance staff report that some of the recently replaced split system units are insufficient. The plumbing system includes crossed supply lines with hot water running through cold water lines and vice versa. The electrical supply is adequate.

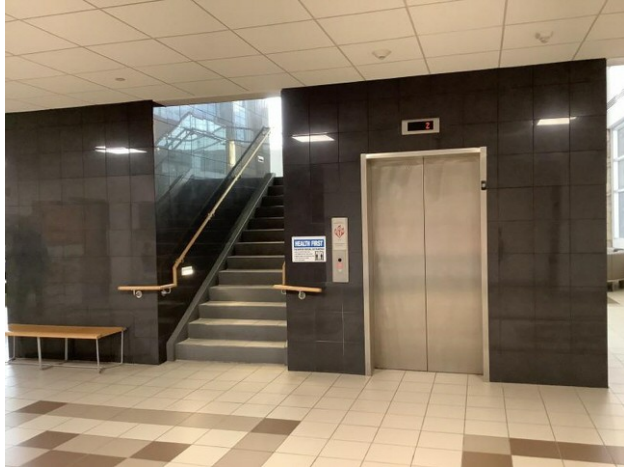
## Project 0639.2005 · Elevator Modernization

The elevator serving the building is original.

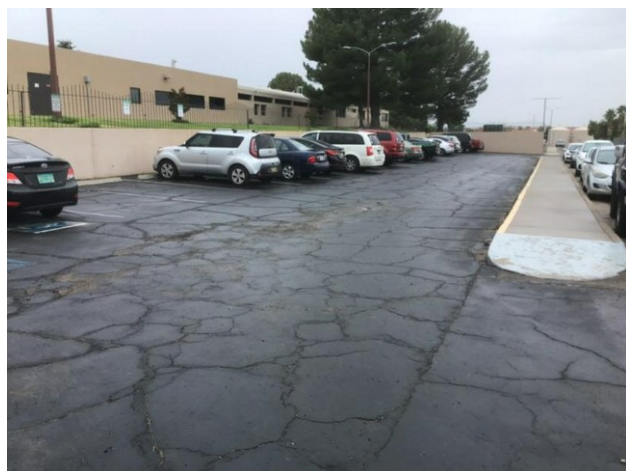
## Project 0341.2001 · Parking Lot Improvements

The site includes three parking lots, which are numbered 69, 70, and 71). All parking lots exhibit heavily cracked asphalt pavement, and the paint delineating the spaces appears faded. A seal coat covers the asphalt at parking lots 69 and 71, and the larger cracks are filled. The asphalt pavement on the driveway between the Technical Studies Building and the Learning Resources Building is in poor condition with cracks and loose aggregate.

Repave and stripe parking lots 69 and 71, as well as the south and east sections of parking lot 70. At the west section of parking lot 70, repave the degraded asphalt, seal the cracks, and seal coat the asphalt surface. Resurface the driveway between the Technical Studies Building and the Learning Resources Building.

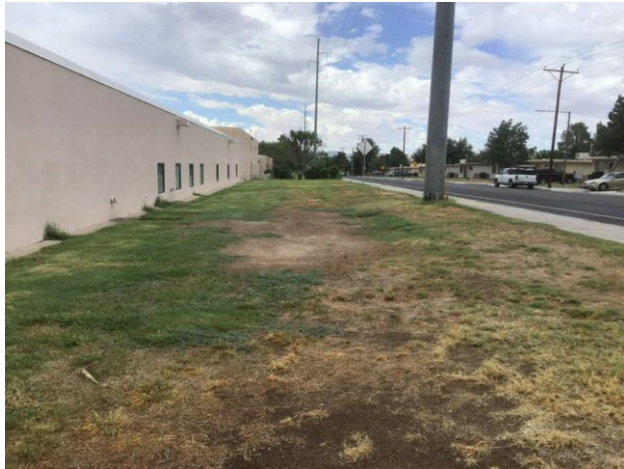
## Project 0341.2002 · Landscaping Improvements

Portions of the grass lawn are dead along the east side of Alex Sanchez Hall, due to the steam lines running below the grass. The lawn is mostly bare between the Technical Studies Building and Alex Sanchez Hall. Weeds grow in many of the gravel beds. In some areas, especially around the Learning Resources Building, the gravel beds are thin, and the landscape fabric is tattered and visible. The patio at the southeast entrance to Alex Sanchez Hall includes cracked concrete and empty planters.

Once the steam lines are replaced with a boiler, reseed the grass lawn on the east side of Alex Sanchez Hall (coordinate with Boiler Upgrades CIP). Reseed the lawn between the Technical Studies Building and Alex Sanchez Hall. Remove the weeds, install landscape fabric, and replenish the gravel beds where needed. Replace the concrete in the patio at the southeast entrance to Alex Sanchez Hall and fill the empty planters. NMSU main campus facility operations is responsible for site amenity refurbishment. Coordinate with NMSU Grounds for these improvements.

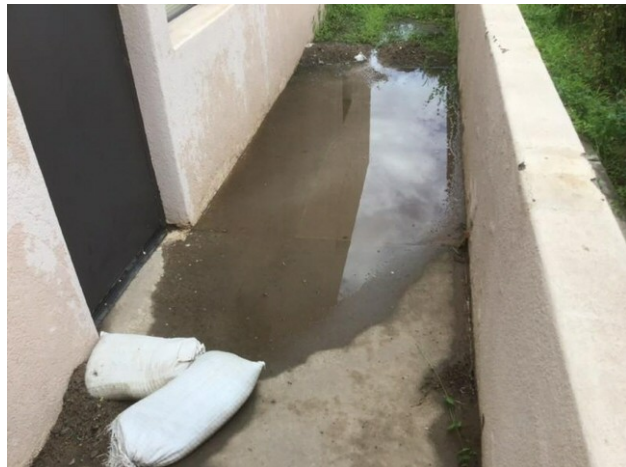
## Project 0341.2003 · Drainage Improvements

Water pools outside the exterior door to lecture hall 96 and runs under the door. The CMU retaining wall surrounding the concrete pad outside of the door is cracked, and the stucco finish is chipped and bubbled.

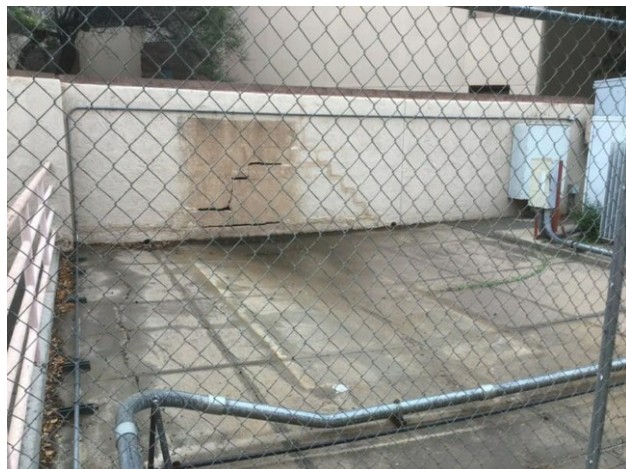
## Project 0341.2004 · Site Wall Improvements

A wall surrounds the grass area at the south corner of the site; the concrete at the top of the wall appears to be heaving in one area, which shows cracked concrete. The concrete on top of the rock wall lining a section of the grass lawn on the site's north edge is cracked and chipped. Several walls have cracked, chipped stucco on the south and east sides of Alex Sanchez Hall. The split-face CMU walls between Alex Sanchez Hall and the Learning Resource Building appear to be settling, resulting in cracks running through the bricks and joints. The stucco-covered CMU wall near the stairway to the basement mechanical room has a section that dropped several inches, resulting in wide gaps in the joints.

Repair the heaving, cracked, and chipped concrete on the rock walls. Repair the cracked and chipped stucco on the walls at the south and east sides of Alex Sanchez Hall. Fog coat the stucco finish. Because the CMU walls are close to the basement mechanical room, investigate the cause of the settling and replace the settling walls.

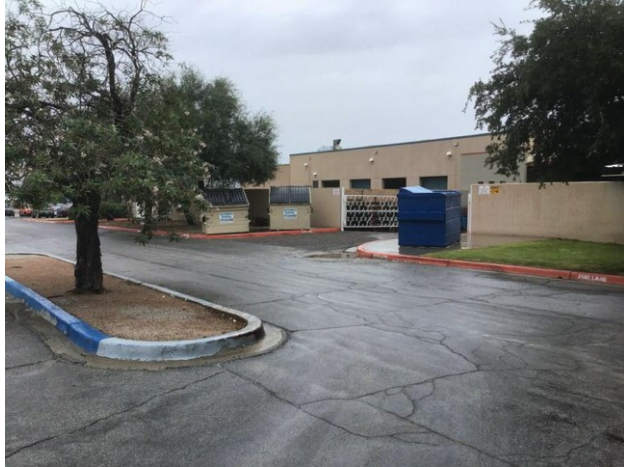
## Project 0341.2005 · Dumpster Enclosure

No enclosure surrounds the dumpsters sitting east of the Technical Studies Building.

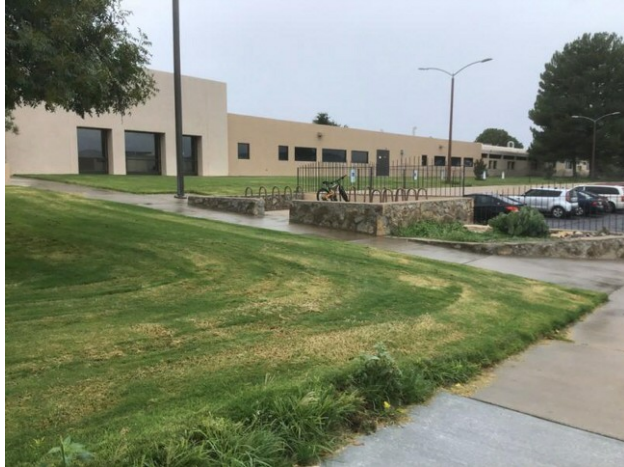
## Project 0341.2006 · ADA Compliance: Entry Access Improvements

The walkway from the small parking lot on the north side of Alex Sanchez Hall leads to the main entrance and has an eight percent slope, which exceeds ADA allowances for a walkway and rises over 30 inches without an intermediate landing. An alternate route from the parking lot to the main entrance requires traveling around the corner to another walkway that is a significantly longer route.

Replace the walkway leading from the small parking lot on the north side of Alex Sanchez Hall to the building's main entrance with a ramp that meets ADA requirements.

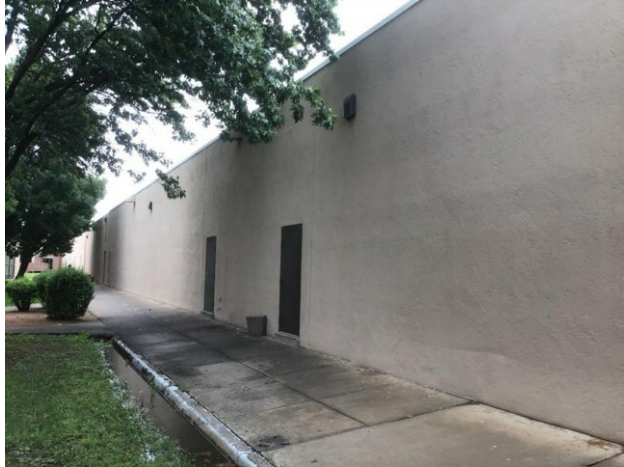
## Project 0341.2007 · ADA Compliance: Walkway Improvements

The sidewalk along the west edge of the south wing of Alex Sanchez Hall has a cross-slope that is too steep at eight percent. Four of the exterior doors open onto the sidewalk and lack landings on the exterior side of the door.

Replace the sidewalk along the west edge of the south wing at Alex Sanchez Hall and construct landings at the exterior doors.

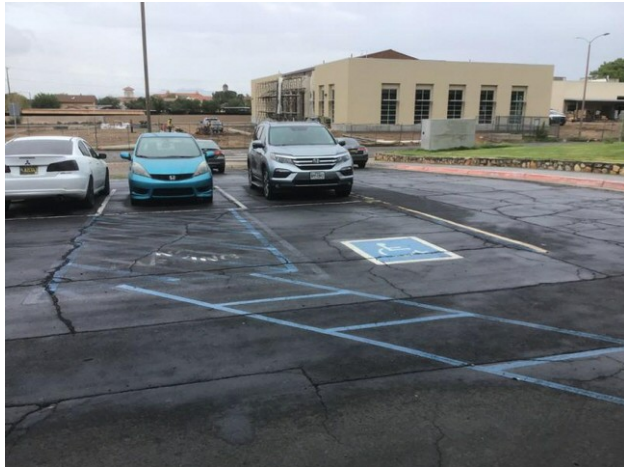
## Project 0341.2008 · ADA Compliance: Minor Site Improvements

No accessible paths lead to the gazebo in the grass area at the south corner of the site. The handrails do not meet ADA requirements on the exterior stair leading to the basement mechanical room. The exterior stair to mechanical room M080 lacks handrails. A sign is missing from one of the ADA parking spaces at the east end of the medium parking lot.

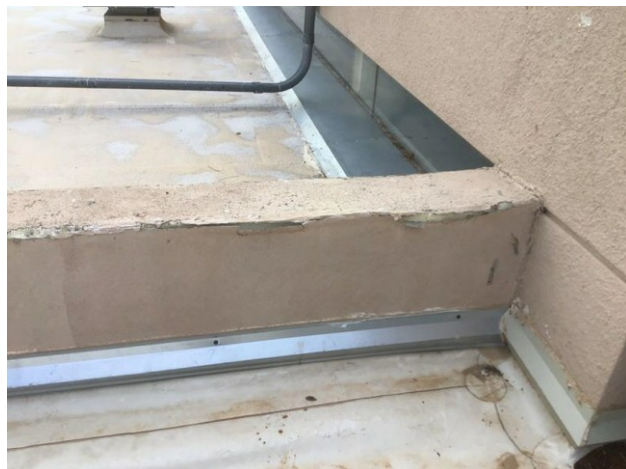
## Project 0341.2009 · Roof Upgrades

The built-up roofing passed its expected life span and is in fair to poor condition with bubbles, loose aggregate, and soft spots. Most of the stucco-covered parapets are in poor shape with cracks and chips. Several areas of the roof have no ladder access.

Replace the built-up roofing with a TPO roofing system. Repair the stucco parapets and install metal caps over all of the stucco parapets. Install roof transfer ladders where needed. Recent silicon overcoat will help delay replacement.

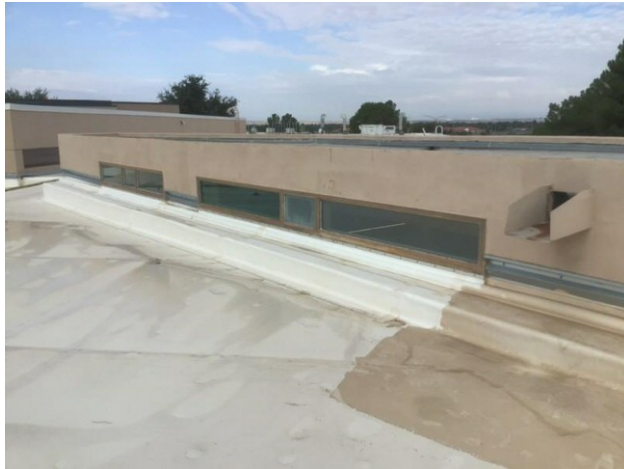
## Project 0341.2010 · Exterior Improvements

Several exterior walls exhibit cracked stucco and the colors are mismatched, especially on the exterior walls that extend above the lower roof lines. Several windows are cracked, and a few are cloudy. Some of the windows above the roof line have rusted frames and caulk running around the edges of the glazing.

Repair the cracked stucco. Fog coat the stucco finish. Replace the windows that are cracked, cloudy, and rusted.

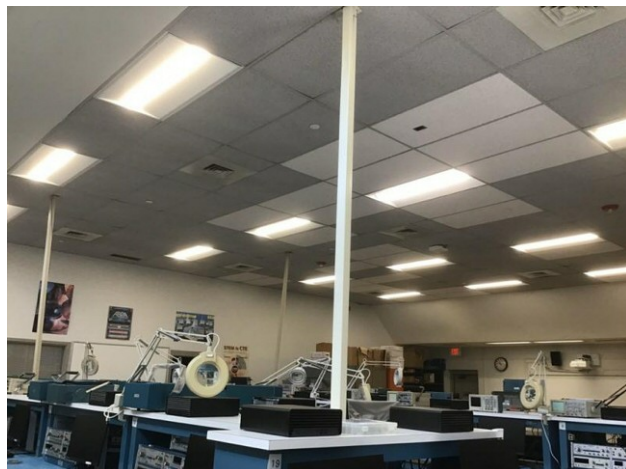
## Project 0341.2011 · Interior Improvements

A few of the suspended acoustic ceiling tiles show water stains from possible roof or roof drain leaks. Several classrooms, labs, and offices have mismatched tiles. Several doors to the mechanical rooms are damaged. The electronics labs have wood veneer desks and metal desks with laminate table tops; the veneer and laminate finishes are worn and chipped.

Replace the stained and mismatched ceiling tiles. Replace the damaged doors. Replace the wood veneer desks and the metal desks.

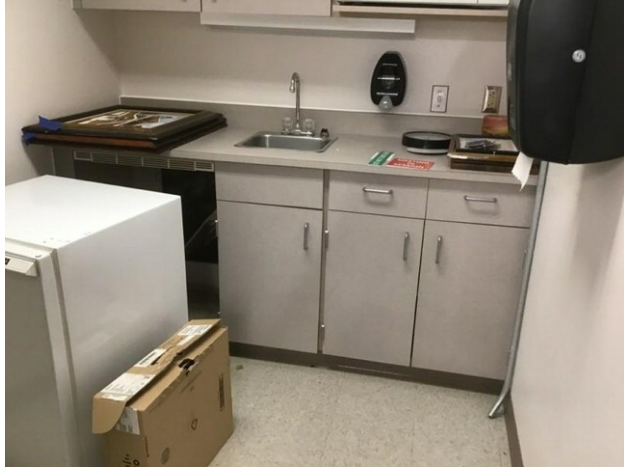
## Project 0341.2012 · Casework Replacement

The casework in the break rooms ranges from good to fair condition with some minor chipping. In some areas, the casework is too tall to meet ADA requirements at 36 inches.

Replace the casework in the break rooms and update them to current ADA standards.
