# DACC

Doña Ana Community College

# Facilities Master Plan

**FMP 2023-2030**

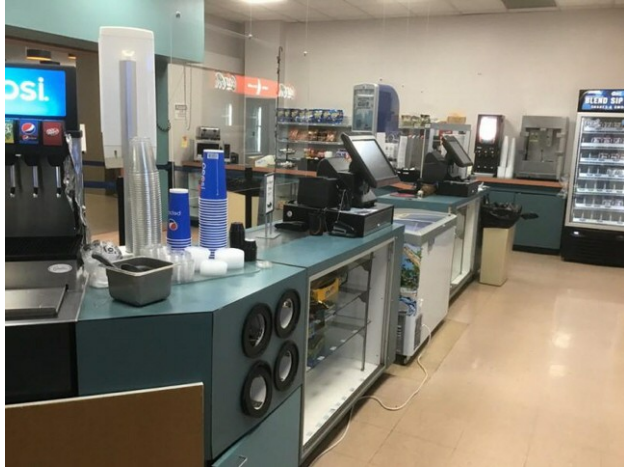
## Project 0341.2013 · Snack Bar Upgrades

The finishes in the snack bar and its support spaces are dated and show wear. Ceramic tiles, carpet tiles, and VCT cover the floors. The tile is in good condition. The VCT is mismatched, discolored, and damaged. The carpet is worn and stained. The veneer on the snack bar's casework is aged and delaminating. The three-compartment sink in the snack bar prep room lacks an air gap.

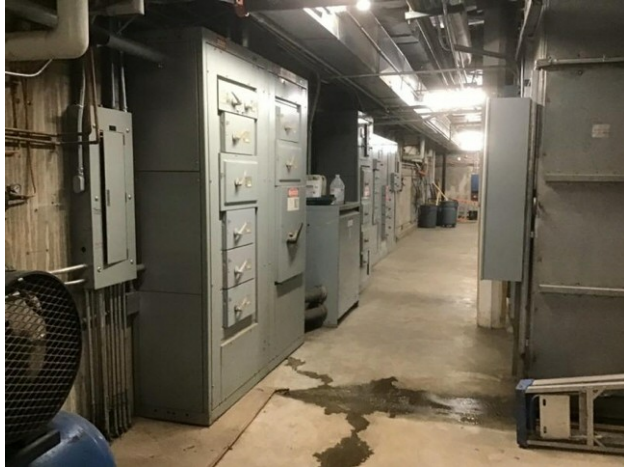
## Project 0341.2015 · Electrical Upgrade

The building's electrical system functions well, but it is original.

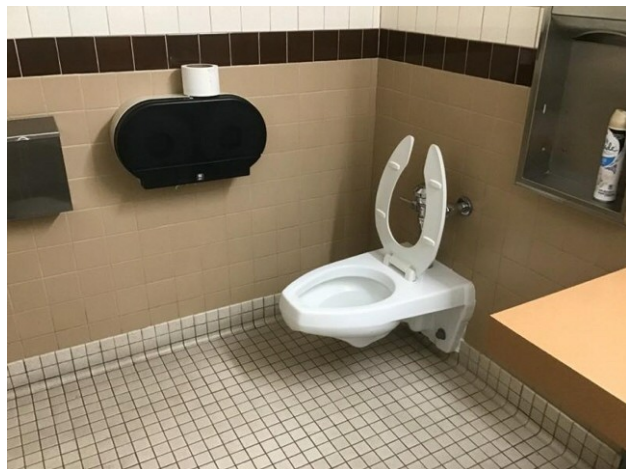
## Project 0341.2017 · ADA Compliance: Minor Restroom Improvements

No vertical grab bars hang in the ambulatory stalls of the women's multistall restrooms R072 and R100, the accessible stall of the men's multistall restroom R102, or the single-occupant restroom R110. No insulation wraps the sink pipes in women's multistall restroom R123. The single-occupant restroom M1 lacks grab bars, and the toilet flush control is not on the open side of the room.

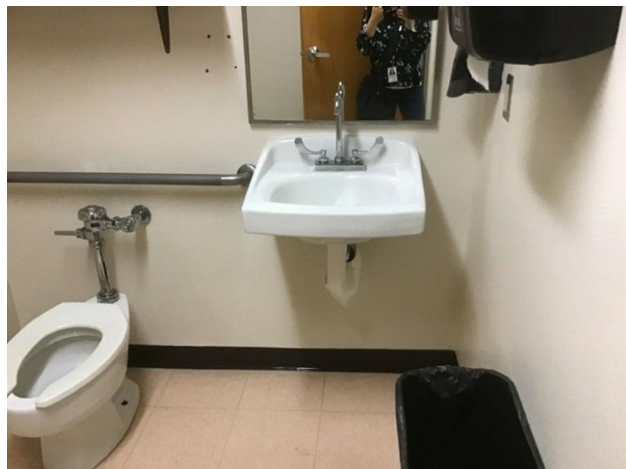
## Project 0341.2018 · ADA Compliance: Restroom Renovation

Single-occupant restroom R116 has no vertical grab bar, the toilet flush control is not on the open side of the room, the toilet paper dispenser hangs too close to the side grab bar, and the sink encroaches on the toilet's clear floor space.

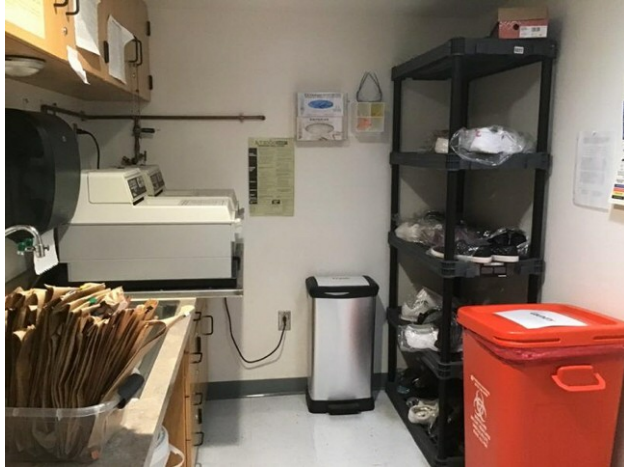
## Project 0341.2019 · Dental Clinic Improvements

The dental clinic has a dark lab with a revolving door, but the room is no longer required and students use it as a changing room.

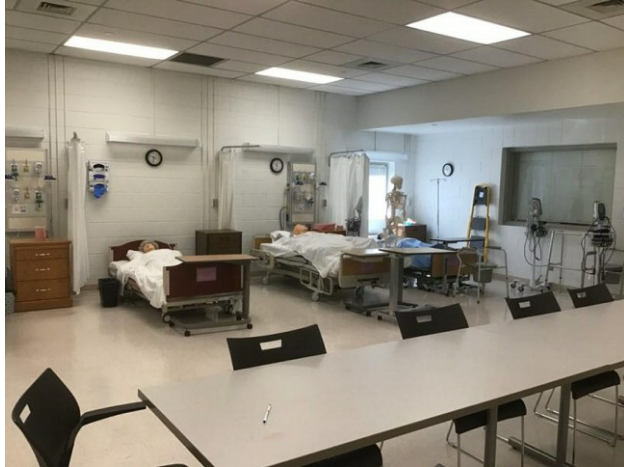
## Project 0341.2020 · Nursing Lab Improvements

The nursing program's lab is not constructed to reflect real-life conditions, making it challenging to prepare students for the field.

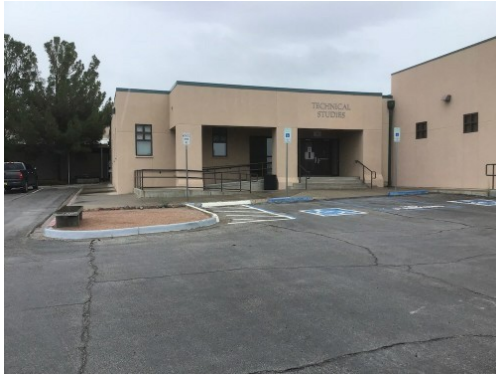
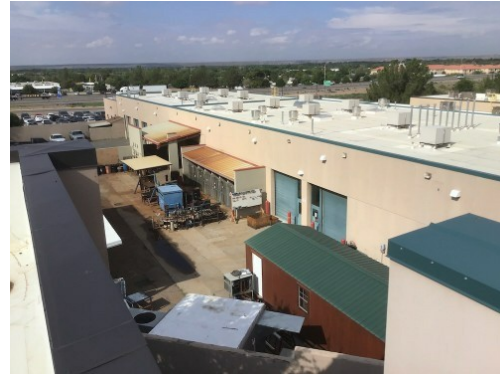
### Site Assessment

Vehicles access the site from either Gregg Street or Sam Steel Way and may park in one of three asphalt-paved lots. Two of the site's parking lots surround three sides of the Technical Studies Building and provide an adequate number of parking spaces. Driveways allow vehicles to access the building's loading dock and the yards for the automotive, welding, and heating, ventilation, and air conditioning labs. The asphalt pavement in the lab yards shows exposed and loose aggregate.

Concrete masonry unit (CMU) walls with a stucco finish enclose the yards outside the labs. The stucco finish on the walls is cracked and chipped, especially at the top. A concrete retaining wall lines the ramp on the northeast side of the building. However, the concrete is spalled, and the stucco is bubbled and peeling due to water damage.

The ramp along the northeast side of the Technical Studies Building is too steep without handrails or intermediate landings. The ramp leading to the northwest entrance of the building is also too steep to be accessible, and the handrails do not extend the entire length of the ramp.

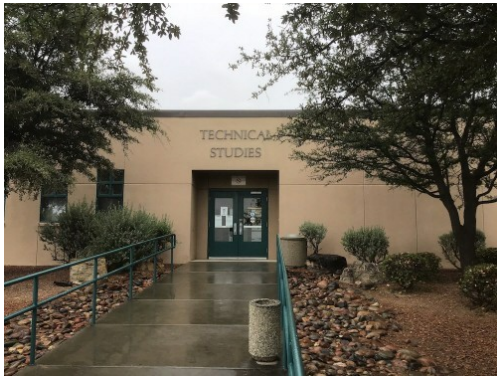
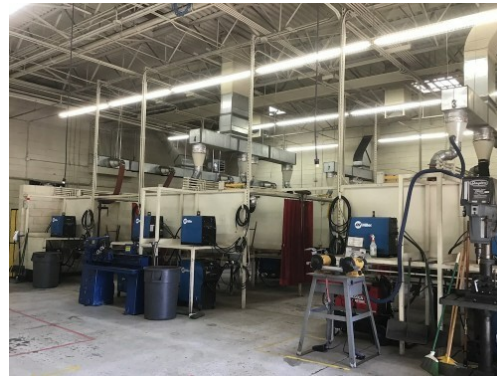
## Building Assessment

A concrete slab-on-grade fountain, concrete masonry unit (CMU) walls, and steel joists compose the building's structure. The structure appears to be in good condition.

The roofing material consists of thermoplastic polyolefin (TPO), which was installed in 2018 and is in good condition. A few ceiling tiles show stains, possibly resulting from roof or mechanical system leaks. Metal caps are in good condition and cover the parapets.

Stucco finishes the exterior walls. The stucco ranges from good to fair condition, but it is discolored and cracked under the roof drain spouts. Minor cracks run through the stucco on some roof parapets. Due to possible water damage, a small section of stucco shows bubbles and cracks below the door to the exterior electrical equipment yard.

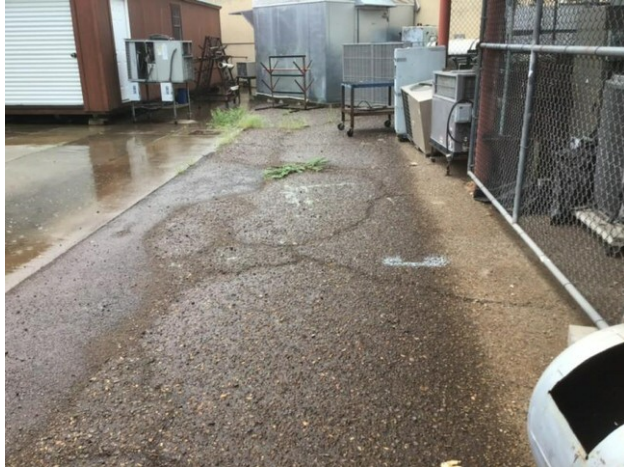
## Project 0357.2001 · Yard Pavement Improvements

The asphalt pavement shows exposed, loose aggregate in the lab yards.

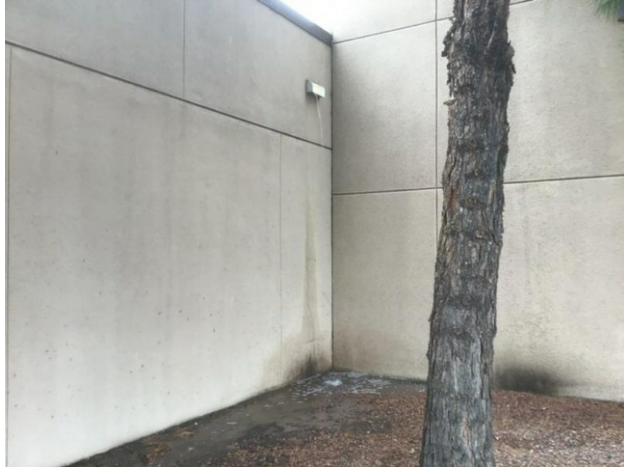
## Project 0357.2002 · Drainage Improvements

Rainwater from the roof gutters ponds next to the building near the north corner of the facility and also below the electrical equipment outside the welding lab.

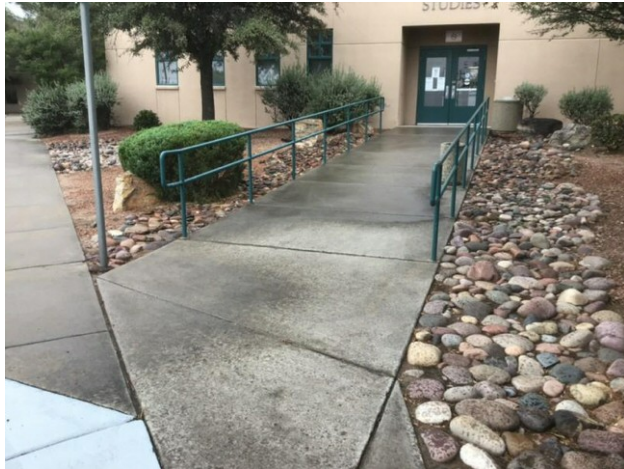
## Project 0357.2003 · ADA Compliance: Ramp Improvements

The ramp along the northeast side of the Technical Studies Building has a steep slope without handrails or intermediate landings. The concrete spalled on the retaining wall lining the ramp. The stucco bubbled and peeled due to water damage. The ramp leading to the northwest entrance is too steep and the handrails do not extend across the full length of the ramp.

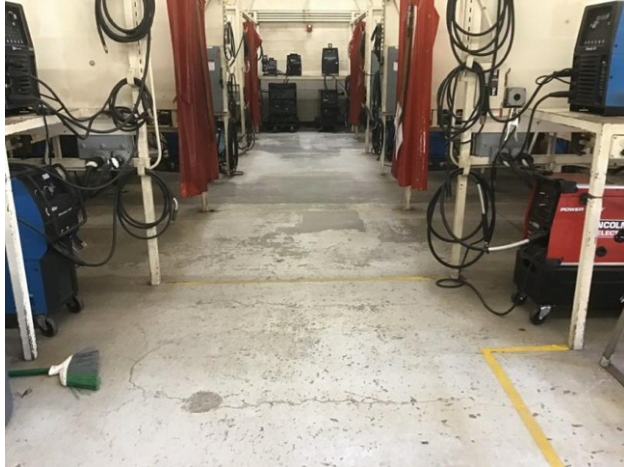
## Project 0357.2005 · Interior Improvements

The painted concrete floors show chips in some areas of the the welding lab and the HVAC lab. The painted CMU walls exhibit dirt and grime in the automotive lab and welding lab. A few suspended acoustic ceiling tiles show water stains, possibly from the roof, roof drain, or mechanical system leaks. Several offices show mismatched tiles. The laminate countertops are delaminating in break room 141B and storage room 141A.

Clean and paint the concrete floors in the welding lab and HVAC lab. Clean and paint the walls in the automotive lab and welding lab. Replace the stained and mismatched ceiling tiles. Replace the delaminating countertops.

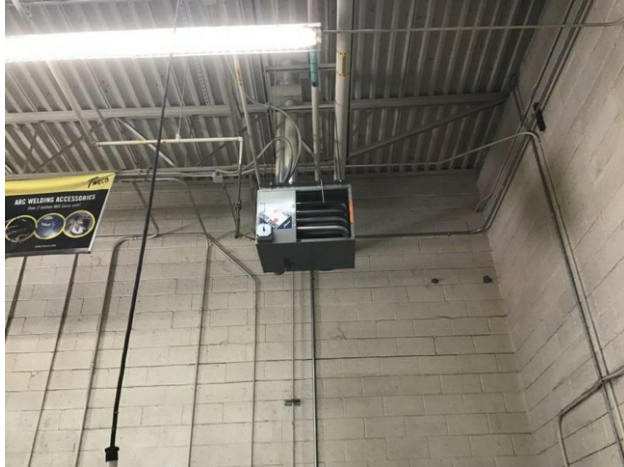
## Project 0357.2006 · Welding Lab HVAC Improvements

The four overhead heaters in the welding lab do not adequately heat the space, and the ventilation system above the welding stations does not meet the lab's needs.

Replace the heaters in the lab, and install an improved exhaust system.

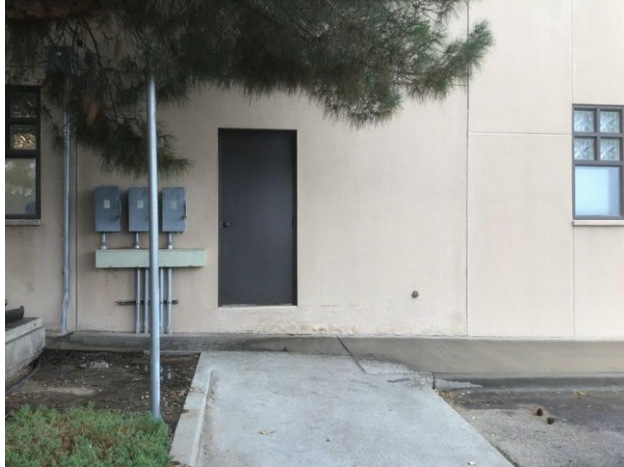
## Project 0357.2007 · ADA Compliance: Interior Improvements

A number of rooms lack tactile and Braille signs. No lockers include ADA signs in automotive storage room 156E, welding lab 150, or facilities support room 157C. A few exterior and interior doors offer doorknobs rather than lever-style hardware.

Install tactile and Braille signs where needed. Mark a locker in each location as accessible. Replace the doorknobs with lever-style hardware.

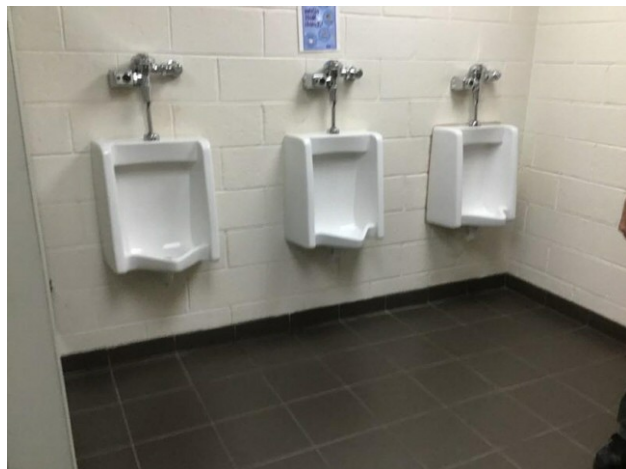
## Project 0357.2008 · ADA and Code Compliance: Restroom Improvements

No vertical grab bars hang in the accessible stalls in restrooms. No insulation wraps the sink pipes in west restrooms R157 and R159. In all restrooms, except men's restroom R159, the toilet paper dispensers hang too close to the grab bars. In the east men's restroom R145, no partitions separate the urinals.

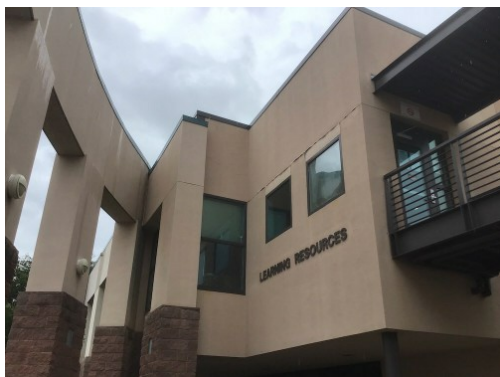
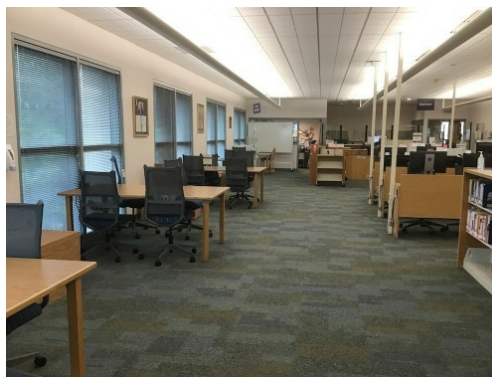
## Building Assessment

The Learning Resources Building is a two-story structure on the site's northeast quadrant. Alex Sanchez Hall wraps the building on the north and east sides with the Technical Studies Building to the west, the General Classroom Building to the southeast, and the large parking lot to the south. In 1995, the college constructed the Learning Resources Building and the General Classroom Building simultaneously; an exterior, second-story walkway connects the two buildings.

A concrete slab-on-grade foundation and steel frame construction compose the building's structure. The structure appears to be in good condition, and staff report no concerns.

The college installed thermoplastic polyolefin (TPO) roofing in 2018. The TPO roof is in good condition. Metal caps cover the parapets and remain in good condition. Built-up roofing with asphalt cap sheets covers the roof on the elevated walkway connecting the Learning Resources and Classroom Buildings. The built-up roof is in fair condition; however, the aggregate is thinning, and the scrim shows through in some areas.

Stucco covers the exterior walls, and split-face concrete masonry unit (CMU) blocks wrap the lower portions of the columns supporting the second floor. The stucco covering the building ranges from fair to poor condition with extensive cracks and mismatched colors. Facilities staff plan to redo the building's stuccowork in the fall of 2022.

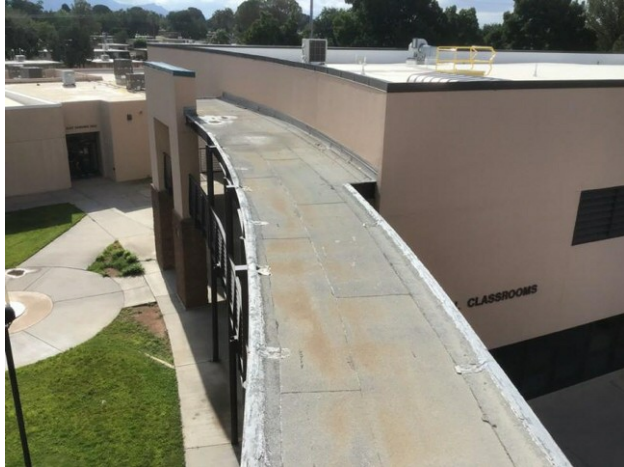
## Project 0479.2001 · Roof Improvements

A built-up roof covers the elevated walkway connecting the Learning Resources and Classroom Buildings. This built-up roof is in fair condition; however, the aggregate is thinning and the scrim shows through in some areas.

Replace the built-up roof with a TPO roof.

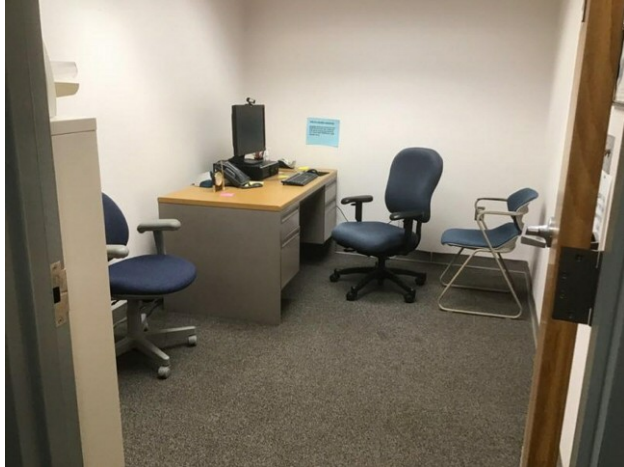
## Project 0479.2002 · Interior Improvements

Many of the offices include old carpet. Several ceiling tiles show stains in the Science, Engineering, and Math Office Suite's corridor on the second floor.

Replace the carpet tile in the offices. Replace the stained ceiling tiles.

Most ceilings hold suspended acoustic ceiling tiles (ACT), but the restrooms and several corridors have hard-lid ceilings. The ceiling finishes are in good condition. However, several ceiling tiles show stains in the second-floor corridor of the Science, Engineering, and Math (SEM) office suite.

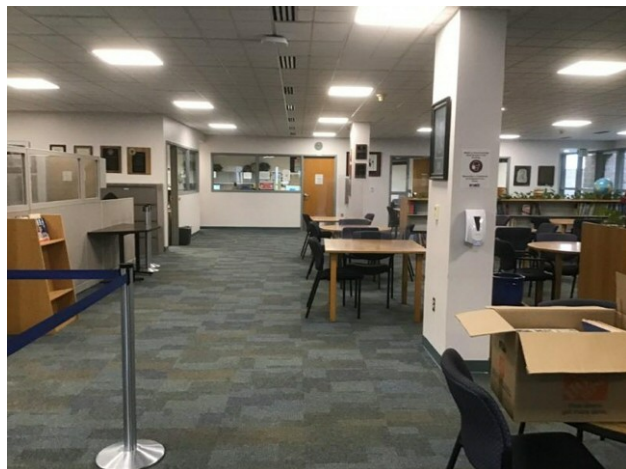
## Project 0479.2005 · Fire Suppression System Installation

The building does not have a fire suppression system.

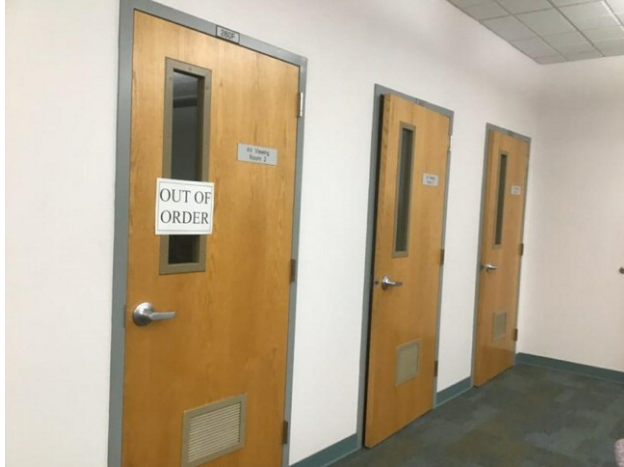
## Project 0479.2006 · ADA Compliance: Sign Improvements

Most rooms lack tactile and Braille signs.

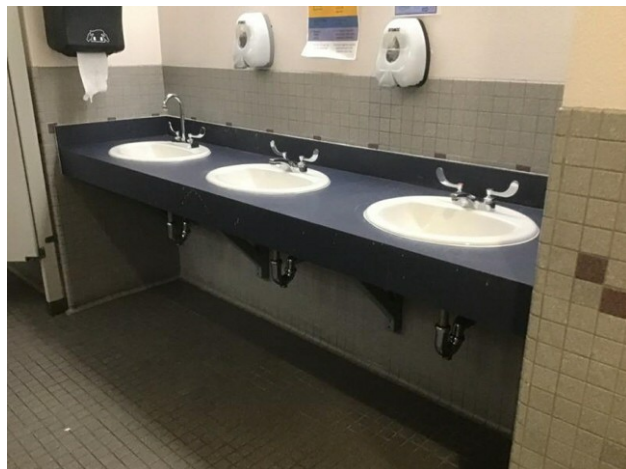
## Project 0479.2007 · ADA and Code Compliance: Restroom Improvements

The first- and second-floor restrooms lack vertical grab bars and have toilet paper dispensers hanging too far from the toilets; both of these occur in the men's restrooms and the women's restrooms. Sinks lack pipe insulation in the second-floor restrooms. No partitions separate urinals in the men's restrooms.

Most rooms lack tactile and Braille signs. The men's restrooms and women's restrooms on the first and second floors lack vertical grab bars, and the toilet paper dispensers hang too far from the toilets. The sinks in the second-floor restrooms lack pipe insulation. No partitions separate the urinals in the men's restrooms.

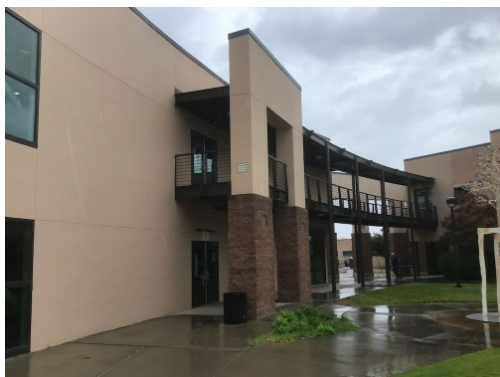
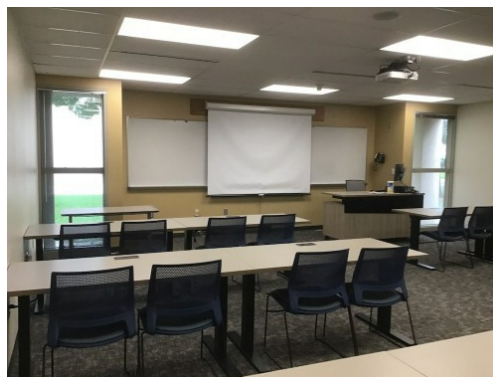
## Building Assessment

The General Classroom Building is a two-story structure on the site's east side. The Learning Resources Building sits northwest of the General Classroom Building, with the Health and Public Services Building to the south, Alex Sanchez Hall to the east, and the Technical Studies Building, and the school's large parking lot to the west. In 1995, the college constructed the General Classroom Building and the Learning Resources Building simultaneously. An exterior, second-story walkway connects the two buildings.

A concrete slab-on-grade foundation and steel frame construction compose the building's structure. The structure appears in good condition, and the staff reports no concerns.

Thermoplastic polyolefin (TPO) installed in 2018 covers the roof and is in good condition. Metal caps in good condition cover the parapets.

Stucco covers the exterior walls, and split-face concrete masonry unit (CMU) blocks wrap the lower portions of the columns at the entrances. The stucco covering the building received refinishing about three years ago and is in good condition.

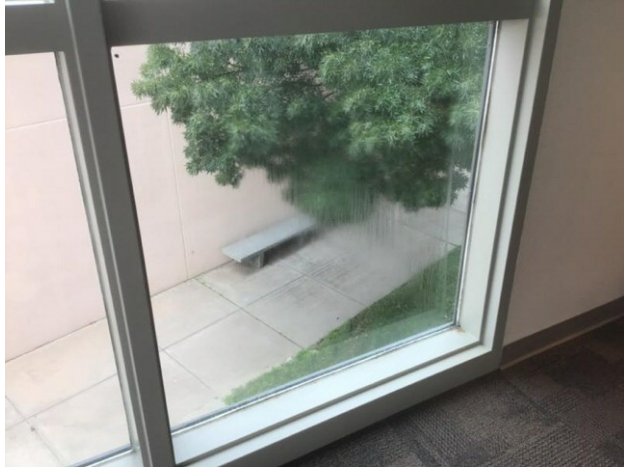
## Project 0480.2001 · Exterior Window Improvements

The double-glazed windows are in good condition, but several window panes show trapped condensation.

Replace the windows with trapped condensation.

The building offers fixed, double-glazed, metal-framed windows. The windows are in good condition, but several window panes have trapped condensation.

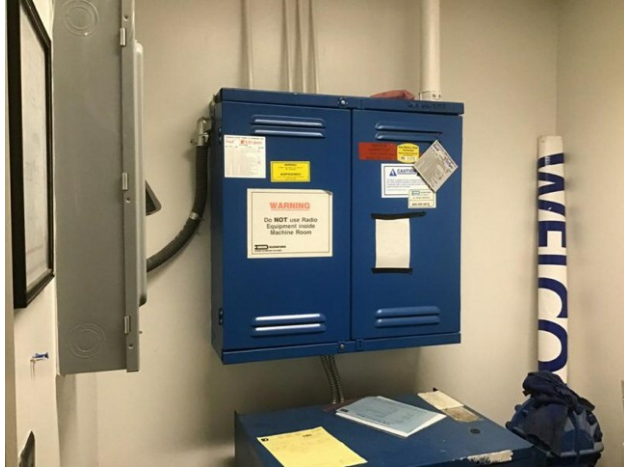
## Project 0480.2002 · Elevator Modernization

The elevator serving the building is original. Replacement parts for the elevator will soon be unavailable, making repairs impossible.

The elevator serving the building is original. Staff reports that replacement parts for the elevator will soon be unavailable, making repairs impossible.

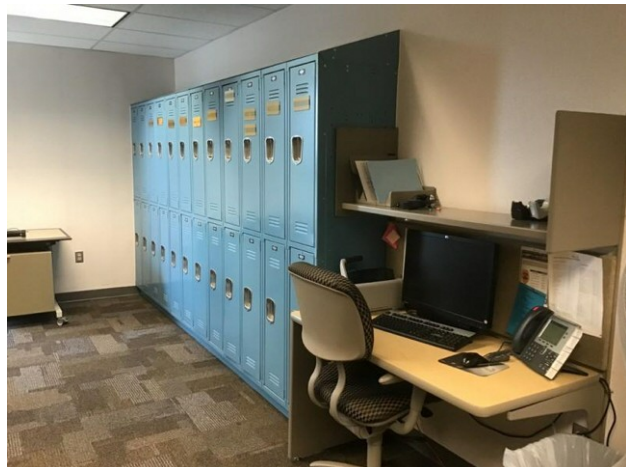
## Project 0480.2005 · ADA Compliance: Sign Improvements

Several rooms lack tactile and Braille signs. None of the lockers in room 270 are marked as accessible.

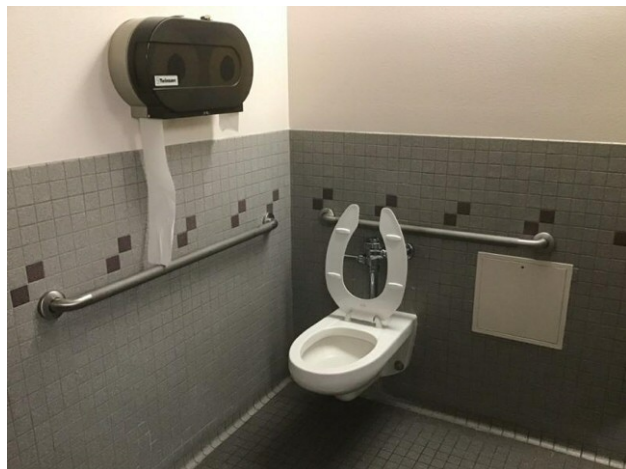
## Project 0480.2006 · ADA and Code Compliance: Restroom Improvements

The men's restrooms and women's restrooms lack vertical grab bars in the accessible and ambulatory stalls. The toilet paper dispensers hang too high to be ADA compliant in the accessible stalls. No insulation wraps the sink pipes in restrooms, except in the women's second-floor restroom. No partitions separate the urinals in the men's restrooms. In the women's second-floor restroom, the toilet's flush control is not on the open side of the stall.

The men's and women's restrooms include no vertical grab bars in the accessible and ambulatory stalls, and the toilet paper dispensers hang too high. No insulation wraps the sink pipes except in the women's restroom on the second floor. No partitions separate the urinals in the men's restrooms. In the second-floor women's restroom, the toilet's flush control is on the wrong side of the stall.

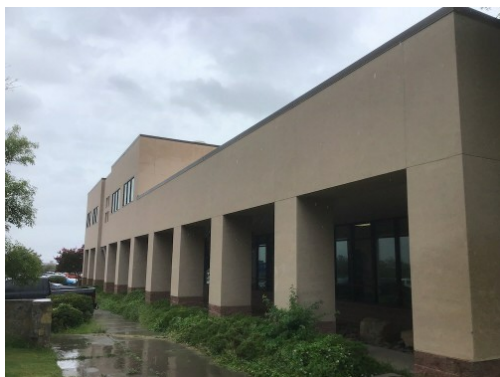
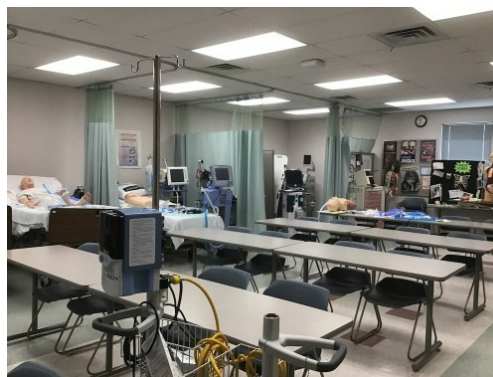
## Building Assessment

The Health and Public Services Building is a two-story facility on the site's south corner. A colonnade connects the structure to the south end of Alex Sanchez Hall, which stands east of the building. The Classroom Building sits north of the Health and Public Services Building, and parking lots border the west and south sides. DACC constructed the building in 1996, and it holds classrooms, labs, and offices.

A concrete slab-on-grade foundation and steel frame construction compose the building's structure. The structure appears in good condition, and staff report no concerns.

The college installed thermoplastic polyolefin (TPO) in 2020. TPO covers most of the roof, except for a tiny section of standing seam metal roofing over the internal stairway and elevator. Both roofs are in good condition. No ladder leads to the lower section of the roof. Accessing the roof from Alex Sanchez Hall is possible, but it requires traveling over or under large pipes.

Stucco covers most of the exterior wall surface and split-face concrete masonry unit (CMU) blocks wrap the lower portion of the building. The CMU is in good condition. The stucco is in fair condition, and it shows numerous small cracks on most sides of the building.

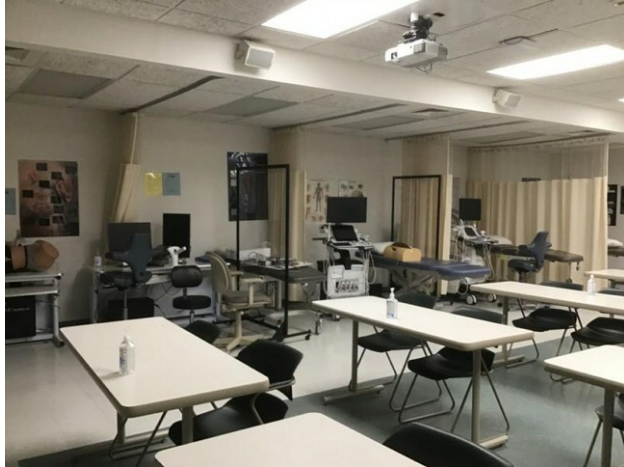
## Project 0540.2002 · HVAC Improvements

The equipment in sonography lab 291 generates a lot of heat. The instructors need to keep the room cool, which requires lowering the temperature for the whole building.

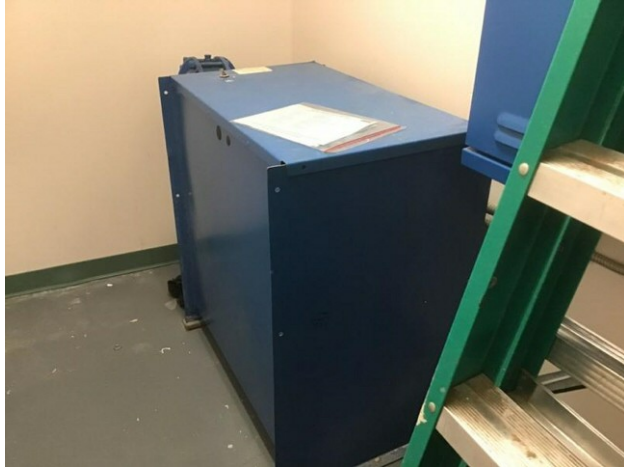
## Project 0540.2003 · Elevator Modernization

The elevator serving the building is original. Replacement parts for the elevator will soon be unavailable, making repairs impossible.

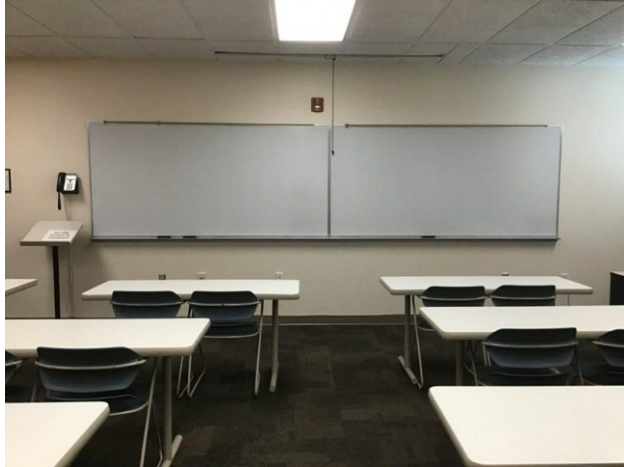
## Project 0540.2004 · Fire Alarm Upgrade

The fire alarm system is aging.

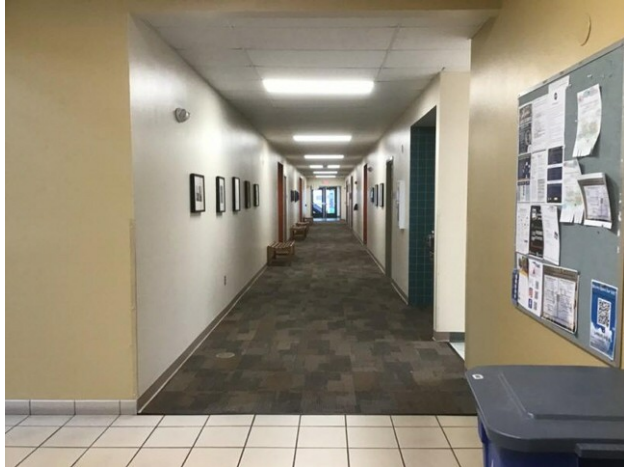
## Project 0540.2005 · Fire Suppression System Installation

The building does not have a fire suppression system.

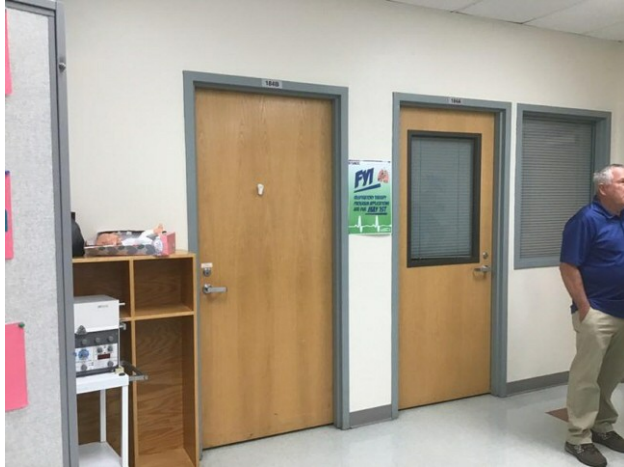
## Project 0540.2006 · ADA Compliance: Sign Improvements

A number of rooms lack tactile and Braille signs.

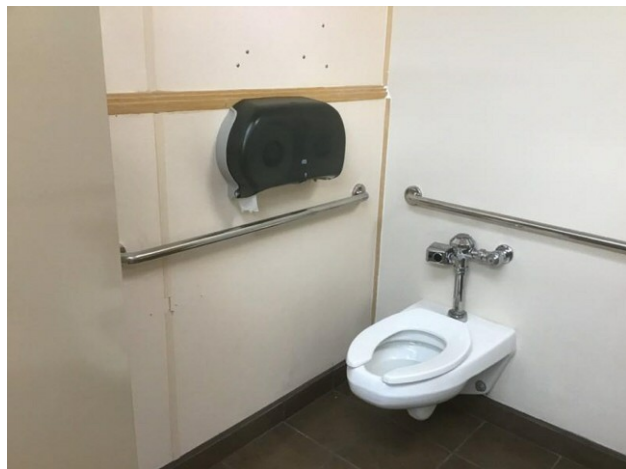
## Project 0540.2007 · ADA Compliance: Restroom Improvements

The first- and second-floor multistall restrooms have no sink pipe insulation and no vertical grab bars. The restrooms in classrooms 184 and 291 lack vertical grab bars. The toilet paper dispenser hangs too close to the side grab bar in the women's first-floor restroom.

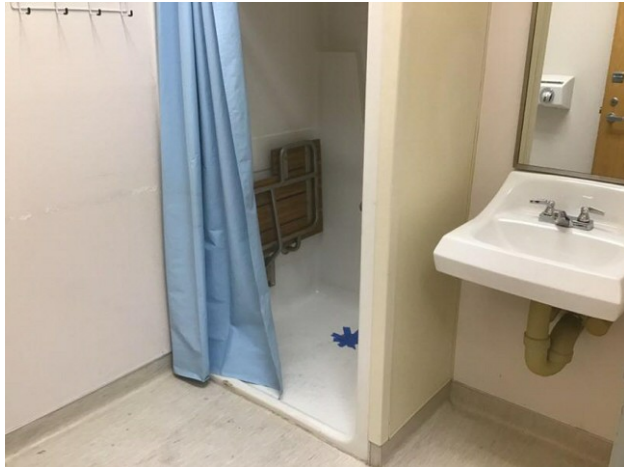
## Project 0540.2008 · ADA Compliance: Shower Room Improvements

The transfer shower in shower room 187D has a threshold that is too high. Room 187D does not offer the required clearance on the seat wall. The transfer shower in restroom 291C does not provide the necessary clearance on the seat wall.

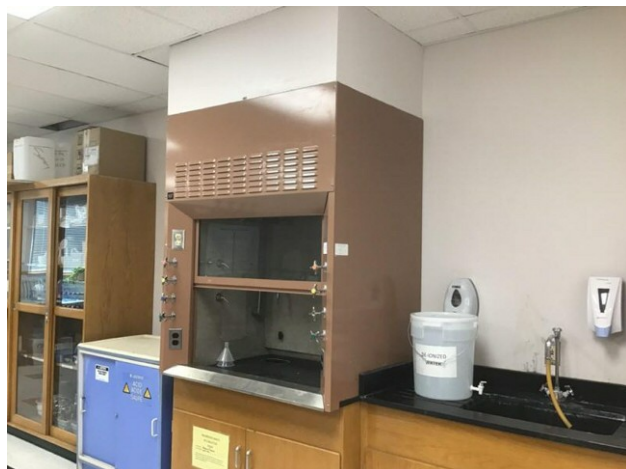
## Project 0540.2009 · Science Lab Upgrades

Science labs 181 and 183 have not been updated since the building's construction in 1996. The finishes and casework range from good to fair condition. The VCT flooring shows minor wear, scuffs, and cracks. In science lab 183, no vacuum lines run to the desk; the fume hood requires an update, including vacuum and gas connections. The hot plates in science lab 183 can trip the circuits. No drains collect water at the emergency showers in science labs 181 and 183.

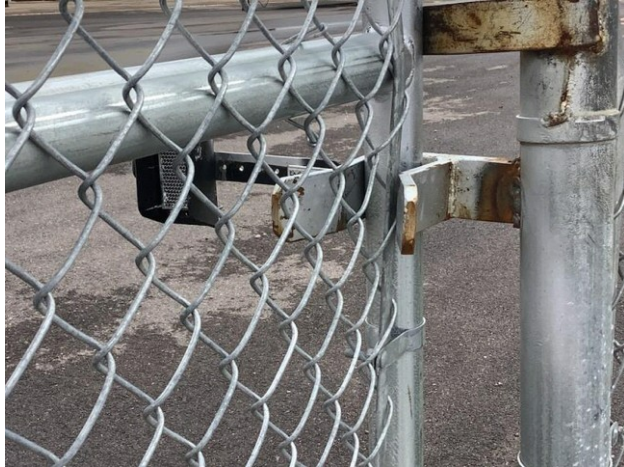
## Project 0476.2001 · Site Access and Marking Improvements

Staff report that trucks frequently break off the remote reflector for the chain-link gate when they turn into the storage space. Staff say that the Truck Driving Academy's markings are insufficient for the program's needs. The north lot lacks fire lane markings.

Signs and gates are in good appearance and good operating condition. Staff report that trucks frequently break off the remote reflector for the chain-link gate when they turn into the storage space.

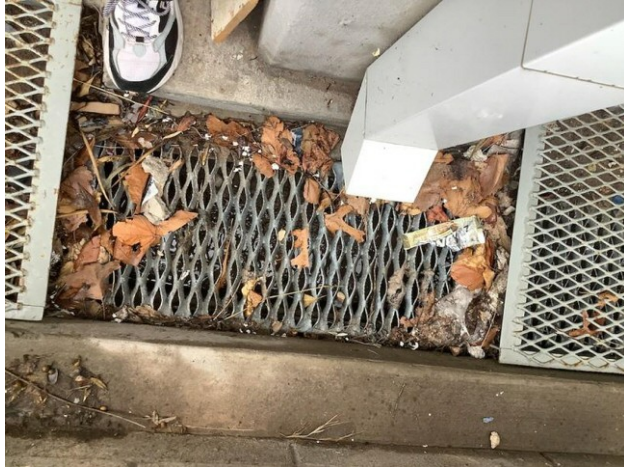
## Project 0476.2002 · Site Drainage Improvement and Damage Remediation

The storm grate along the east lot, between the college and the adjacent building supply company, collects water directed from the roof and site. Dirt and debris fill the grate, causing water to pond and flood a portion of the outdoor pottery space and the east corridor exit. Water infiltrated the building and caused damage to the floor finish in the administrative conference room.

Clean out drain pipes and storm drains. Replace damaged carpet tiles in the administrative conference room.

The site drains from the northeast to the west and south. Parking lots carry stormwater to the west edge of the campus, a retention pond on the building's northwest corner, and Nevada Ave. A storm grate lies along the east lot line, between the college and the building supply company, and collects runoff water from the site and the roof. The storm grate contains dirt and debris, causing water to pond and flooding a portion of the outdoor pottery space and the east corridor exit. Water infiltrated the building and damaged the floor finish in the administrative conference room.

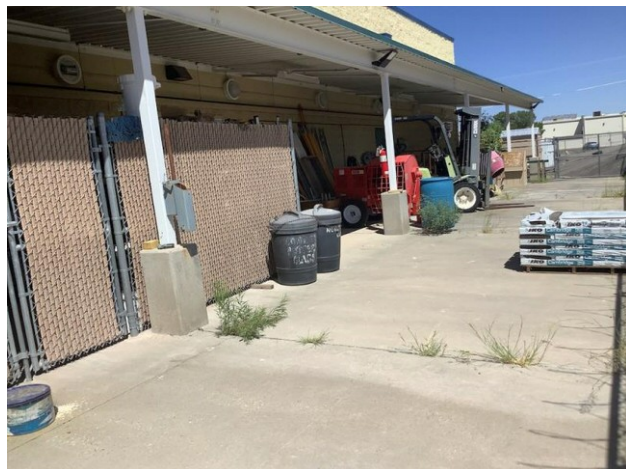
## Project 0476.2003 · Security Improvements

Concertina wire sits along the eastern chain-link fence and the retaining wall standing to the east of the outdoor pottery/construction space. Staff report that this area is an access point for the theft of materials and equipment from the outdoor learning spaces. Wind gusts in the area will blow out the flame on the gas kiln. Building materials lack secure storage. Some building materials sit in makeshift organizational shelves, typically under dock canopies; however, some materials lie in the open, exposed to the elements. There is no after-hour access to pottery kilns for firing events extending past business hours. Minimal lighting is provided at the outdoor learning spaces for construction technologies and the Truck Driving Academy. Building lighting is aging and broken in some areas. No security cameras are supplied on the exterior and interior of the building.

Extend chainlink fence and privacy/wind screen to roof canopy. Provide organizational shelving and an after-hours entry system to enclose and secure the equipment and materials in the outdoor learning spaces. Install pole lighting at the outdoor learning spaces for construction technologies and the Truck Driving Academy. Replace aged, broken building lighting. Install exterior and interior surveillance cameras.

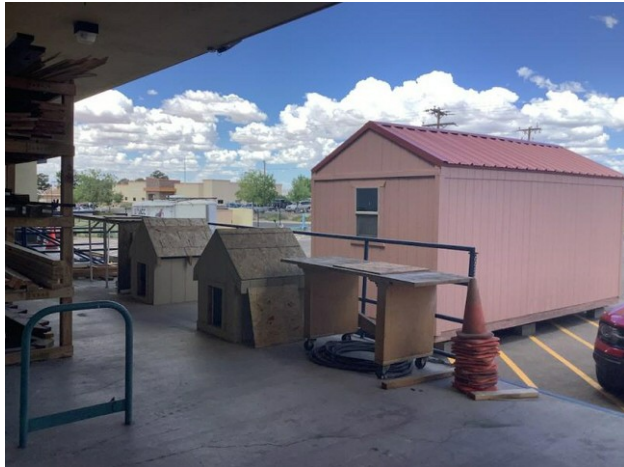
## Project 0476.2004 · Safety Improvements

The loading docks at the construction lab are too tall, lack visual barriers, and lack fall protection—as required by Occupational Safety and Health Administration (OSHA) standards. The pottery kilns lack a carbon monoxide detector.

Staff lacks after-hour access to pottery kilns for firing events. The kiln's gas flame extinguishes in windy conditions and lacks a remote alert system for when this happens. The firing area lacks a carbon monoxide alarm.

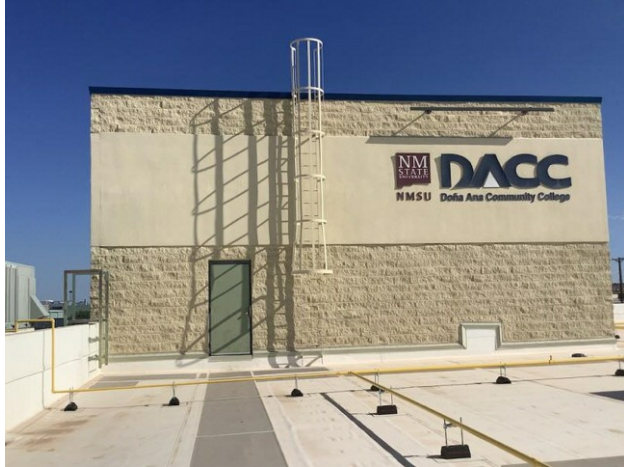
## Project 0476.2005 · Roof Ladder and Cage Replacement

The access ladder to the penthouse roof is surrounded by a safety cage, which is no longer acceptable per current OSHA requirements.

Replace the roof ladder and safety cage with an OSHA-compliant roof ladder, equipped with a ladder safety system or personal fall arrest system.

The second-story penthouse gives access to the main roof, and fixed roof ladders reach the second-story roof and over the walls. The access ladder to the penthouse roof is surrounded by a safety cage which are no longer acceptable per current OSHA requirements. A crane lift stands in the penthouse for large equipment. Membrane-capped parapets with metal drip edges surround the perimeter and the roof firewalls. The parapets are in good general condition. Membranes cover the flat roofs and generally appear in good condition—exhibiting minimal ponding and sandy deposits near seams, roof drains, scuppers, and corners. Roofs slope to internal drains with scuppers and roof gutters with downspouts, all of which appear clear of debris. Splash guards protect the roof membrane from the second story's drain runoff. Drains lead to the ground and empty to splash guards, storm grates, and landscape drains. Walkway pads surround mechanical systems. The elevated gas lines have yellow paint. Metal-panel canopies are in good condition over the entrance and the outdoor pottery space.

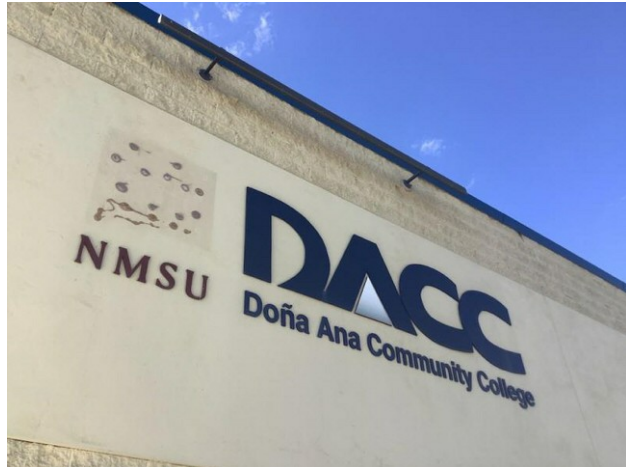
## Project 0476.2007 · Exterior Surface Improvements

On the north side of the building, identification signs are warped and missing decorative panels. The stucco is dirty and exhibits impact damage near the administrative windows. The east facade shows bulging, cracked stucco on the second story. The overhang's soffits and the concrete walls at the loading docks exhibit peeling paint. Several exterior doors exhibit wear and oxidation.

Replace identification signs. Power wash and repair damaged stucco. Fog coat the stucco to match the remaining stucco. Repaint soffits, walls, and doors.

Exterior walls are stucco with two-tone color and expansion joints, which create a decorative finish. The stucco exhibits impact damage near the administrative windows. Bulging and cracked stucco appears at the east façade on the second story.

Building identification signs hang on the south and north facades. The signs on the north side are warped and missing decorative panels.

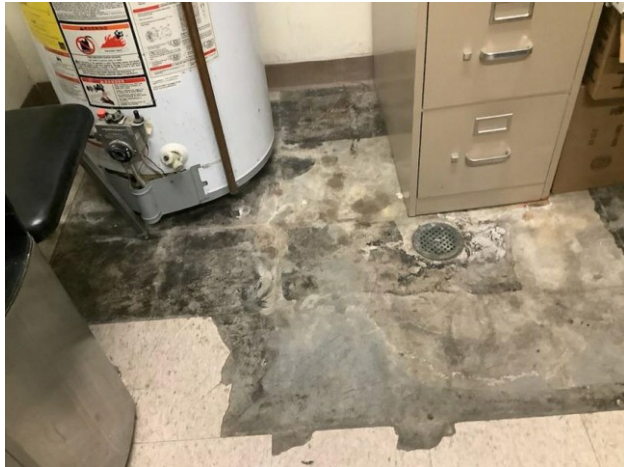
## Project 0476.2008 · Interior Floor Improvements

The aged vinyl composition tile (VTC) is in fair condition and covers most of the facility. Corridors floors are polished, and lab floors appear worn and dull. The VTC floor near the water heater is broken in the janitorial closet by the commons, and large areas of the VTC are missing. Exterior mechanical rooms are typically concrete, and those with a painted finish are worn and peeling.

Replace VTC in the janitorial closet and repaint the concrete floors.

Ceramic tile covers the floors in the south and east lobbies with floor mats lying at the doors; all are in good condition. The aged vinyl composition tile (VTC) is in fair condition and blankets most of the facility. The corridors floors are polished while lab floors appear worn. The lab floors have OSHA markings around all equipment, and the plumbing lab includes grate drains in the floor. The carpet acts as a sound insulator in classrooms. The carpet is in good condition, except for the water infiltration damage in the administrative conference room. The restrooms' ceramic tile floors are clean and in good condition, although tile styles differ between the public restrooms. The VTC floor near the water heater in the janitorial closet near the commons is damaged, with large areas missing. Exterior mechanical rooms exhibit concrete floors, and those with a painted finish are worn and peeling.

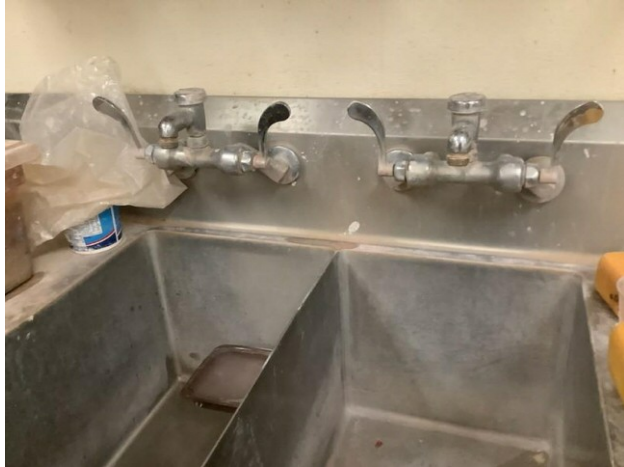
## Project 0476.2009 · Interior Wall Improvements

Fiber-reinforced panels (FRP) hang in the wet areas of all the labs, except at the sinks in the pottery classroom.

Walls have painted gypsum board with corner guards throughout most of the building. The construction technology labs feature painted CMU walls. Acoustic panels hang in the automation and manufacturing lab. Fiber-reinforced panels (FRP) hang in all the labs' wet areas, except the pottery classroom sink. Metal surrounds protect the walls at the mop sinks in the janitorial closets. Centralized classrooms have acoustic sliding partitions between rooms. The various wall systems are in good condition but show wear near sinks in lab classrooms.

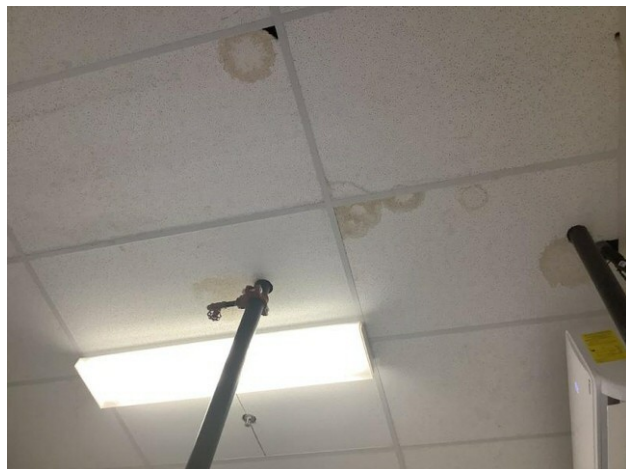
## Project 0476.2010 · Ceiling Improvements and Fire Suppression Leak Inspection

Water stains appear on the ACT near the fire risers in room E124, various sprinklers throughout the building, and the east corridor's exit door that is adjacent to the administrative conference room.

Replace stained ACT and schedule a service call for leaks in the fire suppression lines.

Acoustic ceiling tiles (ACT) hang in offices, general classrooms, corridors, and lobbies. Tiles are generally in good condition. However, water stains appear near fire risers, sprinklers, and the east corridor's exit door, which is adjacent to the administrative conference room. The construction technology labs have exposed-structure ceilings and show no damage.

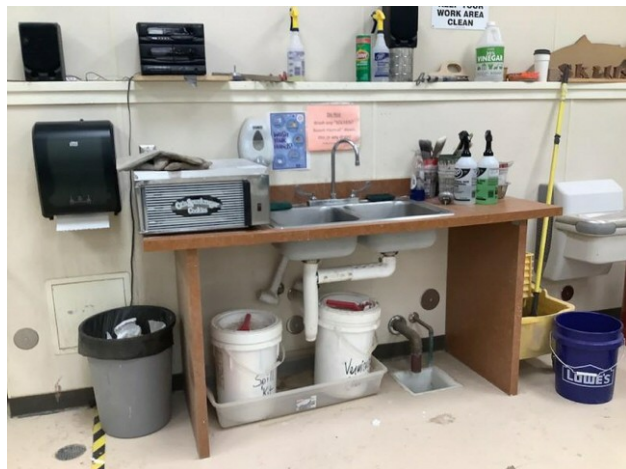
## Project 0476.2011 · Casing Improvements

The countertop and sink in the construction lab are aged and worn. The drain lacks a paint trap. The pottery classroom does not provide a sink with an ADA-compliant reach range.

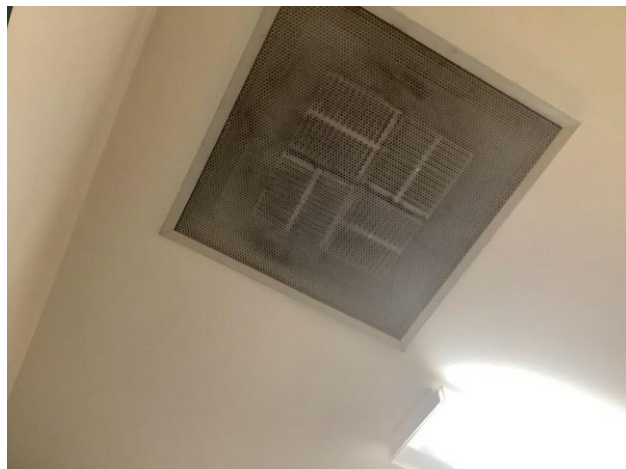
## Project 0476.2013 · Heating, Ventilation, and Air Conditioning Upgrades

Staff report hot and cold rooms in the administrative wing with a lack of airflow in offices. Air vents are clogged with dust and debris throughout the facility. Air circulation fans are not available in lab rooms and outdoor learning spaces. The pottery classroom does not contain mechanical ventilation or filtration. The staff placed MERV 13 filters in the return ducts to prevent particulates and other contaminants from infiltrating the rest of the duct system.

Balance heating, ventilation, and air conditioning system (HVAC) in the administrative wing. Clean ducts throughout the structure. Install ceiling fans in the lab classrooms and outdoor learning spaces. Install an energy recovery ventilation (ERV) system in the pottery classroom.

Rooftop combination units temper the facility, and temperature control is off-site. The structure lacks mechanical ventilation, and doors are the only source of passive ventilation. Staff reports hot and cold rooms and a lack of airflow in offices. Evaporative cooling units hang in construction labs that utilize garage doors. Air-circulation fans are missing in the construction lab rooms, docks, and the outdoor pottery learning space.

The pottery glazing storage room contains a direct exhaust vent, but the rest of the room does not offer mechanical ventilation or filtration. The school has placed minimum efficiency reporting values (MERV) 13 filters in the return ducts to prevent particulates and other contaminants from infiltrating the rest of the duct system.

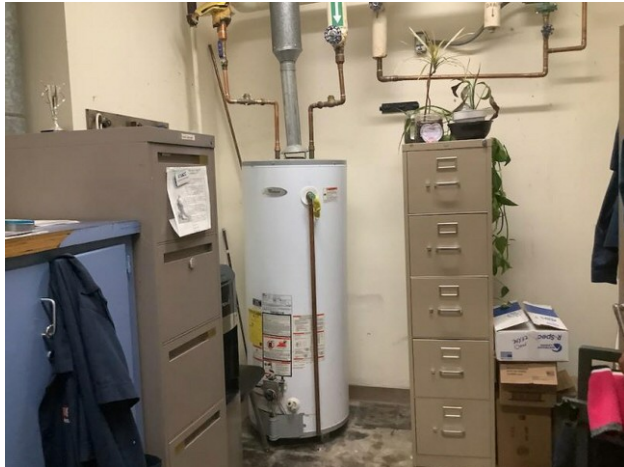
## Project 0476.2014 · Hot Water System Improvements

Aged, energy-inefficient domestic water heaters supply hot water. Copper hot-water pipes near the water heaters are uninsulated. Legacy vent ducts remain from old equipment.

Replace water heaters with energy-efficient models that have recirculating pumps. Insulate the copper pipes. Remove legacy vent ducts. Repair and paint the gypsum board.

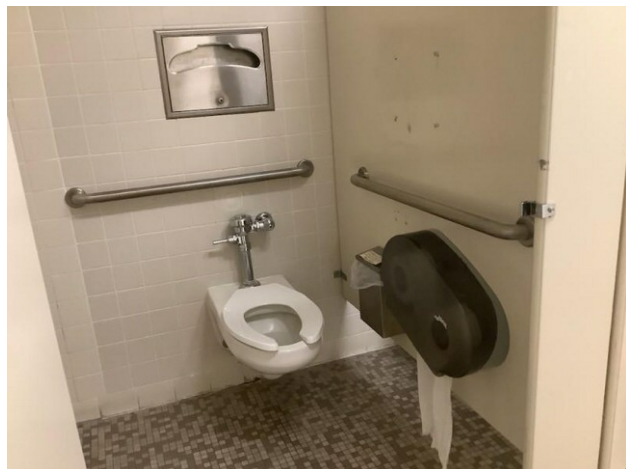
## Project 0476.2015 · ADA Compliance: Restroom Upgrades

The administrative corridor does not have a dedicated restroom. Stall panels in the east restroom exhibit damage and holes from legacy fixtures. Vertical grab bars are missing in the west restroom. In the east women's restrooms, the grab bars and toilet paper dispensers hang too high to be ADA compliant.

Toilets hang from the wall, and faucets offer levered handles. All restroom fixtures appear in good condition. Restrooms include hose bibs and floor drains. Stall panels in the east restrooms exhibit damage and legacy holes.

Vertical grab bars are missing in the west restroom. Grab bars and toilet paper dispensers hang too high in the east women's restrooms.

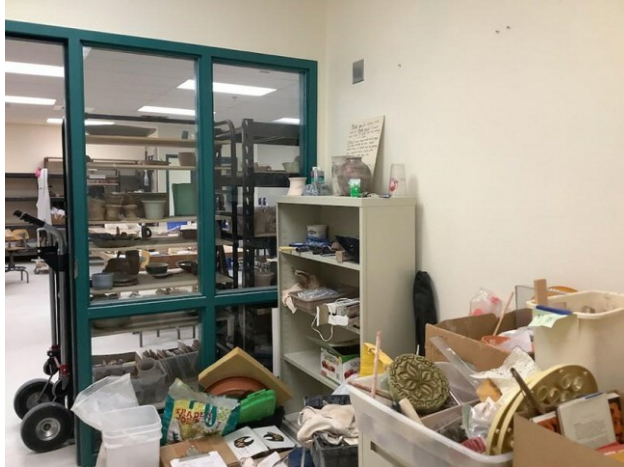
## Project 0476.2016 · Organizational Storage Improvements

The pottery classroom, the outdoor pottery space, and janitorial closets are crowded, lacking organizational shelving for equipment and supplies.
