# DACC

Doña Ana Community College

# Facilities Master Plan

**FMP 2023-2030**

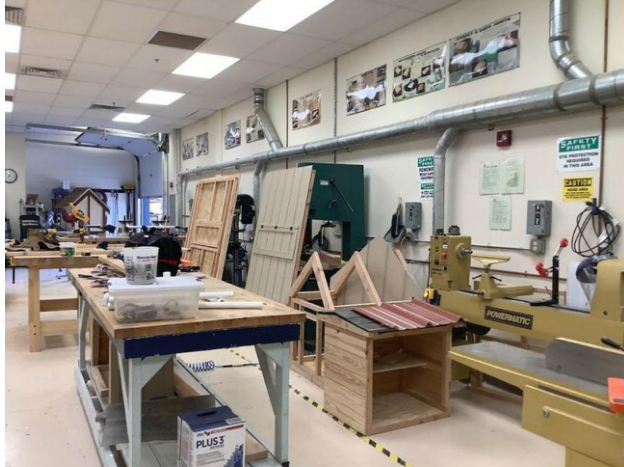
## Project 0476.2017 · Dust Collection Upgrade

The motor for the dust collection system in the construction lab does not provide adequate suction for all the shop equipment.

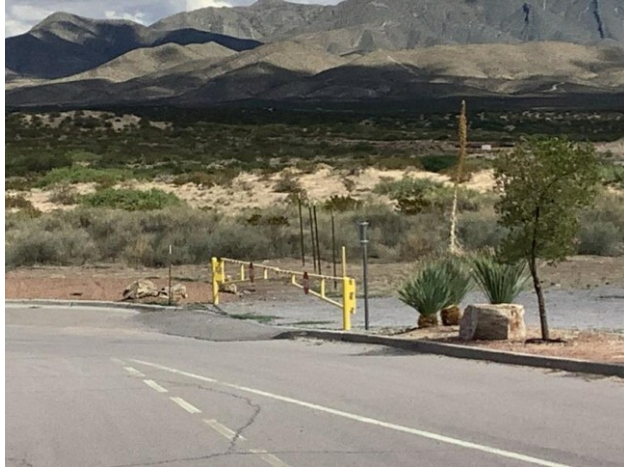
## Project 0567.2001 · Overflow Parking Lot Improvements

A tubular swing gate secures the overflow parking lot and swings into the street when opened. The asphalt creates a ramp leading into the overflow parking lot; however, the access point requires a curb cut. The pedestrian gate lacks an ADA-compliant curb ramp into the parking lot. No walking path leads to the overflow lot. A rolling chain-link gate opens on uneven dirt.

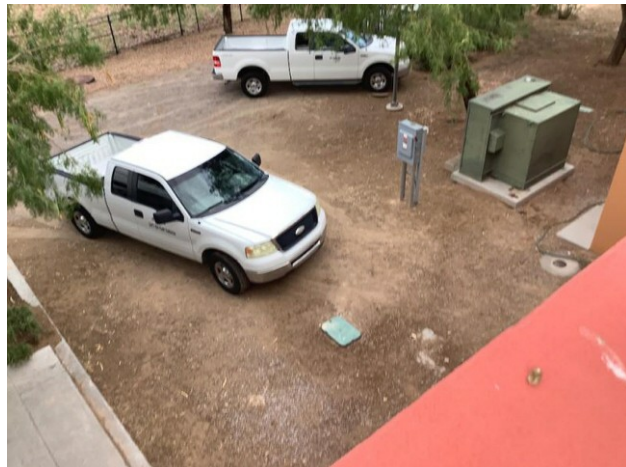
## Project 0567.2002 · Service Parking Lot

The service parking area lacks a paved surface. Traffic from service and delivery vehicles damages the cleanouts and other in-ground systems. The sidewalk entrance to the mechanical room lacks a curb ramp. One of the drain outlets is eroding and cracking the sidewalk.

A crusher-fine service drive extends from the south parking lot to a chain-link swing gate for the water station. The service drive then wraps around to the west of the Main Building and leads to the propane tanks, exterior-access mechanical rooms, and roof-access rooms. While the service road is in good condition, the access area lacks a paved parking area. Service -vehicle traffic damages the cleanouts and other in-ground systems.

At the exterior entrance of the west mechanical room, the sidewalk lacks a curb ramp from the parking area; drainage from the mechanical room erodes the sidewalk, creating cracks in the surface.

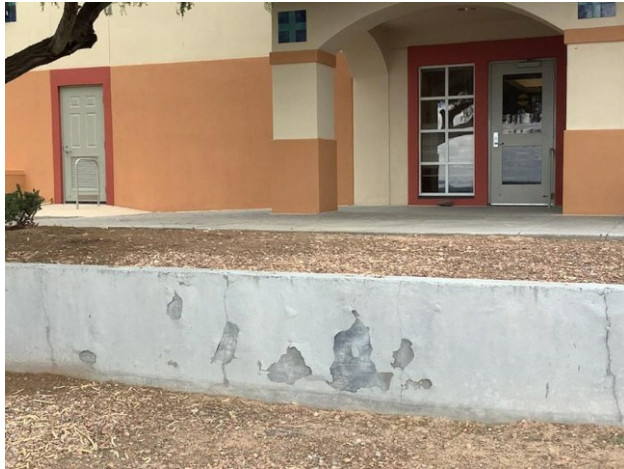
## Project 0567.2003 · Retaining Wall Improvements

Retaining walls are typically exposed concrete, and one painted area exhibits cracked and peeling paint. Although drains serve the base, efflorescence shows near areas of irrigation and on the stone veneer near the grass turf.

A stone veneer covers the east- and south-facing retaining walls near the parking lots and service road. Exposed concrete walls stand to the north and west, and one painted area exhibits cracked and peeling paint. Although drains lie at the base of the retaining walls, efflorescence shows near irrigation areas and within the stone veneer near the grass turf.

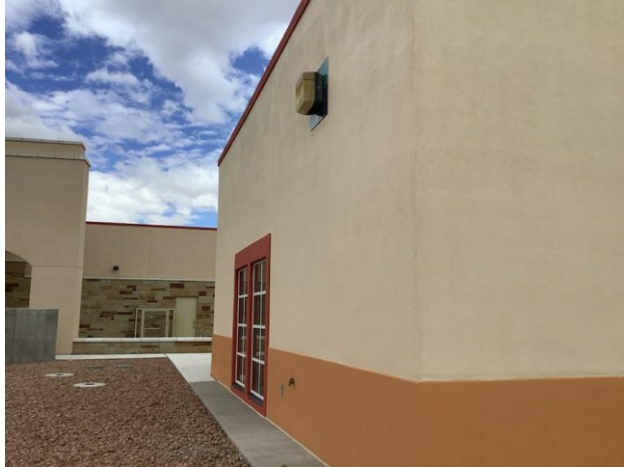
## Project 0567.2004 · Exterior Lighting Improvements

Wall pack light fixtures hang around the buildings on ceramic tile accents. The older wall packs exhibit yellowing and cracking.

Replace aged wall packs.

Pole-mounted lights illuminate the parking lots and walkways between the buildings. Ceiling-mounted fixtures illuminate the covered porches and entrances. Various models of wall packs hang at the building's exterior on ceramic tile accents. The older wall packs exhibit yellowing and cracking.

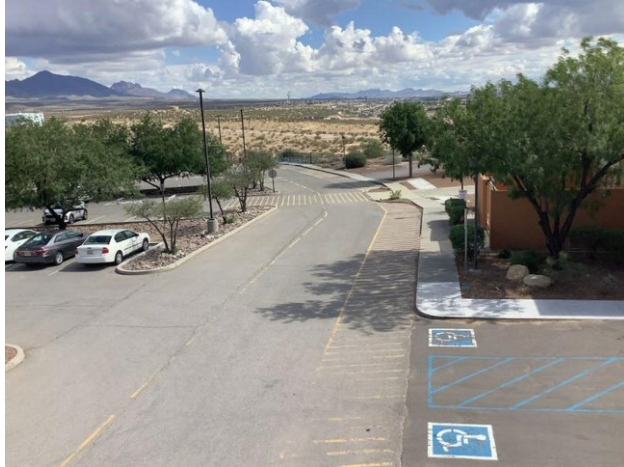
## Project 0567.2005 · ADA Compliance: Parking Lot Improvements

The parking lots lack two of the required accessible stalls. The aisles for van access lack No Parking markings. The asphalt is in good condition; however, grass grows in some long cracks, which cross the parking lots in the lane swales. Directional markings appear faded. The markings are also faded on the crosswalk, fire lane, drop-off zone, and parking stalls.

The parking lots lack the two required accessible stalls, and No Parking verbiage is missing from the van-access aisles.

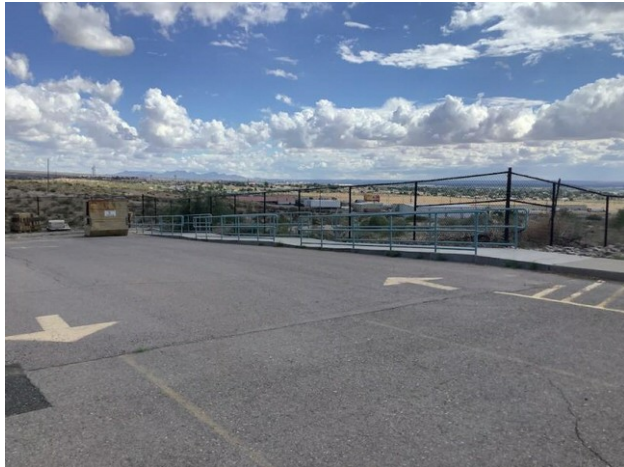
## Project 0567.2006 · ADA Compliance: Site Improvements

The east sidewalk leading to the south parking lot lacks detectable warnings at the curb ramps. Reclaimed water supplies irrigation, but no signs alert the public that the water is not potable. Two picnic tables and a bike rack stand in the landscape with decorative rocks. No accessible paths and pads serve the area with the picnic tables and the bike rack.

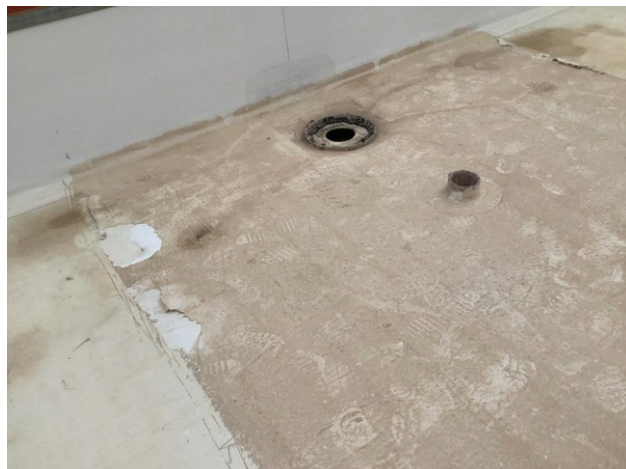
## Project 0567.2007 · Roof Upgrades

The original membrane roof ranges from fair to poor condition with patches, wrinkling, and a peeling coat. Walk pads are aged, cracked, and peeling away. The roof hatch at the west mechanical room lacks a safety railing. Several roof drain grates are broken. The roof vents are low and some are broken. Scuppers pour out to the sidewalks and building aprons, and runoff undermines the courtyard sidewalk. Several clay tiles are broken on the patio covers.

Ship ladders at the west mechanical room and the bell tower rise to roof hatches. The ship ladders lack safety railings. A secondary roof ladder rises from the north mechanical room and offers a safety post. Stucco-capped parapets surround the roof's perimeter and are in good condition. One area over the computer office exhibits caulked, cracked stucco. The membrane roof is original to the building, and it ranges from fair to poor condition with patches, wrinkling, and peeled coating. Walkway pads leading to mechanical units are aged, cracked, and peeling away. Several roof drain grates are broken and filled with debris. Roof vents are short, and some are broken. Scuppers pour out onto sidewalks and building aprons. The runoff undermines the courtyard sidewalk.

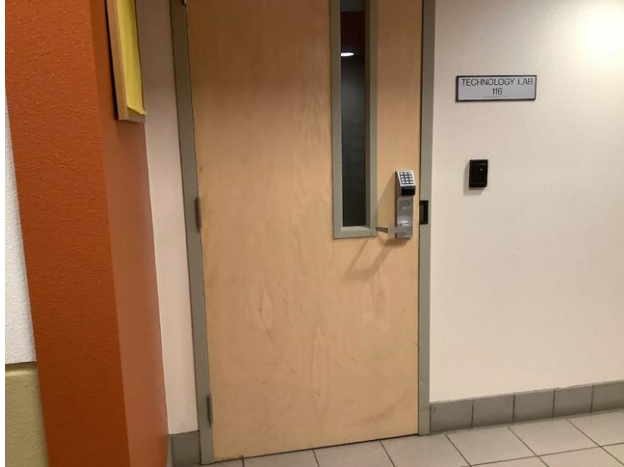
## Project 0567.2008 · Interior Improvements

The interior wall finishes are in good condition; however, the building lacks corner guards and a facility map.

Painted gypsum board finishes the interior walls with a two-tone wainscot in the corridors and accent colors around classroom doors. Ceramic tile wainscot protects the restroom walls behind plumbing fixtures. Acoustical panels hang in the construction technology lab. The interior wall finishes are in good condition; however, the building lacks corner guards.

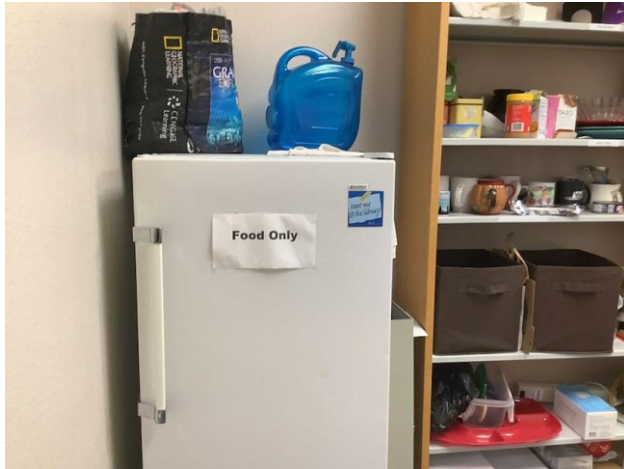
## Project 0567.2009 · Casework Upgrades

The library's break room was once a storage room and offers a microwave and refrigerator; however, it lacks casework, counters, and a sink. The administrative copy room uses old tables and shelving, but it lacks casework and a counter.

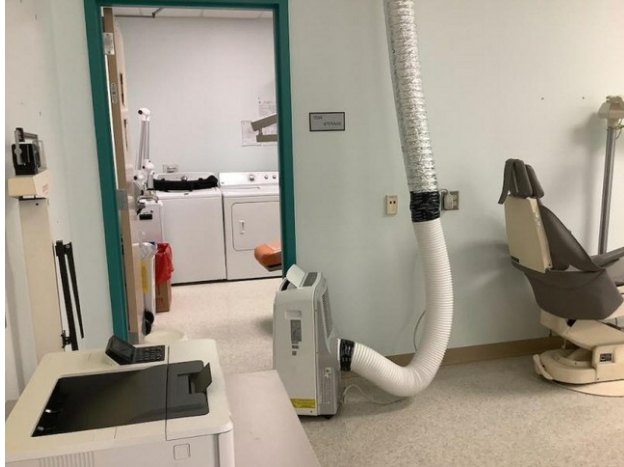
## Project 0567.2010 · HVAC Distribution Improvements

The dental lab clinic was once a health lab storage room and uses a portable HVAC unit to condition the room. The science lab maintains higher temperatures due to several heat-producing appliances and equipment. The construction technology lab lacks air circulation fans.

A portable unit conditions the dental lab clinic, which was once the health lab storage room. The science lab maintains higher temperatures due to several heat-producing appliances and equipment. The construction technology lab lacks air-circulation fans. Staff report that, due to fuel costs and limited on-site supply, temperatures are lowered outside of business hours and during breaks. Interior spaces are cold in the mornings and take a long time to reach warm temperatures.

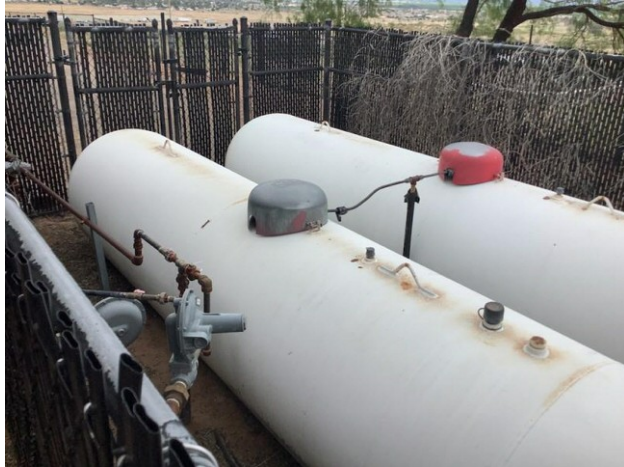
## Project 0567.2011 · Propane Tank Expansion

The Gadsden Center Campus operates with two propane tanks. Staff report that temperatures are lowered outside business hours and during school breaks in the heating season, due to fuel costs, limited on-site supply, and delivery schedules. Interior spaces are cold in the mornings and take a long time to reach warm temperatures.

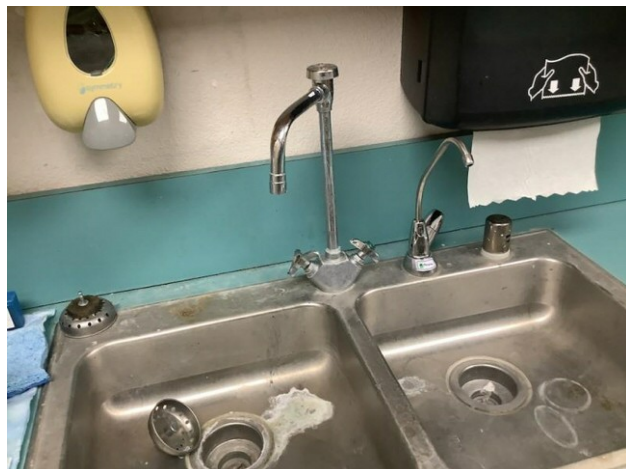
## Project 0567.2012 · Water Treatment Upgrade

The science lab sink and the drinking fountain near the administrative office show heavy mineral buildup, which is visible on plumbing fixtures and the tile surround at the drinking fountain.

Drinking fountains hang in each corridor, and the fountain near the administrative office shows heavy mineral buildup at the spout and on the tile surround. The science lab sink also exhibits heavy mineral buildup. The janitorial closet offers a mop sink and water-resistant backsplash and is in good condition.

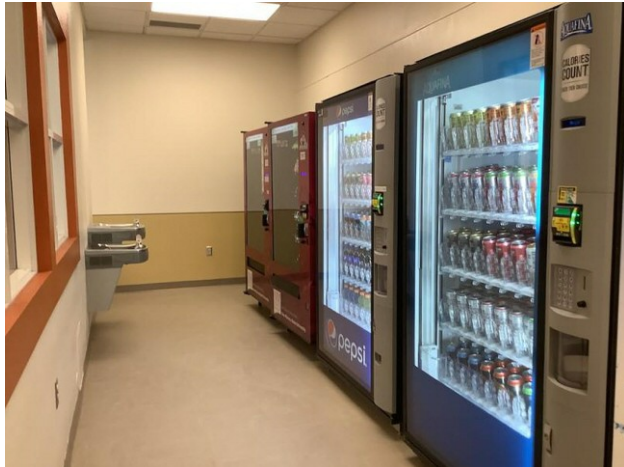
## Project 0567.2013 · ADA Compliance: Interior Improvements

The administrative counters lack an ADA-compliant section. Faucets in the science lab have twist handles. Drinking fountains protrude into the corridor outside the administrative office and the walkway near the commons vending machines. Unrefurbished restrooms lack vertical grab bars.

The building is mainly ADA-compliant. However, counter have ADA-noncompliant heights in the administrative office. Faucets in the science lab have twist handles. Drinking fountains protrude into the walkways at the corridor outside the administrative office and at the vending machines in the commons. The restrooms that have not received refurbishments lack vertical grab bars.

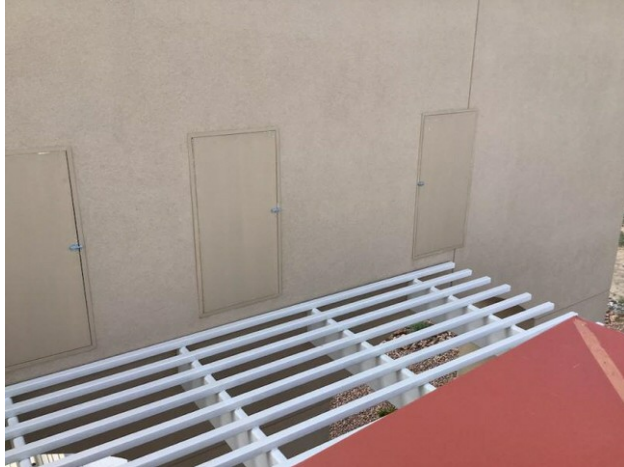
## Project 0654.2001 · Roof Safety Improvements

The roof hatch lacks a safety railing. The access panels to the campus's large logo sign cross the metal awning and do not have a safe access path of. Staff report that they do not access the space.

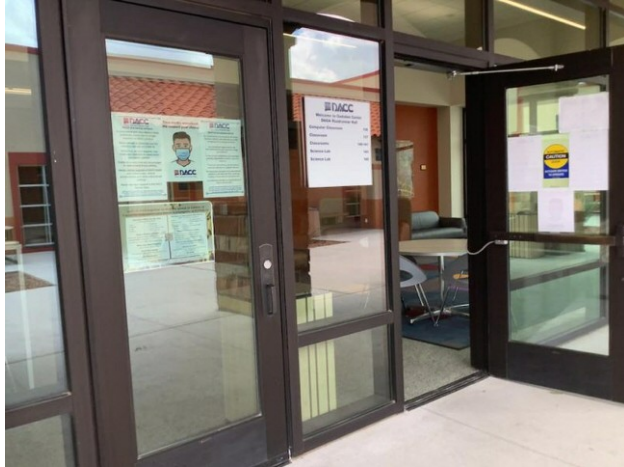
## Project 0654.2002 · Vestibule Additions

Three entryways in Roadrunner Hall lack vestibules, allowing debris to blow in and the building to lose heat when the doors are open in the fall and winter.

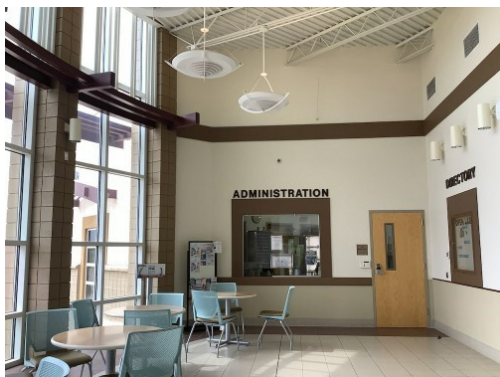
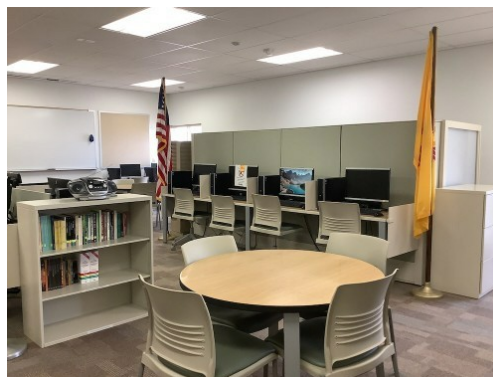
The facility lies on the west midpoint of the site. The Chaparral Center comprises a permanent building with three portable classrooms to the north, a parking lot to the south, and a yard for the Lineworker Certification Program that lies to the north of the portables.

The single-story building dates from 2011—housing the administrative area, a commons area, and three large general classrooms.

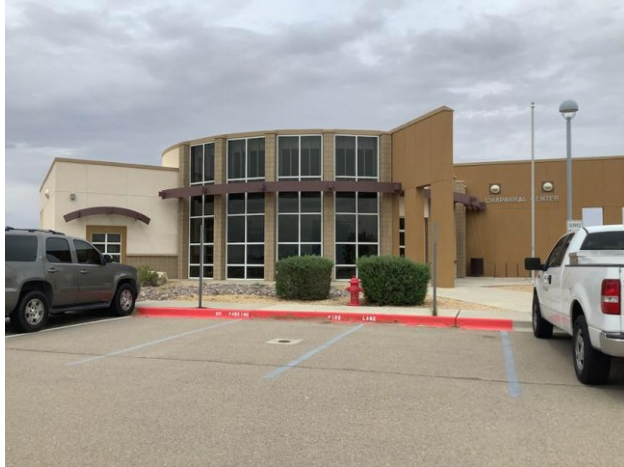
## Project 0637.2001 · Parking Lot Improvements

The parking lot is in fair condition with the asphalt exhibiting long cracks from east to west. Concrete wheel stops lie at accessible stalls. Yet general parking lacks wheel stops, allowing vehicles to protrude into the sidewalk and narrowing the walkable area. Paint is fading on the fire lane curb, and legacy sign poles remain in the sidewalk.

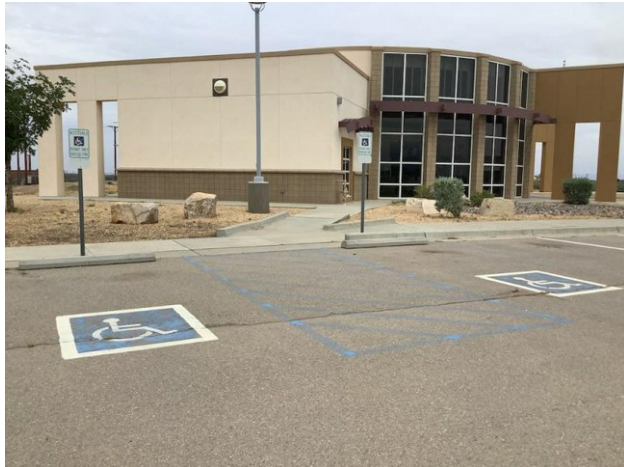
## Project 0637.2002 · ADA Compliance: Site Improvements

The markings are fading on the accessible parking stalls. Stalls lack signs for van accessibility, and pathways lack No Parking markings. The sidewalk curb ramp lacks detectable warning tiles. The Lineworker Certification Program yard lacks an accessible path from campus.

The campus is mainly American with Disability Act (ADA) compliant. However, the accessible parking stalls do not lie at the shortest path to the front door, the markings appear faded, pathways lack No Parking markings, and posts lack signs for van accessibility. The sidewalk curb ramp lacks detectable warnings, and the Lineworker Certification Program yard lacks an accessible path from the campus.

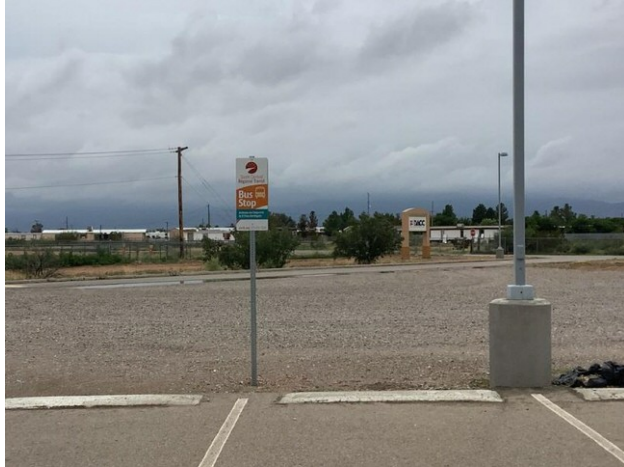
## Project 0637.2003 · Outdoor Shelter Upgrades

A regional-transit bus stop lies across the parking lot from the main entrance. The bus stop lacks shelter and seating. The Lineworker Certification Program yard lacks shade and seating.

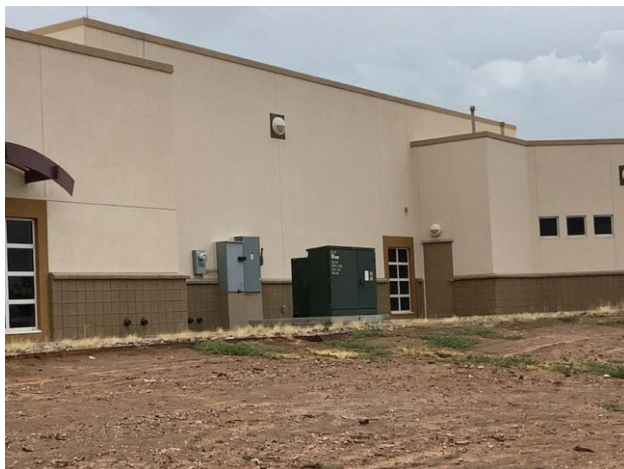
## Project 0637.2004 · Utility Protection Upgrades

A pad-mounted transformer sits on the building's northeast side, near the exterior access electrical room with electric boxes mounted on exterior walls. Gas enters at the southwest corner of the building. Both utilities lack security screens and protection.

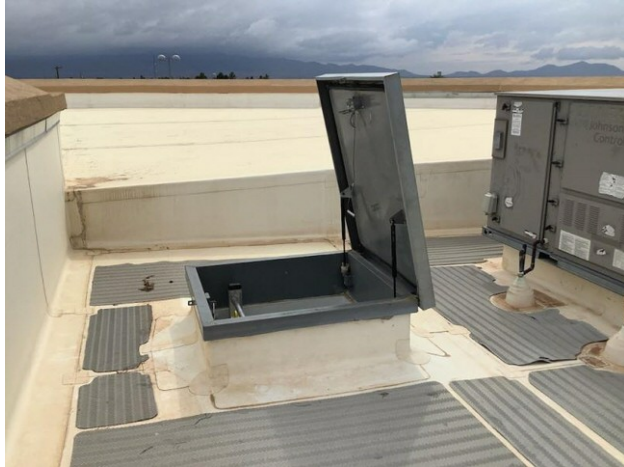
## Project 0637.2005 · Roof Improvements

Roof walk pads exhibit oxidation, cracking, and lifting. Gas lines emerge from the roof near mechanical equipment and lack yellow paint.

Stucco-capped parapets surround the perimeter and are in good condition. The membrane roofing is in good condition and protects the flat roof; however, walk pads exhibit oxidation, cracking, and lifting. Roofs slope to the northeast and southwest. Roofs incorporate crickets leading to roof drains with scuppers that appear clear of debris.

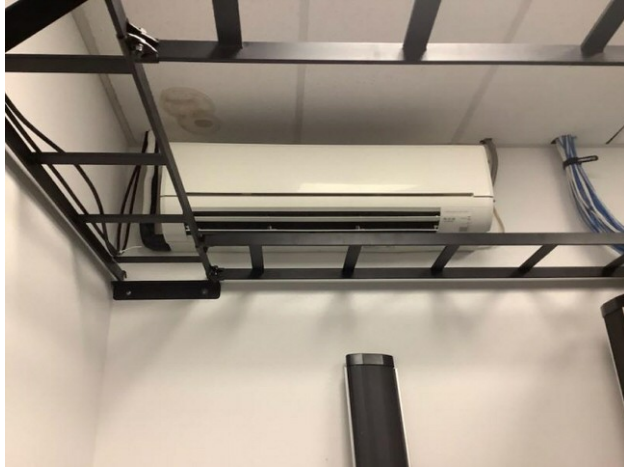
## Project 0637.2006 · Ceiling Improvement

Insulation at the rooftop mini split condenser exhibits deterioration and gaps in the roof-penetration sealant. Stains show in the acoustic ceiling tiles (ACT) near the indoor cassette in the server room.

Rooftop combination units heat and cool the facility with a network-based system controlling temperatures. Diffusers hang from ceilings in the administrative office and corridors, wall registers lie in the commons, floor grates sit in classrooms, and an exhaust vent lies in the restroom; all appear clean without debris and damage. A mini split regulates the temperature in the server room. The rooftop units are original to the building and in good condition. The mini split is also in good condition, apart from the deteriorated insulation and the gaps in the sealant at the conduit roof penetrations. The staff

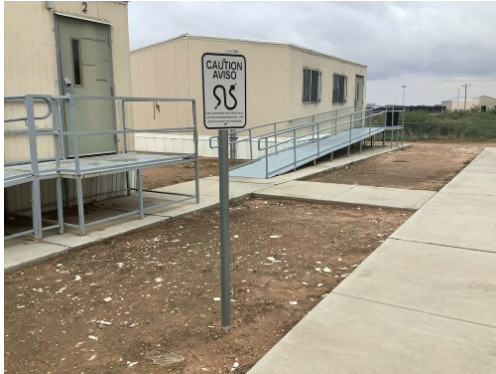
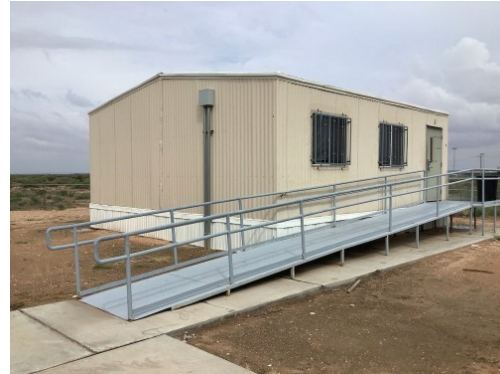
Portable 1 sits to the north of the Main Building on the Doña Ana County Community College Chaparral Campus in Chaparral, New Mexico. Portable 1 is the westernmost of three portables, standing in a row with two other portables. The portable has access via a sidewalk from the parking lot and a secondary sidewalk exiting the north corridor of the Main Building.

A sidewalk wraps around the Main Building. Another walkway leads to the portables, with metal ramps rising to each entrance. The concrete sidewalks are in good condition; however, the ramp at Portable 1 has rusted with worn, chipped, and oxidized paint, and there is more than a half-inch rise between the landing and door jamb.

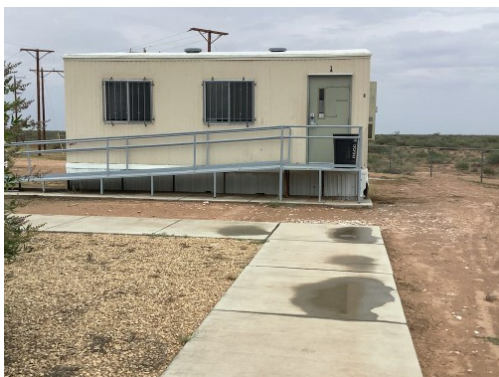
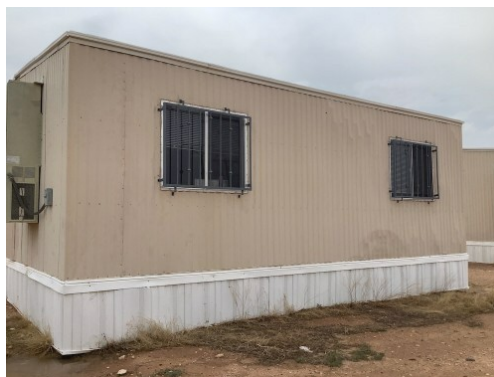
Portable 1 is the westernmost of the three portables north of the Main Building. The portable serves as a single-room classroom and does not contain a restroom. The structure dates from 1993 and is past its expected service life.

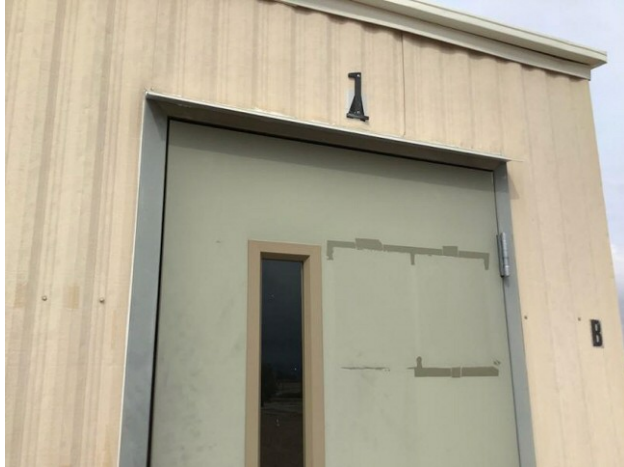
## Project 477A.2002 · Exterior Lighting Improvements

The portable lacks lighting at the entrance door.

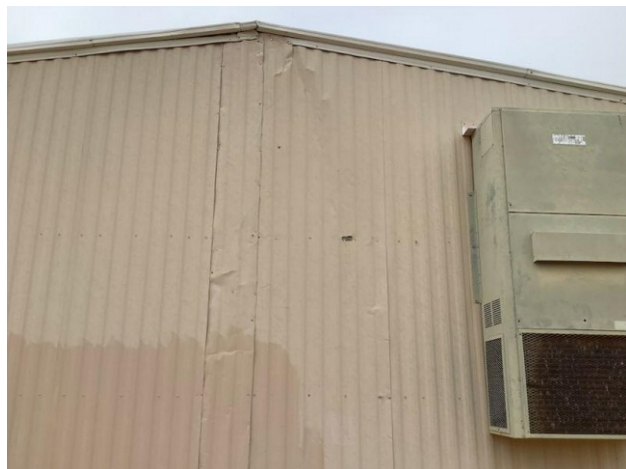
## Project 477A.2003 · Roof Replacement

The metal-panel pitched roof is in poor condition with dents, oxidation, and layers of aged, weather-damaged liquid roof sealant. The roof lacks gutters and roof drains, and the drip edge is bent and does not provide a continuous protective surface.

The metal-panel pitched roof is in poor condition and shows dents, oxidation, and layers of old and weather-damaged liquid roof sealant. The roof lacks gutters and roof drains. The drip edge is bent and does not provide a continuous protective surface.

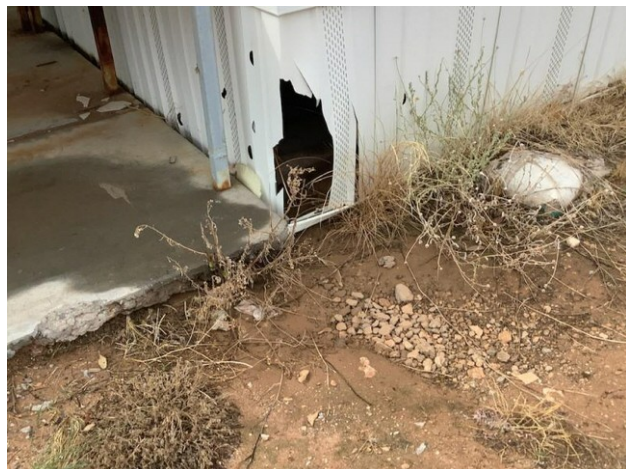
## Project 477A.2004 · Exterior Surface Improvements

The metal-panel sheathing exhibits denting, oxidation, and rust. Some misaligned panels show gaps in the seams. The skirting and drip edge exhibit dents, holes, and twisting—exposing the underside of the portable. The building identification has several unrelated legacy numbers and letters mounted around the entry doors.

The metal-panel sheathing exhibits denting, oxidation, and rust. The sheathing is in poor condition with some misaligned panels and gaps in the seams. The building's identification has several unrelated legacy numbers and letters mounted around the entry door.

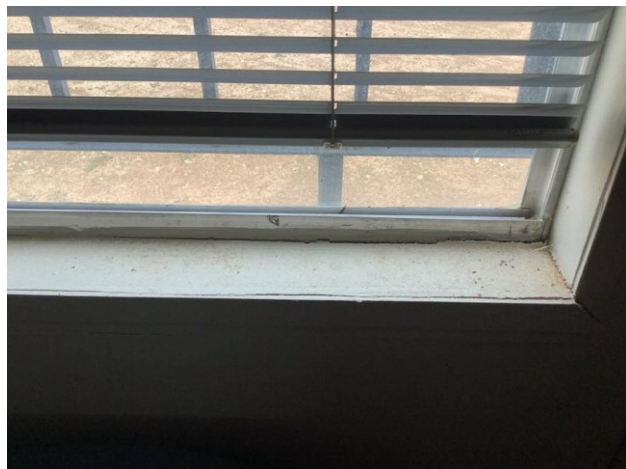
## Project 477A.2005 · Door and Window Upgrades

The metal-panel door shows oxidized paint and tape remnants. The threshold is bent with the metal-panel sheathing below pulling away and exposing the wall cavity. The single-pane, energy-inefficient windows have sand-filled frames. The windows do not slide open and sit in painted wood sills, which exhibit gaps and warping. The windowsills are covered in layers of blown-in sand. Window screens are threadbare. The pull cords are dry, weak, and do not operate the venetian blinds.

The metal-panel door includes a narrow lite, code lock, panic bar, and door closer. It is in fair condition with oxidized paint and tape remnants covering the exterior. The threshold is bent with the metal panel sheathing below pulling away and exposing the wall cavity. The door sweep is in good condition and seals the bottom of the door.

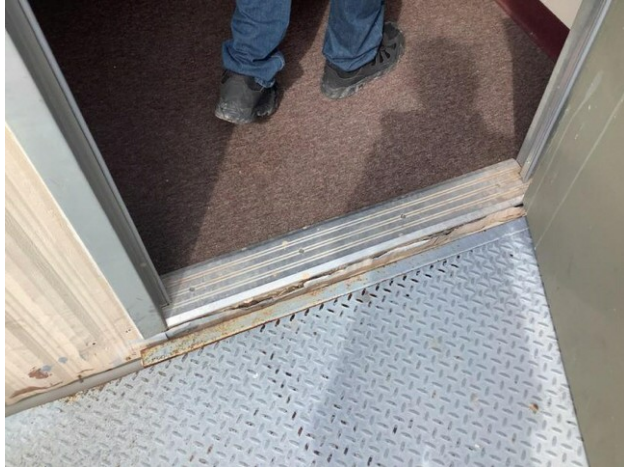
## Project 477A.2006 · Carpet Replacement

Aged carpet covers the floor and shows fiber breakdown, which is off-gassing odors.

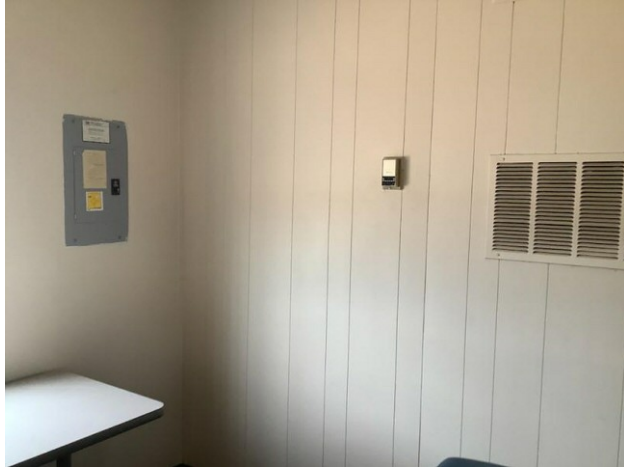
## Project 477A.2007 · Heating and Cooling Upgrades

An electric heat pump hangs on the west exterior wall, and it heats and cools the interior through a single vent on the west side of the room. The electric heat pump is original to the building and past its expected serviceable life. A manual thermostat controls it. The portable receives no mechanical ventilation. The door is the only opening for passive ventilation.

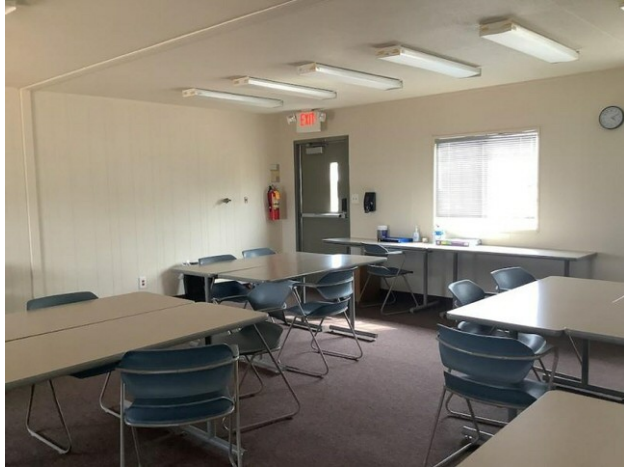
## Project 477A.2008 · Lighting Improvements

Aged, ceiling-mounted light fixtures illuminate the interior of the room. The fixtures use a variety of color-temperature tube lights, ranging from yellow to blue. The fixtures operate via toggle switches hanging near the door.

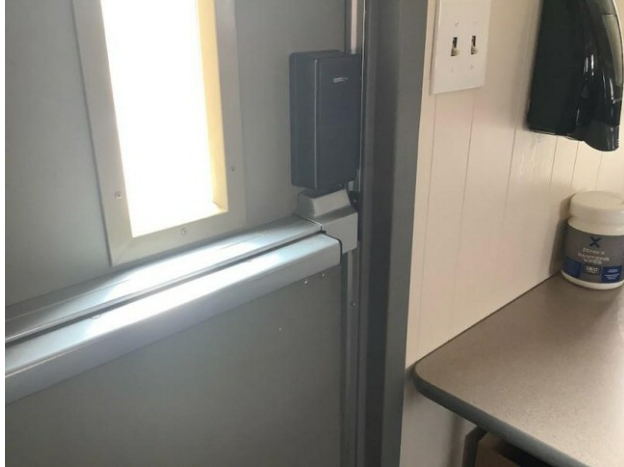
## Project 477A.2009 · Security and Safety Upgrades

While the main campus includes an alarm system, the portables do not. Staff report that the Wi-Fi connection is poor. A fire extinguisher hangs next to the door; however, the room does not include a smoke detector.

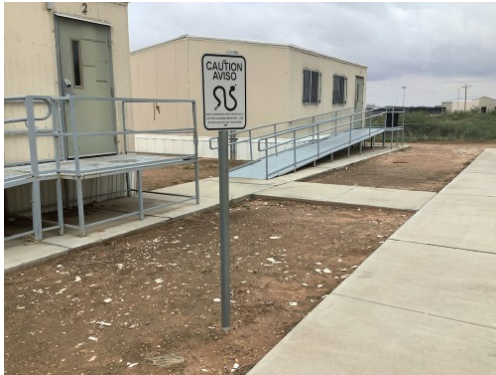
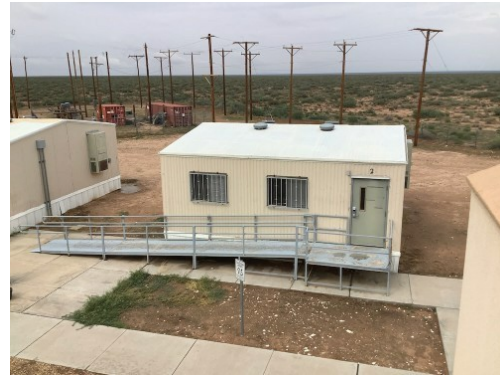
Portable 2 sits north of the Main Building on the Doña Ana County Community College Chaparral Campus in Chaparral, New Mexico. Portable 2 is the middle portable, standing in a row with two other portables. The portable has access via a sidewalk from the parking lot and a secondary sidewalk exiting the north corridor of the Main Building.

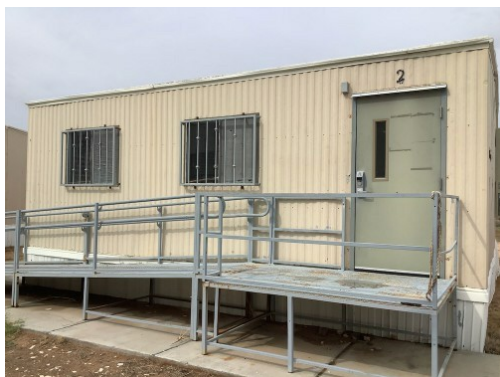
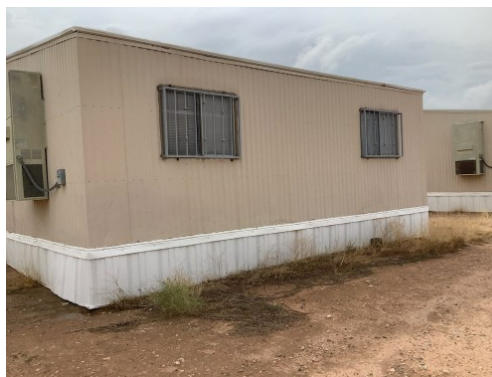
Portable 2 is the middle of the three portables sitting north of the Main Building. Portable 2 serves as a single-room classroom and does not contain a restroom. The structure dates to 1993 and is past its expected service life.

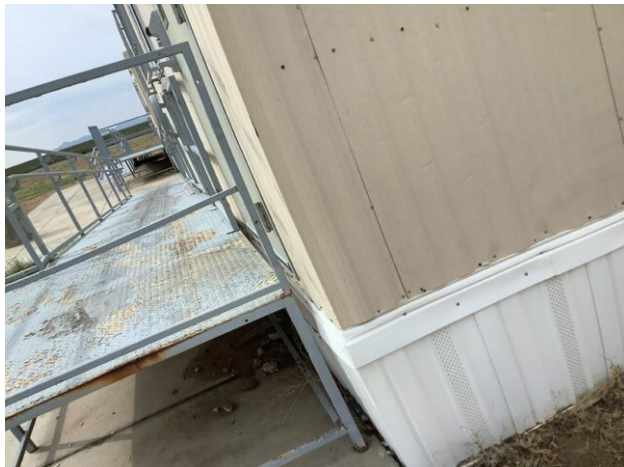
## Project 477B.2001 · ADA Compliance: Ramps

The ramp is rusted with worn, chipped, and oxidized paint on the landing. The rise between the landing and the doorjamb is more than half an inch high, and it does not meet ADA threshold requirements.

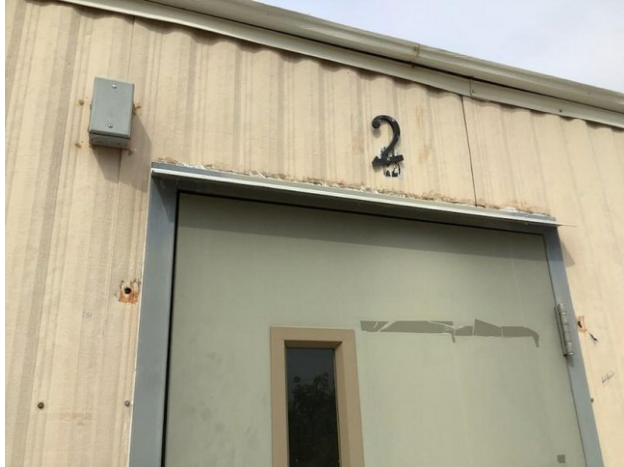
## Project 477B.2002 · Exterior Lighting Improvements

The portable lacks lighting at the entrance door.

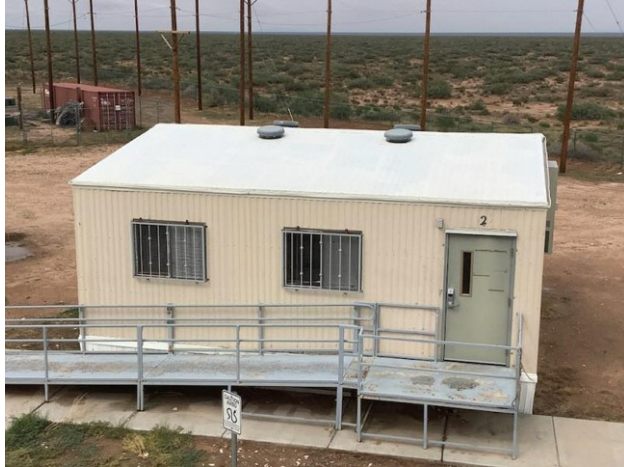
## Project 477B.2003 · Roof Replacement

The metal-panel pitched roof is in poor condition with dents, oxidation, and layers of aged and weather-damaged liquid roof sealant. The roof lacks gutters and roof drains, and the drip edge is bent and does not provide a continuous protective surface. The roof leaks.

Replace the roof and install gutters, downspouts, drip edges, and splash blocks.

The metal-panel pitched roof is in poor condition and shows dents, oxidation, and layers of old and weather-damaged liquid roof sealant. The roof lacks gutters and roof drains. The drip edge is bent and does not provide a continuous protective surface. The evaluator observed an active roof leak in the interior of the classroom.

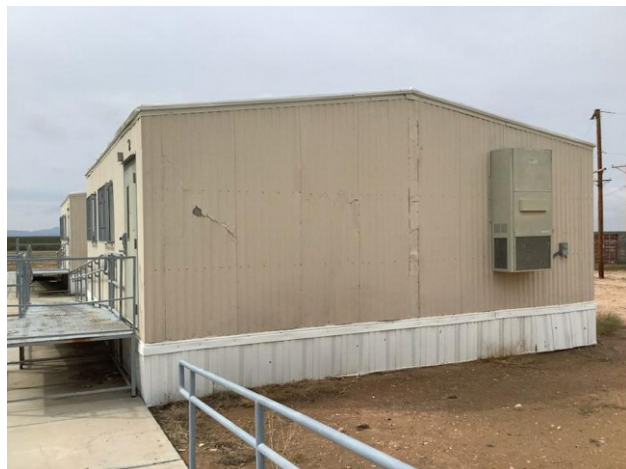
## Project 477B.2004 · Exterior Surface Improvements

The metal-panel sheathing exhibits denting, oxidation, and rust. Some misaligned panels show gaps in the seams. The skirting and drip edge exhibit dents, holes, and twisting—exposing the underside of the portable. The building identification includes several unrelated legacy numbers and letters around the entry doors.

Power wash the exterior surface and replace damaged panels. Paint the surface and install building identification.

The metal-panel sheathing exhibits denting, oxidation, and rust. The sheathing is in poor condition with some misaligned panels and gaps in the seams. The building's identification has several unrelated legacy numbers and letters mounted around the entry door.

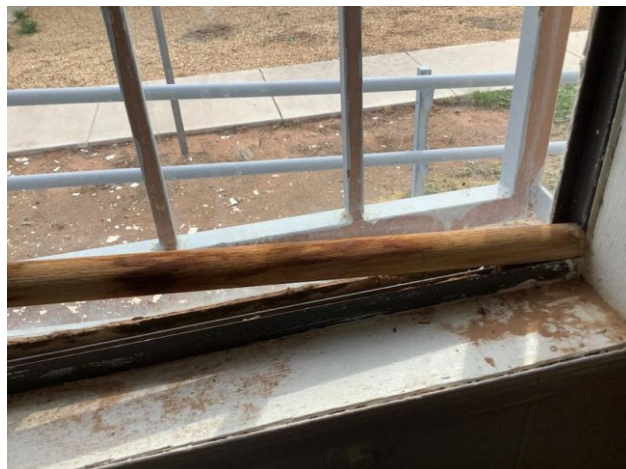
## Project 477B.2005 · Door and Window Upgrades

The metal-panel door shows oxidized paint and tape remnants. The threshold is bent with the metal-panel sheathing below pulling away and exposing the wall cavity. The single-pane, energy-inefficient windows have sand-filled frames filled. The windows do not slide open and sit in painted wood sills, which exhibit gaps and warping. The windowsills are covered in layers of blown-in sand. Window screens are threadbare. The pull cords are dry, weak, and do not operate the venetian blinds.

Repaint the door and frame. Install weather stripping and a threshold. Install energy-efficient windows, screens, and blinds. Replace the windowsills. Replace door and window trims.

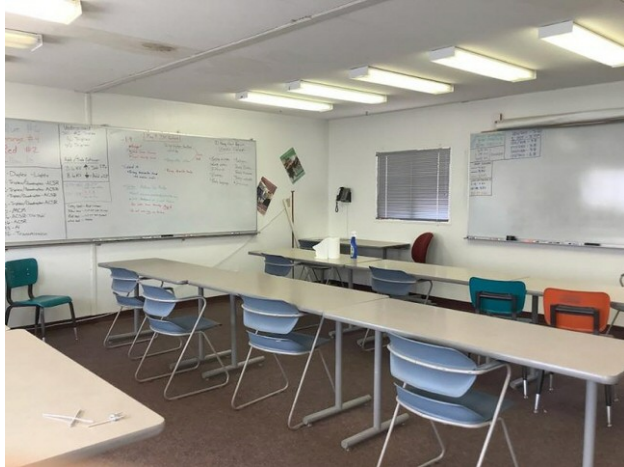
## Project 477B.2006 · Carpet Replacement

Aged carpet covers the floor and shows fiber breakdown, which is off-gassing odors.

Replace carpet.

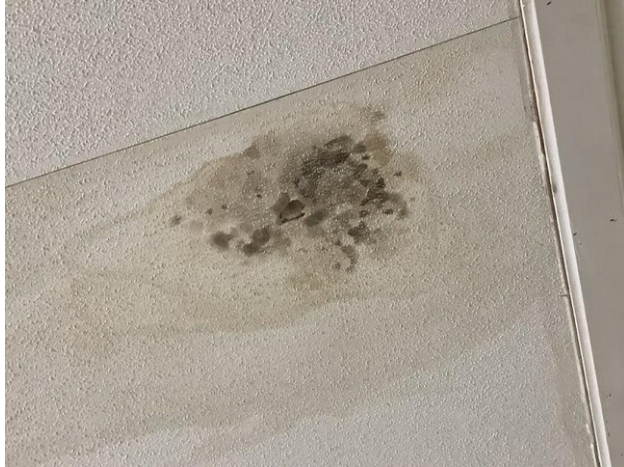
## Project 477B.2007 · Ceiling Improvements

The textured, painted ceiling panels are in poor condition; they exhibit uneven paint, cracks along the seams, and mold. The roof leaks.

Replace ceiling panels. Coordinate with the Roof Replacement CIP.

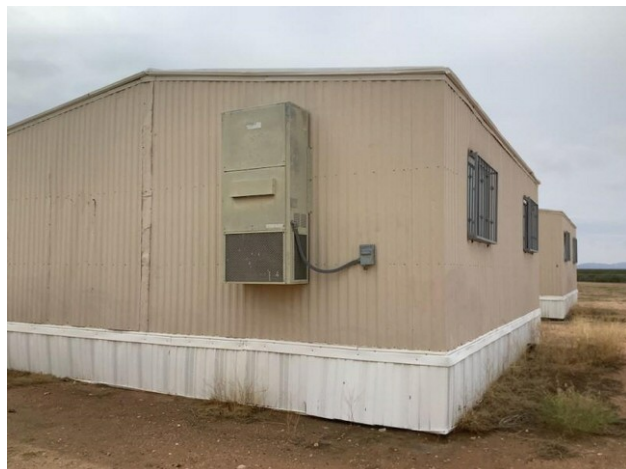
## Project 477B.2008 · Heating and Cooling Upgrades

An electric heat pump, original to the building and past its expected serviceable life, hangs on the west exterior wall. The pump heats and cools the interior through a single vent. A manual thermostat controls it. The portable receives no mechanical ventilation. The door is the only opening for passive ventilation.

Replace the heat pump with an energy-efficient model and a programable thermostat.

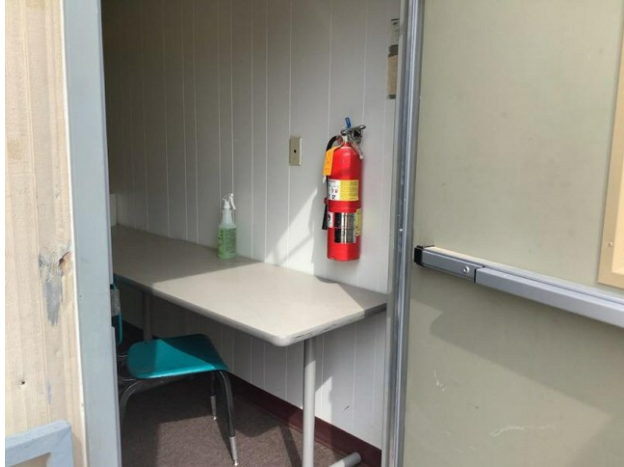
## Project 477B.2010 · Security and Safety Upgrades

While the main campus includes an alarm system, the portables do not. Staff report the Wi-Fi connection is poor. A fire extinguisher hangs next to the door; however, the room does not include a smoke detector.

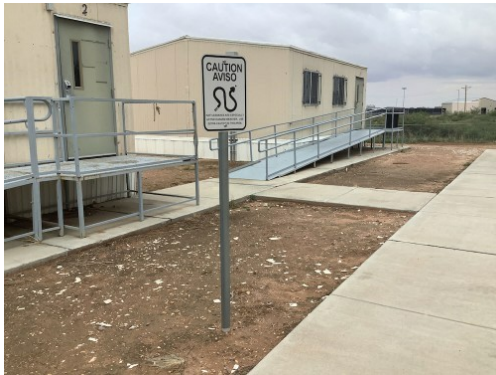
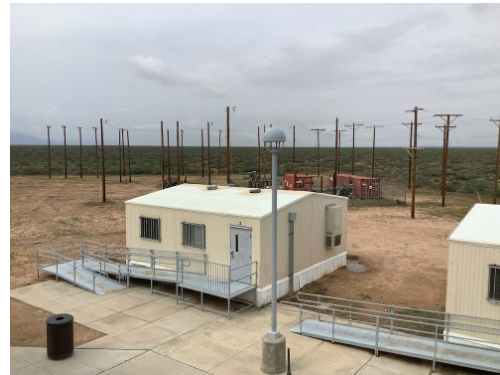
### Site Assessment

Portable 3 sits north of the main building on the Doña Ana County Community College Chaparral Campus in Chaparral, New Mexico. Portable 3 is the easternmost portable, sitting in a row with two other portables. The portable is accessed via a sidewalk from the parking lot and a secondary sidewalk exiting the north corridor of the main building.

A sidewalk wraps around the Main Building. Another walkway leads to the portables, with metal ramps rising to each entrance. The concrete sidewalks are in good condition; however, the ramp at portable 3 has rusted with worn, chipped, and oxidized paint, and there is more than a half-inch rise between the landing and door jamb.

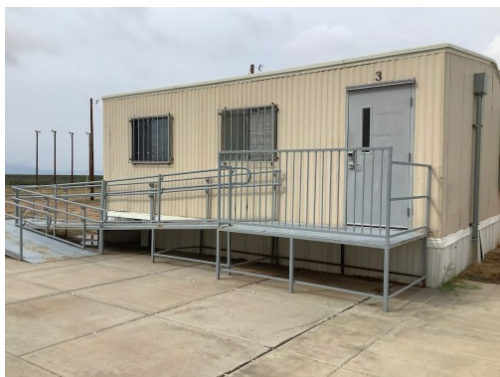
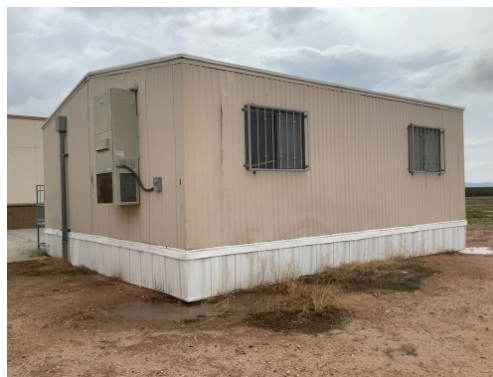
## Building Assessment

The prefabricated building sits elevated from the exposed ground with vinyl skirting insulating and deterring animals from the underside of the structure. Ponding occurs at the corners of the building. The skirting exhibits dents, holes, and twisting—exposing the structure's underside.

The metal-panel door includes a narrow lite, code lock, panic bar, and door closer. It is in fair condition with oxidized paint and tape remnants covering the exterior. The threshold is bent with the metal panel sheathing below pulling away and exposing the wall cavity. The door sweep is in good condition and seals the bottom of the door.

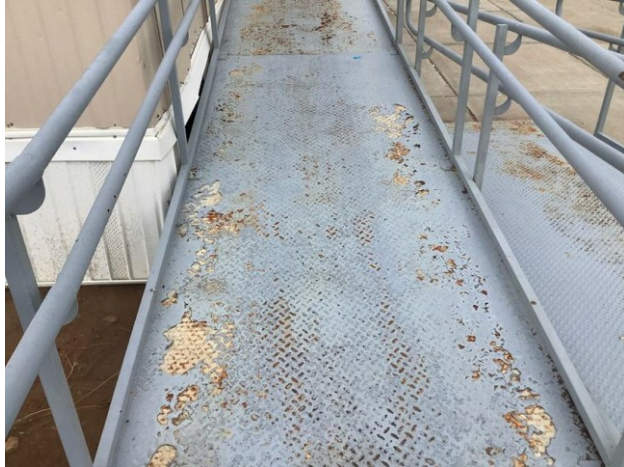
## Project 477C.2001 · ADA Compliance: Walkways

The ramp is rusted with worn, chipped, and oxidized paint on the landing. The rise between the landing and the doorjamb is more than half an inch high, and it does not meet ADA threshold requirements.

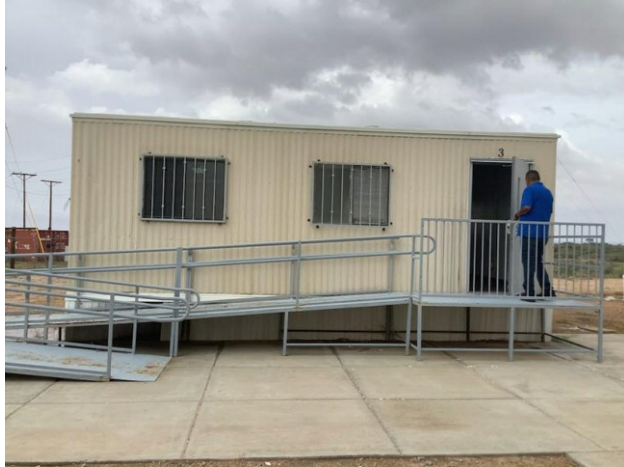
## Project 477C.2002 · Exterior Lighting Improvements

The portable lacks lighting at the entrance door.

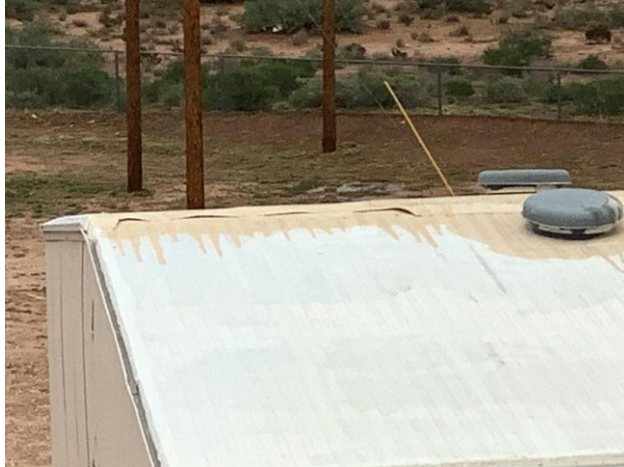
## Project 477C.2003 · Roof Replacement

The metal-panel pitched roof is in poor condition with dents, oxidation, and layers of aged and weather-damaged liquid roof sealant. The roof lacks gutters and roof drains. The drip edge is bent and does not provide a continuous protective surface.

Replace the roof and install gutters, downspouts, drip edges, and splash blocks.

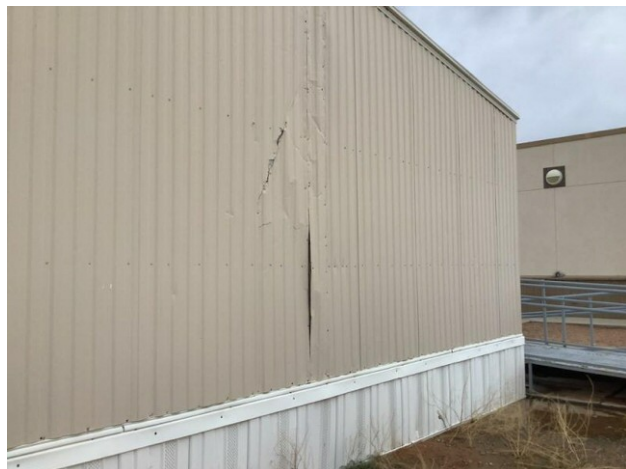
## Project 477C.2004 · Exterior Surface Improvements

The metal-panel sheathing exhibits denting, oxidation, and rust. Some misaligned panels show gaps in the seams. The skirting and drip edge exhibit dents, holes, and twisting—exposing the underside of the portable. The building identification has several unrelated legacy numbers and letters mounted around the entry doors.

Power wash the exterior surface and replace damaged panels. Replace the drip edge. Paint the surface and install building identification.

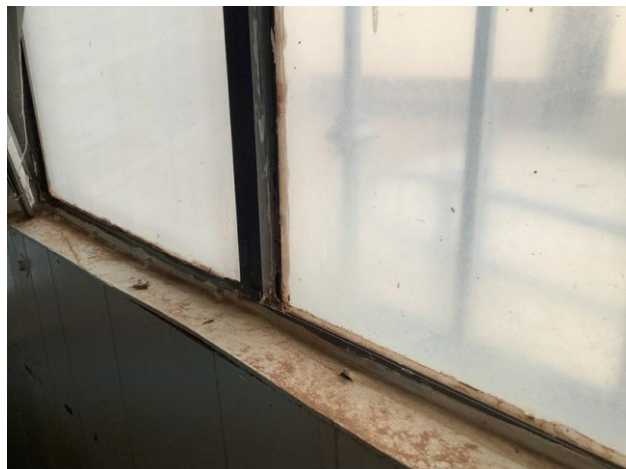
## Project 477C.2005 · Door and Window Upgrades

The metal-panel door shows oxidized paint and tape remnants. The threshold is bent with the metal-panel sheathing below pulling away and exposing the wall cavity. The single-pane, energy-inefficient windows have sand-filled frames. The windows do not slide open and sit in painted wood sills, which exhibit gaps and warping. The windowsills are covered in layers of blown-in sand. Window screens are threadbare. The pull cords are dry, weak, and do not operate the venetian blinds.

Repaint the door and frame. Install weather stripping and a threshold. Install energy-efficient windows, screens, and blinds. Replace the windowsills. Replace door and window trims.

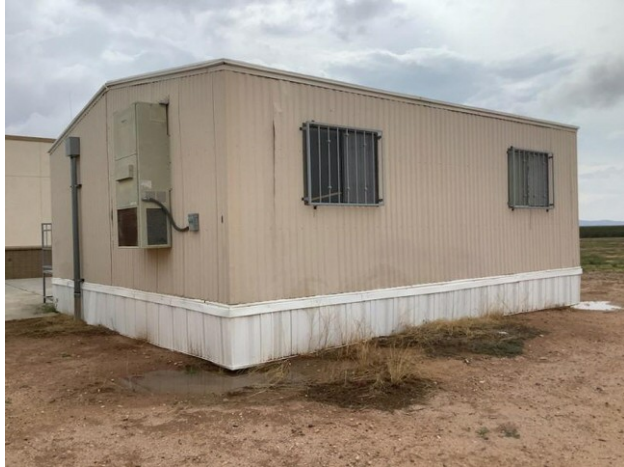
## Project 477C.2007 · Heating and Cooling Upgrades

An electric heat pump, original to the building and past its expected serviceable life, hangs on the west exterior wall. The pump heats and cools the interior through a single vent. A manual thermostat controls it. The portable receives no mechanical ventilation. The door is the only opening for passive ventilation.

Replace the heat pump with an energy-efficient model and a programable thermostat.
