# DACC

Doña Ana Community College

# Facilities Master Plan

**FMP 2023-2030**

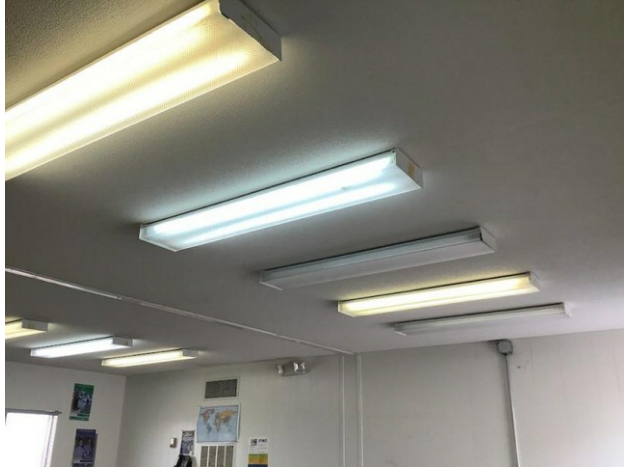
## Project 477C.2008 · Lighting Improvements

Aged, ceiling-mounted light fixtures illuminate the interior of the room. The fixtures use a variety of color-temperature tube lights, ranging from yellow to blue. The fixtures operate via toggle switches hanging near the door.

Replace fixtures with energy-efficient LED lighting. Install a motion-sensor switch.

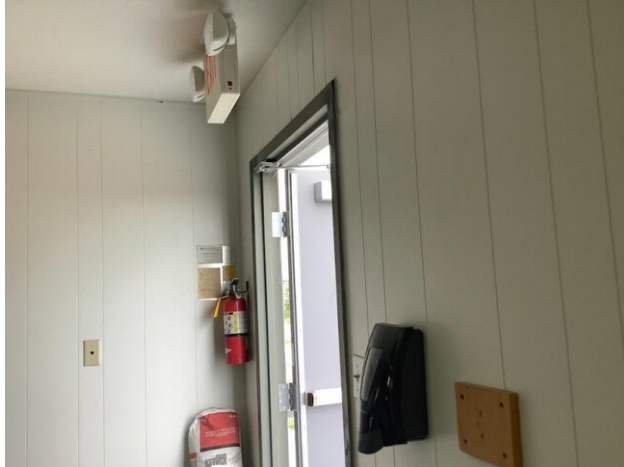
## Project 477C.2009 · Security and Safety Upgrades

While the main campus includes an alarm system, the portables do not. Staff report that the Wi-Fi connection is poor. A fire extinguisher hangs next to the door; however, the room does not include a smoke detector.

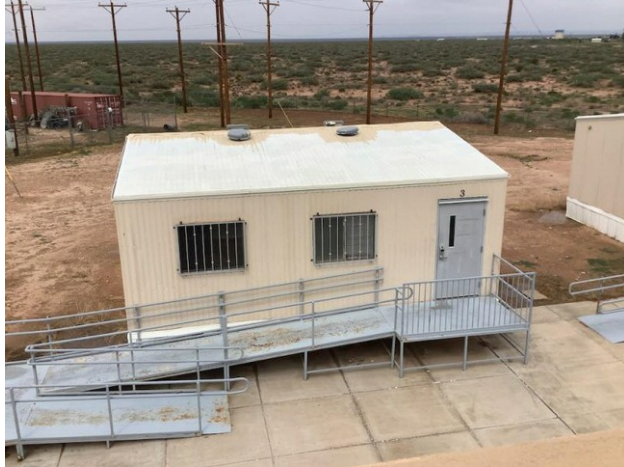
## Project 477C.2010 · Alternative Solution: Portable Replacement

The 1993 structure is past the average serviceable lifespan of a portable classroom. The portable is energy inefficient, heavily aged, and worn. The portable's footprint and height are smaller than classrooms in the Main Building. It lacks a restroom, a drinking fountain, storage space, and organizational equipment. The renovation estimate is \$53,662.

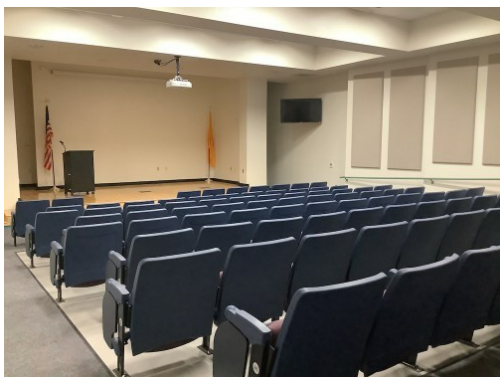
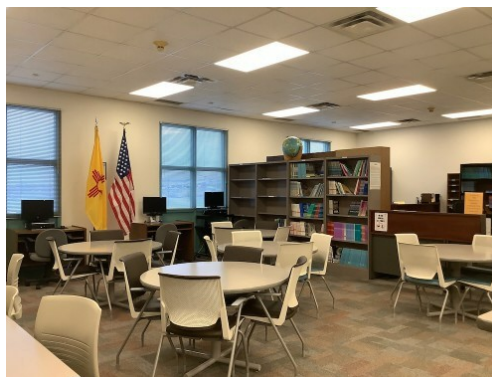
## Building Assessment

The Sunland Park Campus comprises a permanent Main Building and three portables on a three-plot site. The Main Building, portables, and parking cover the two eastern plots, and the third remains undeveloped.

The original structure dates to 2000. The district added a lobby, administration, and classroom addition in 2005. In 2014, the district provided additional general classrooms, vocational classrooms, and a theater.

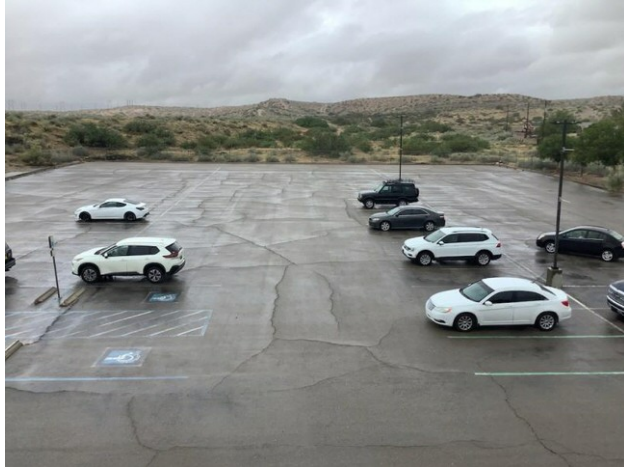
## Project 0546.2001 · Parking Lot Improvements

The asphalt in all three parking lots is in fair condition, exhibiting cracks. The crosswalks and the general parking stall markings appear faded or are missing. The paint is faded and worn on the fire lane and the drop-off zone curb.

Clean and seal cracks. Seal coat asphalt. Restripe the crosswalks and the general parking stalls. Paint fire lanes and curbs. Coordinate with ADA Compliance: Parking Lot Improvements.

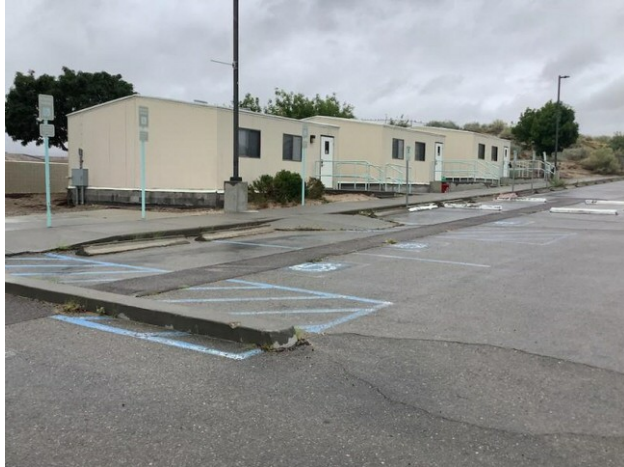
## Project 0546.2002 · ADA Compliance: Parking Lot Improvements

ADA parking stall signs and markings are fading, and asphalt repairs partially cover some of the markings. In some areas, markings are out of compliance for van-accessible stalls and ramp routes.

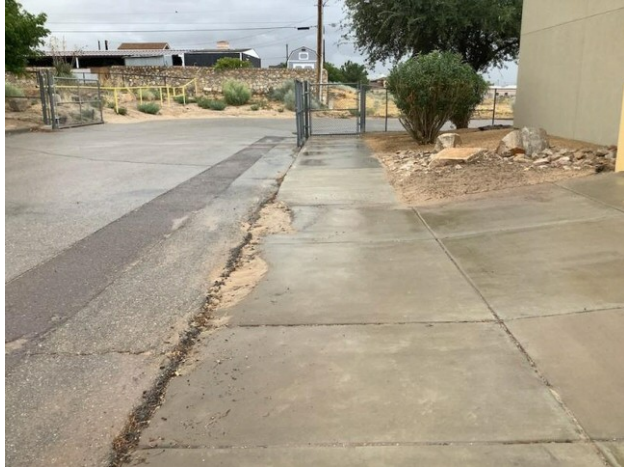
## Project 0546.2003 · Driveway Improvements

A driveway leads into the outdoor learning space for welding and exhibits areas of concrete with broken and missing material.

Remove broken sections and replace concrete.

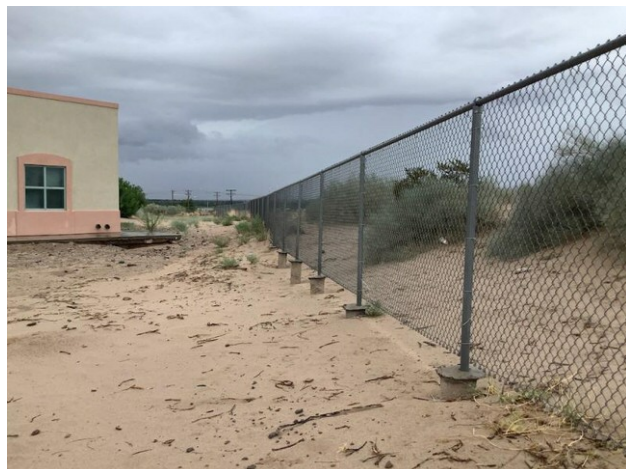
## Project 0546.2004 · Soils and Drainage Upgrades

Soil is stripped of vegetation and scarred with significant wind and water erosion, which undermines the sidewalks adjacent to the building; this problem occurs to the south of the portables and along the northeast to south edge of the parking lots. Windblown sand dunes are encroaching and covering the sidewalks on the east side of the building; a few sections of the sidewalk are broken at the southeast corner. While the fencing itself is in good condition, moving sand dunes unearthed the footings and are burying the fence in some areas.

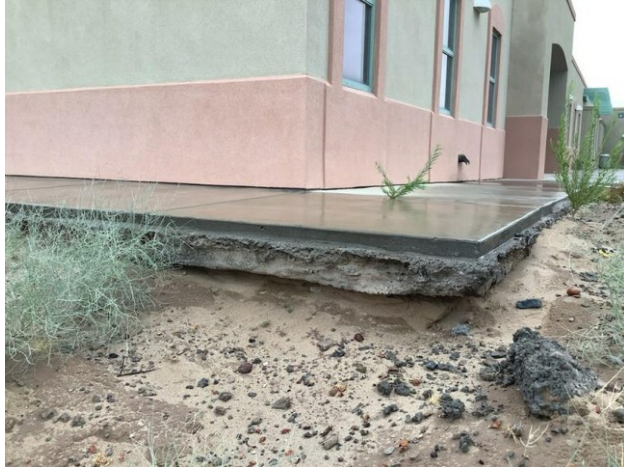
## Project 0546.2005 · Terracing, Walkway, and Landscape Upgrades

At the south and east edges of the building, sidewalk sections include some broken areas that are beginning to collapse where water flow undermined the soil beneath.

Regrade and engineer the soil around the south and east edges of the building. Install terraced retaining walls and French drains around sidewalks. Install irrigation and soil-stabilizing landscaping along the south walls and in the terracing. Replace sidewalk sections. Coordinate with the Soils and Drainage Upgrades CIP.

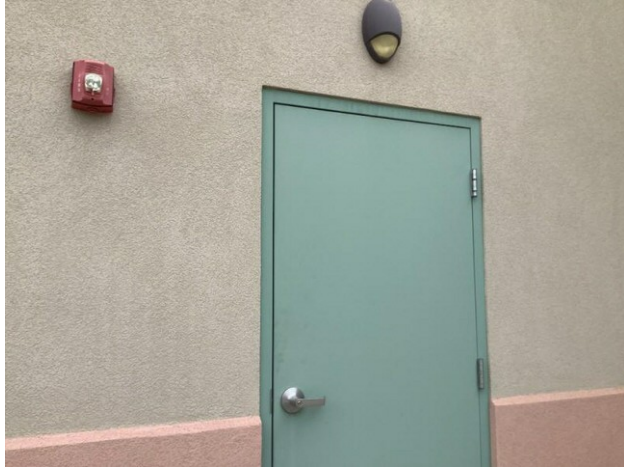
## Project 0546.2006 · Site Lighting Upgrades

Aged and yellowed lights hang over the outdoor learning space for welding.

Replace aged lights.

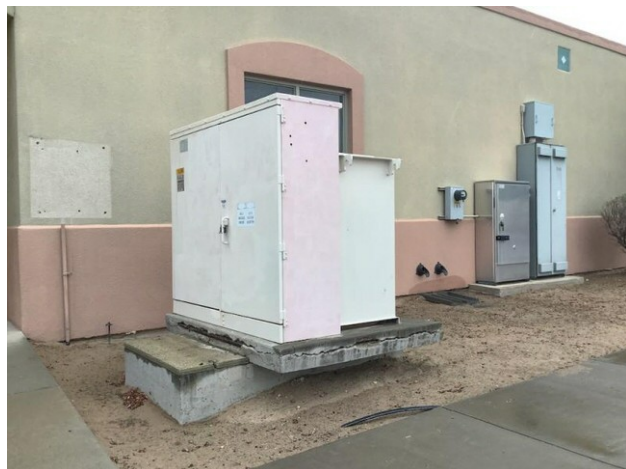
## Project 0546.2007 · Utility Protection Upgrades

Electric transformers stand unprotected and unscreened at the west entrance. One transformer sits on a broken, elevated concrete pad. The natural gas meter stands unprotected at the southwest of the building, near the exterior access mechanical room.

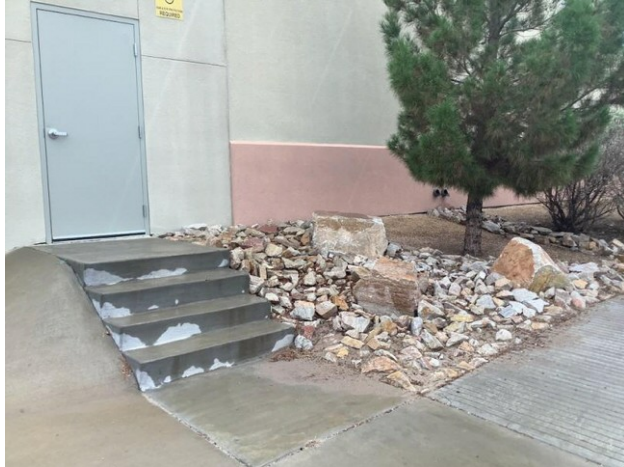
## Project 0546.2008 · ADA Compliance: Site Walkways

Handrails and step contrast are missing at the ramped entrance and outdoor welding stairs on the west side of the building. A protective bollard at the outdoor welding learning space narrows the walkway and ramp out of ADA compliance.

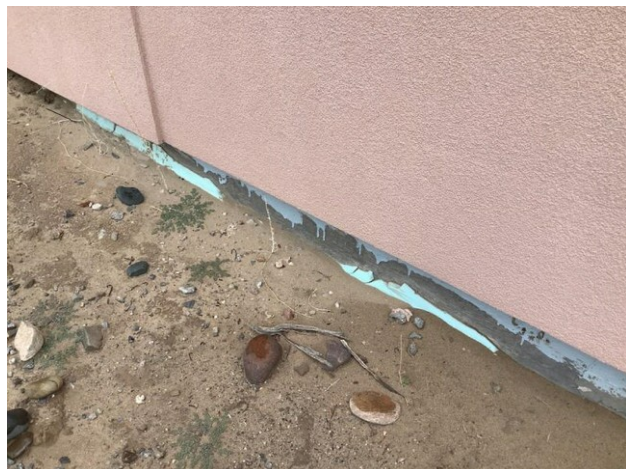
## Project 0546.2009 · Stem Wall and Stucco Drip Edge Improvements

The southwest stem wall is exposed, and the rigid insulation is degraded and missing in some areas, leaving the underside of the exterior wall's sill plate unprotected. The bottom of the exterior stucco wall lacks a drip edge and is chipping, exposing the building wrap material.

Replace rigid insulation. Install a French drain with a six-inch separation from the earth to the sill, sloping it away from the structure. Install a drip edge and stucco it with a fog coat to match. Apply a separate coat of stucco over the sill and insulation, and extend it below grade.

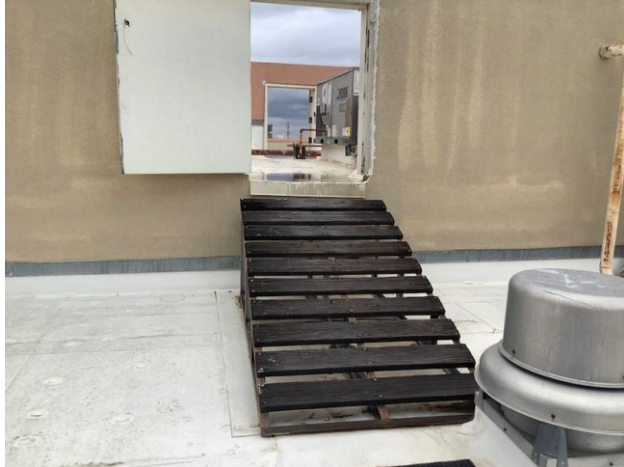
## Project 0546.2010 · ADA Compliance: Roof Access Upgrades

The roof hatch lacks a safety railing. Makeshift roof ramps show large gaps between weathered wood slats and lack landings at the doorways.

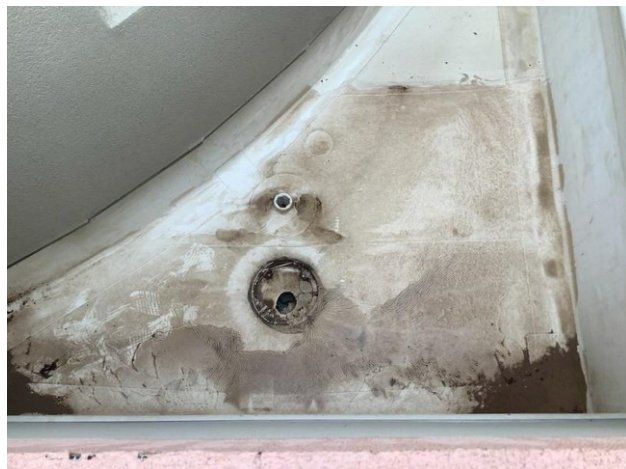
## Project 0546.2011 · Roof Upgrades and Replacement

Stucco-capped parapets surround the perimeter and exhibit cracks, some filled with caulk and others unsealed. Slashes in the membrane are not repaired near the mechanical equipment over the administrative wing; other areas have numerous repairs, including rippled liquid roof coating. Walkway pads lie inconsistently around mechanical equipment. Pads over the administrative wing are slashed with dirt and debris collecting under the damage. Roof drains with scuppers lead to the ground; some include splash guards and those without create erosion in the landscape and soil. The evaluator observed clogged drains and active roof leaks.

Install metal-capped parapets. Replace the roof membrane and walk pads. Clean the roof drains, replace missing and broken grates, and provide splash guards. Coordinate with the Roof Improvements CIP. Scheduled for Fall 2023.

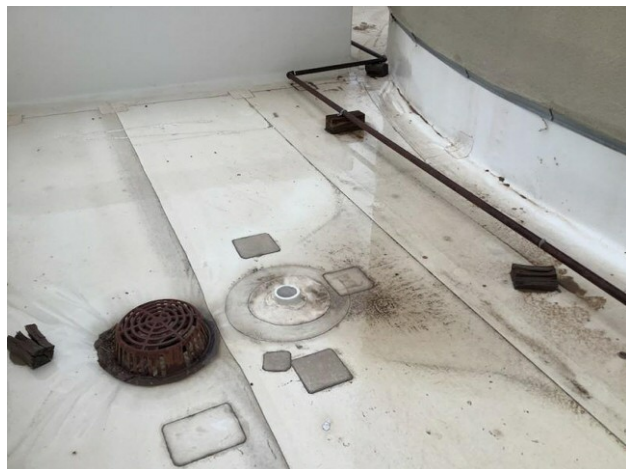
## Project 0546.2012 · Roof Improvements

Gas lines are not painted yellow and lie elevated on wood blocks. Several blocks are dislodged, and some are missing. Painted metal rafters on the pergola entries appear chipped and faded. The doors exhibit faded, chipped paint on the roof crossover.

Install gas line supports. Paint gas lines, pergola metal rafters, and crossover doors. Coordinate with the Roof Upgrades and Replacement CIP and the Door and Window Improvements CIP. Scheduled for Fall 2023.

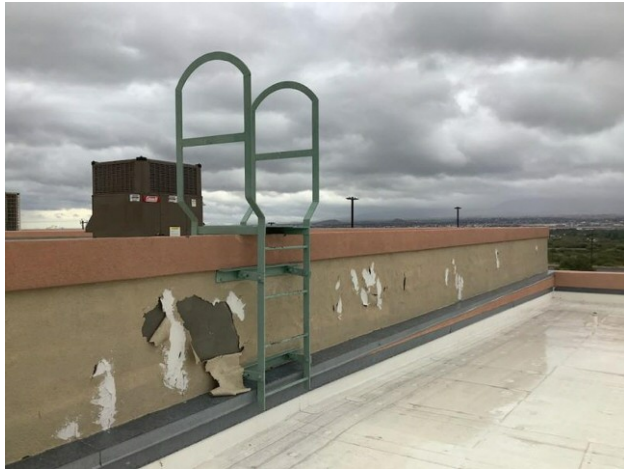
## Project 0546.2013 · Stucco Repair

At the 2014 north addition, the stucco is bubbling and peeling along the east wall and the roof fire walls. Shadows remain from legacy fixtures in areas where lights and equipment have been replaced. One section of the west facade appears to have heavy grime near the garage door.

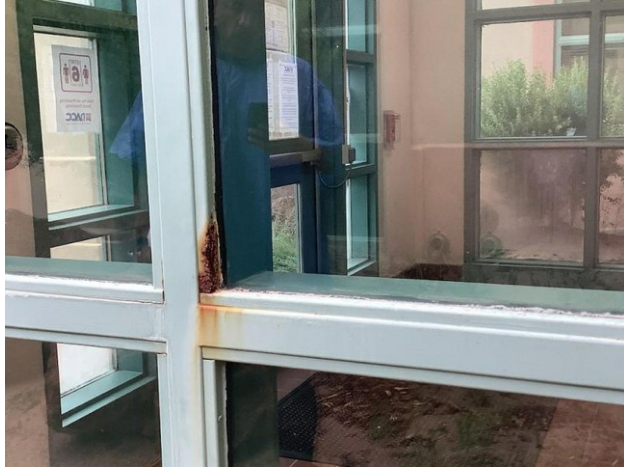
## Project 0546.2014 · Door and Window Improvements

Mullions exhibit severe rust on the front entry's window wall. The exterior doors and door frames exhibit paint oxidation.

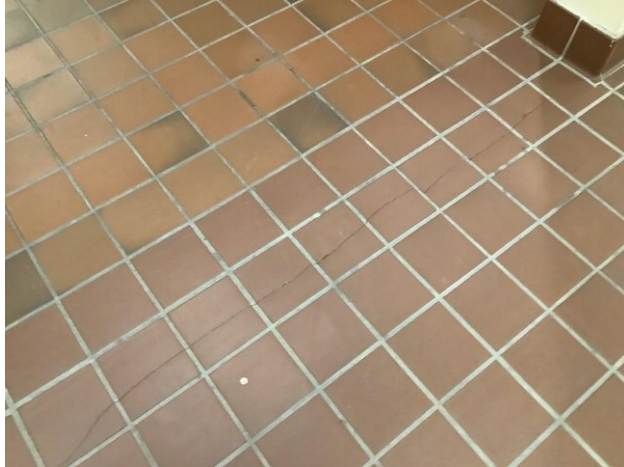
## Project 0546.2015 · Slab Crack Repair

A long crack in the ceramic tile runs along the north 2014 Addition where it meets the Main Building.

Repair cracks in the slab and replace the ceramic tile.

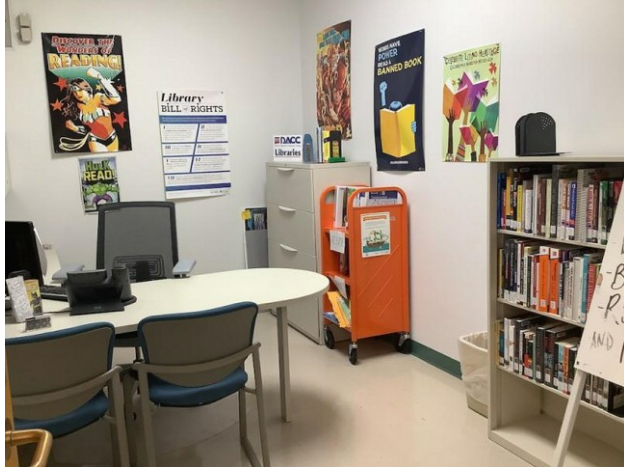
## Project 0546.2016 · Library Office Flooring

The library research assistant's office is the only library office with vinyl composite tile (VCT) flooring; all others include carpet tiles.

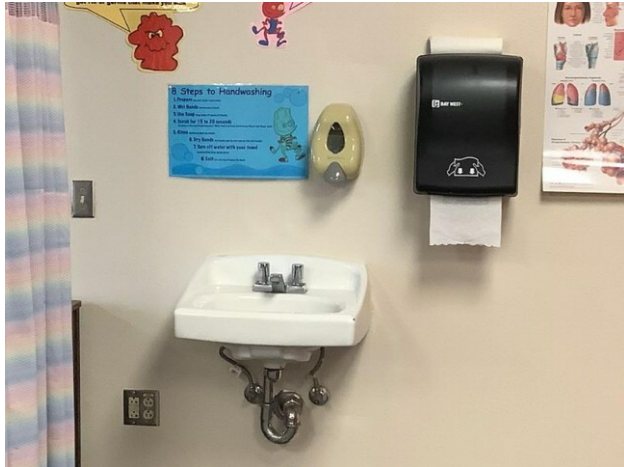
## Project 0546.2017 · Wall Improvements

Painted walls shows wear in the welding lab. Water damage appears on the south rotunda wall. Corner protection does not protect the corridor walls. The wet areas of the health lab lack a water-resistant surround.

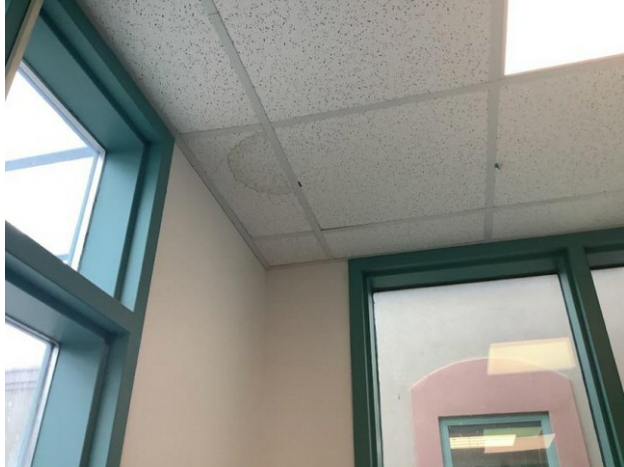
## Project 0546.2018 · Ceiling Improvements

Water stains appear on the ceilings in the main entrance vestibule and the south classroom.

Replace acoustic ceiling tiles (ACT).

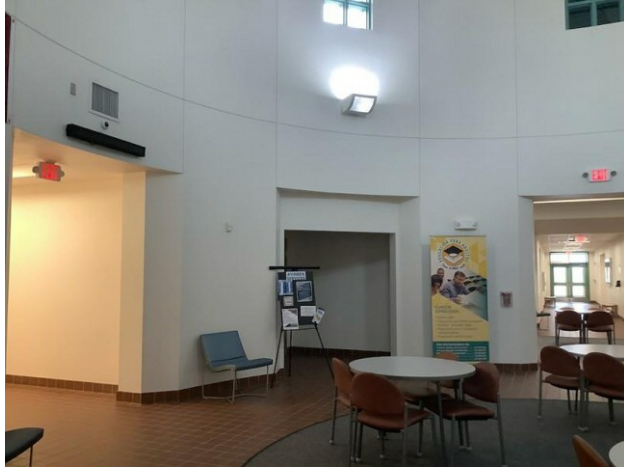
## Project 0546.2019 · Wayfinding Improvements

The lobby lacks a wayfinding directory and facility map.

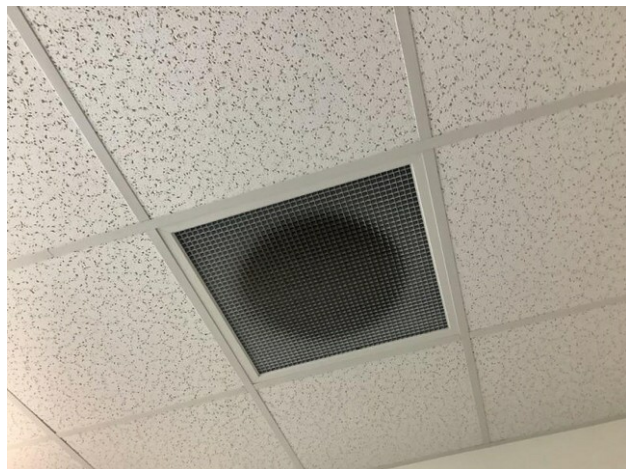
## Project 0546.2020 · Indoor Air Quality Improvements

Thick, cracking mastic covers the rooftop ductwork connecting to mechanical units. Air circulation fans and filtered ventilation are not available in the welding lab or the outdoor welding learning space. Air vents exhibit dust and debris throughout the facility.

Replace rooftop ductwork with insulated ductwork. Install circulation fans in the indoor and outdoor welding learning spaces. Install an energy recovery ventilation (ERV) system in the welding lab. Clean ductwork throughout the facility.

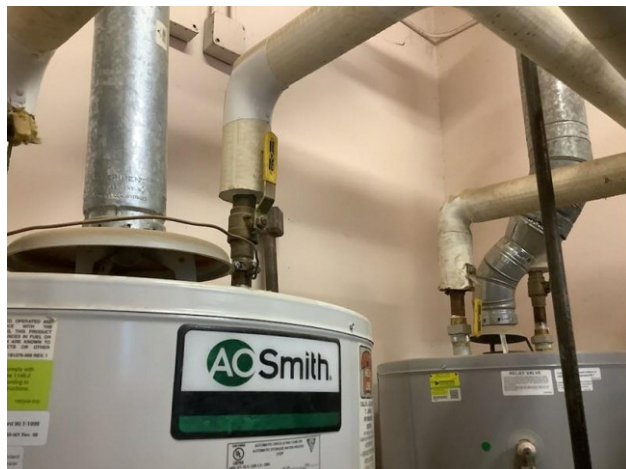
## Project 0546.2021 · Domestic Water Heater Improvements

Two aged, energy-inefficient domestic water heaters deliver hot water through insulated pipes. The system lacks recirculating pumps, timers, and a water softener.

Replace the domestic water heaters and install recirculating pumps, timers, and a water softener.

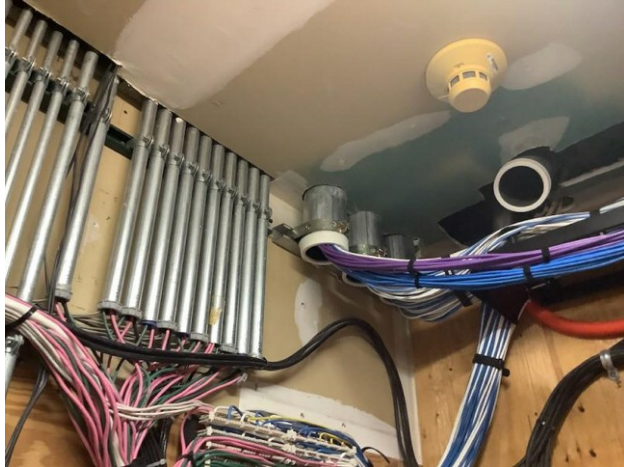
## Project 0546.2022 · Fire Safety Improvements

The mechanical, electrical, and communication rooms lack fire stop sealant.

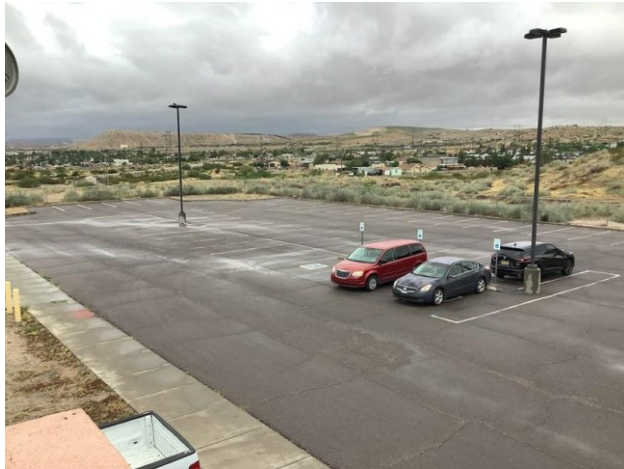
## Project 0546.2023 · Security Upgrades

Doors remain unlocked during business hours. Trespassing occurs in the parking lot and surrounding undeveloped areas. No surveillance system protects the campus.

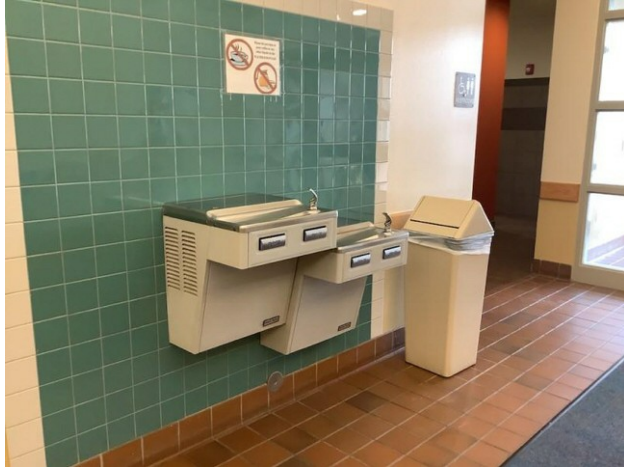
## Project 0546.2024 · ADA Compliance: Restroom and Plumbing Improvements

The administrative single-occupant restrooms lacks vertical grab bars. Drinking fountains project into the walking path in the library lobby. The sink lacks pipe insulation in the health lab.

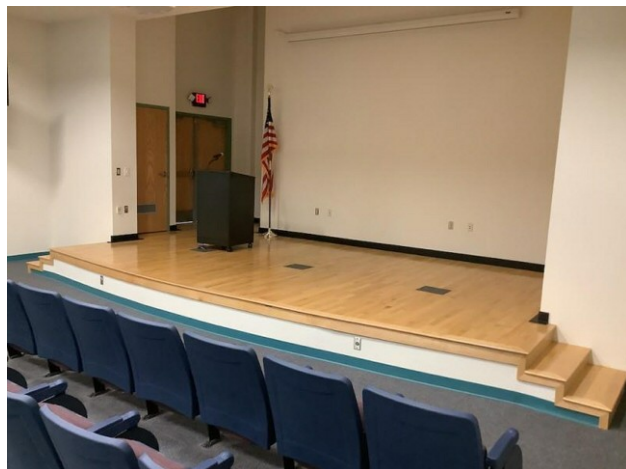
## Project 0546.2025 · ADA Compliance: Lecture Hall

The lecture hall stage lacks handrails and contrasting tread strips, which are required by both the building code and the ADA. The lecture hall seats 100 people and provides amplification, yet lacks an assistive listening system (ALS).

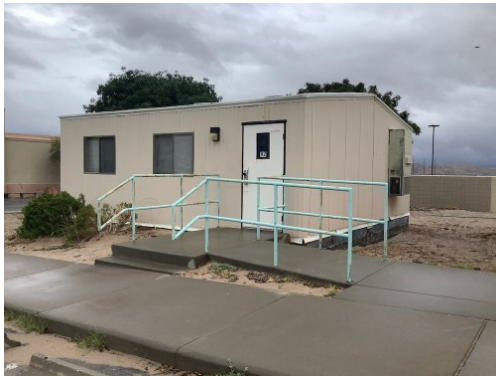
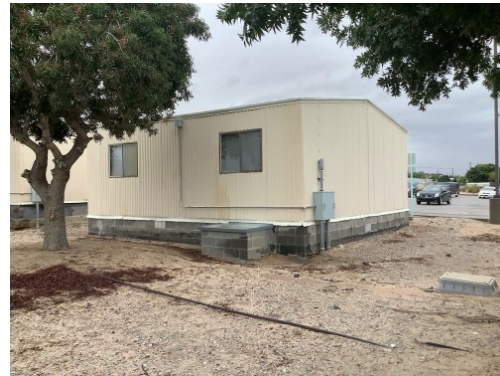
### Site Assessment

Portable 2 sits on the Doña Ana County Community College Sunland Park Campus in Sunland Park, New Mexico. Direct access is available from the parking lot and via a sidewalk from the Main Building. It sits in a row with two other portables.

The site slopes west to east. Water drains along the asphalt parking lot in front of the portables. Unmanaged runoff causes soil erosion in the undeveloped landscape towards the rear of the portables.

A concrete sidewalk runs along the north entrance side of the portable. Concrete steps and a ramp rise to the entrance's landing. The concrete walkway components are in good condition; however, the metal pipe handrails lack extensions, the paint on the pipe is chipped and oxidizing, and the step treads lack contrast.

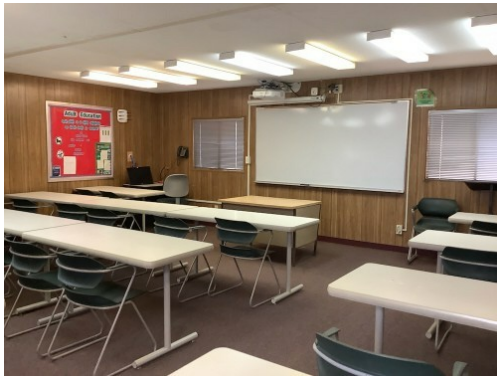
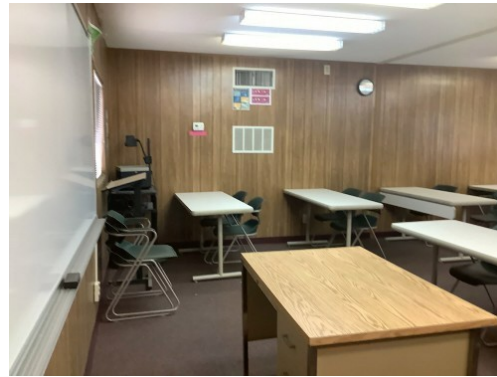
## Building Assessment

Portable 2 stands the furthest west and is nearest to the Main Building. The portable serves as a single-room classroom and does not contain a restroom. The data plate states the modular building is constructed to the 1988 Uniform Building Code and falls under Seismic Zone 1; however, Sunland Park lies in Seismic Zone 2.

The prefabricated structure sits elevated from the exposed ground on a concrete masonry unit (CMU) stem wall. Other than a bent and mangled metal drip edge, it is in good condition. However, water runoff undermines the concrete footing on the stem wall and exhibits spalling. The stem wall extends out to provide access to a crawl space, which is covered with a loose-fitting metal lid.

The metal-panel pitched roof is in poor condition with dents, oxidation, and layers of aged and weather-damaged liquid roof sealant. The roof lacks gutters and roof drains. The fascia's drip edge appears misaligned and bent, and it does not provide a continuous protective surface.

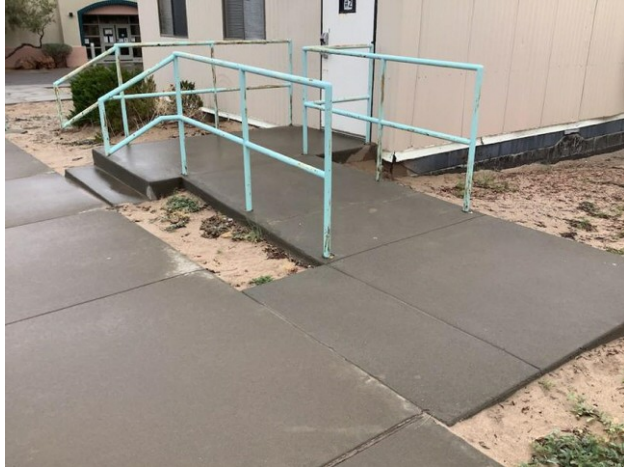
## Project 477E.2001 · ADA Compliance: Walkways

The concrete walkway components are in good condition; however, the metal pipe handrails lack extensions, the paint on the pipe is chipped and oxidizing, and the stairs lack tread nosing contrast.

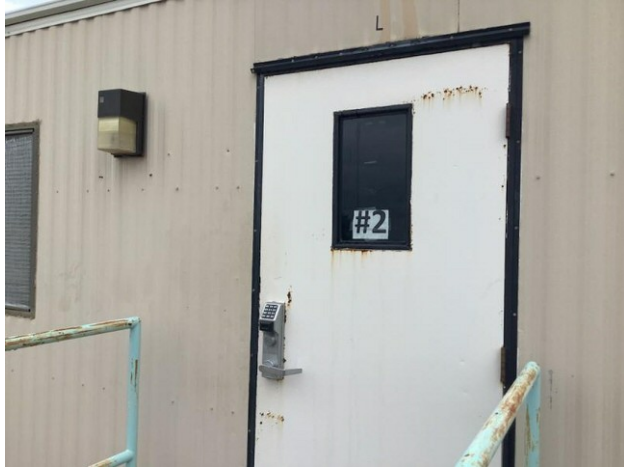
## Project 477E.2002 · Exterior Lighting Improvements

A cracked, yellowing, wall-mounted light fixture hangs next to the door.

Replace the light fixture.

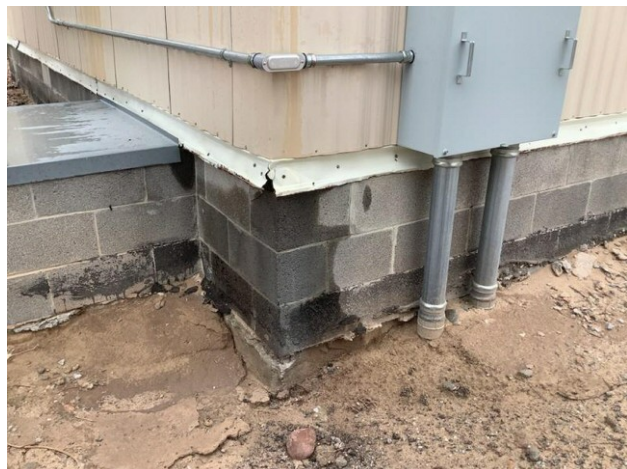
## Project 477E.2003 · Foundation Repairs and Drainage

The concrete masonry unit (CMU) stem wall has a bent, damaged metal drip edge. Water runoff undermines the concrete footing that the stem wall rests on. The concrete footing exhibits spalling.

Replace the metal drip edge. Patch the spalling concrete. Correct the drainage.

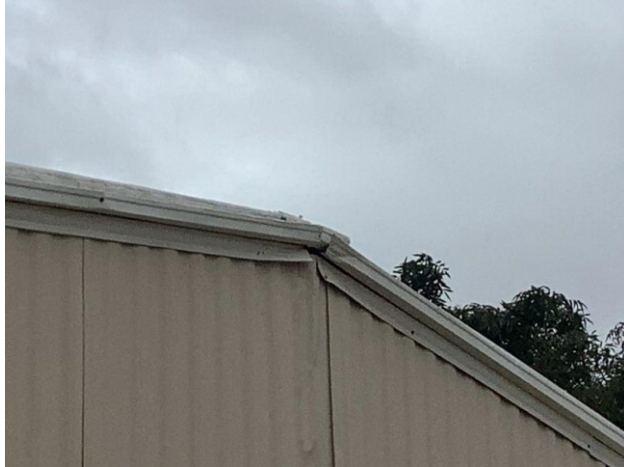
## Project 477E.2004 · Roof Replacement

The metal-panel pitched roof is in poor condition with dents, oxidation, and layers of aged and weather-damaged liquid roof sealant. The roof lacks gutters and roof drains. The fascia's drip edge is misaligned and bent, and it does not provide a continuous protective surface.

Replace the roof and install gutters, downspouts, drip edges, and splash blocks.

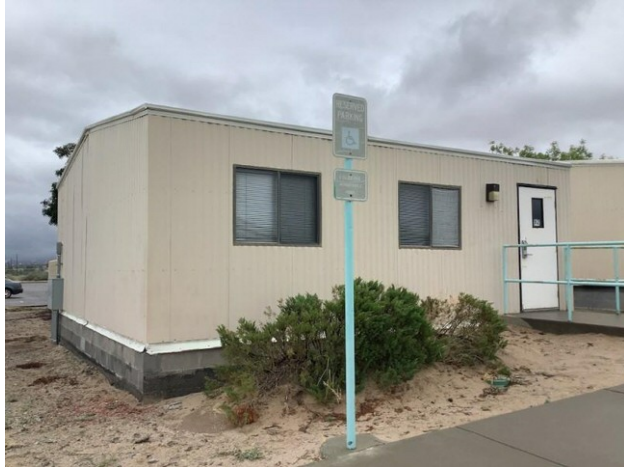
## Project 477E.2005 · Exterior Surface Improvements

The metal-panel sheathing exhibits minor denting, oxidation, and rust. The sheathing is in poor condition. The adhesive vinyl numbers for building identification are cracking and peeling off.

Power wash, seal gaps, and paint the sheathing. Replace building identification.

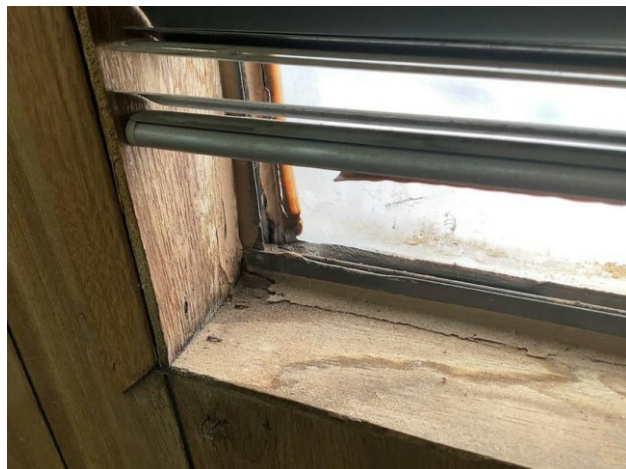
## Project 477E.2006 · Door and Window Upgrades

The metal-clad wood door is in poor condition with the cladding exhibiting dents, oxidation, and rust. Large gaps show between the door sweep and threshold, allowing sand and mud to accumulate inside the door. The single-pane, energy-inefficient windows are broken and do not slide in their frames. Glazing seals exhibit incorrect repairs and are filled with aging, peeling caulk. The interior wood sills and surrounds are weather-worn and cracked from sun damage and water intrusion; they are covered in layers of blown-in sand. Window screens are threadbare. Pull cords appear dry and weak, and they do not operate the venetian blinds. Interior door and window trim exhibit wear and damage

Repaint the door and frame. Install weather stripping and a threshold. Install energy-efficient windows, screens, and blinds. Replace the sills. Replace the interior door and window trim.

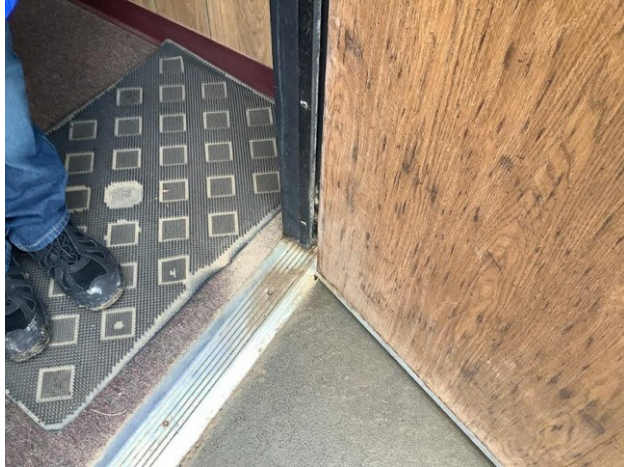
## Project 477E.2007 · Carpet Replacement

Aged carpet covers the floor and shows fiber breakdown, which is off-gassing odors. Damage from water and sand intrusion shows at the foot of the door, which is covered with a floor mat.

Replace carpet.

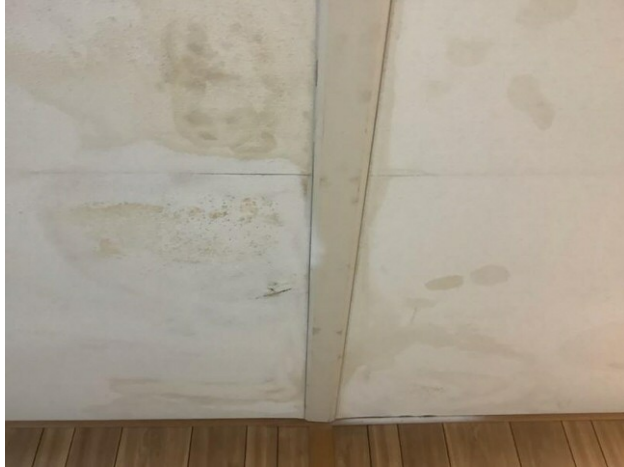
## Project 477E.2008 · Ceiling Improvements

The ceilings are in poor condition with uneven paint, cracks along the seams, and heavy water staining.

Replace ceiling panels.

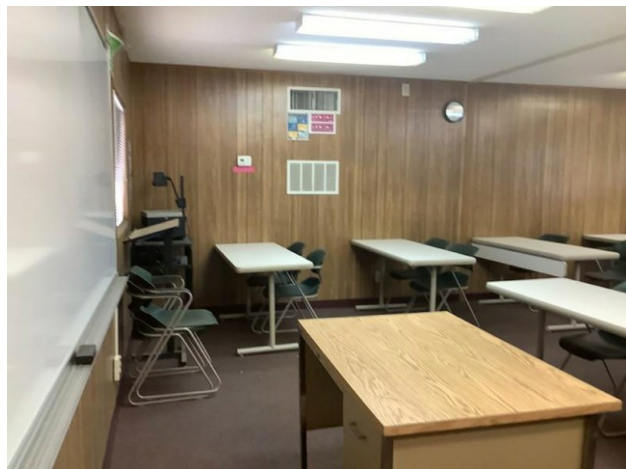
## Project 477E.2009 · Heating and Cooling Upgrades

An electric heat pump, which is original to the building and past its expected serviceable life, hangs on the exterior wall. The electric pump heats and cools the interior through a single wall vent. A manual thermostat controls the unit. The portable lacks mechanical ventilation; thus, opening the door is the only option for passive ventilation.

Replace the heat pump with an energy-efficient model and a programmable thermostat.

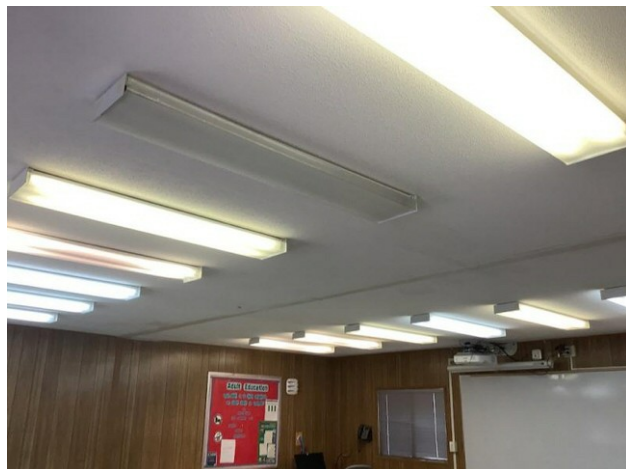
## Project 477E.2010 · Lighting Improvements

The aged, ceiling-mounted light fixtures have a variety of color-temperature tube lights, which range from yellow to blue. The fixtures produce an uneven light quality and illuminate the room's interior. One fixture is not functioning. Original toggle light switches hang near the door with a sign reminding users to turn off lights and the mechanical equipment.

Replace fixtures with energy-efficient LED lighting. Install a motion-sensor light switch.

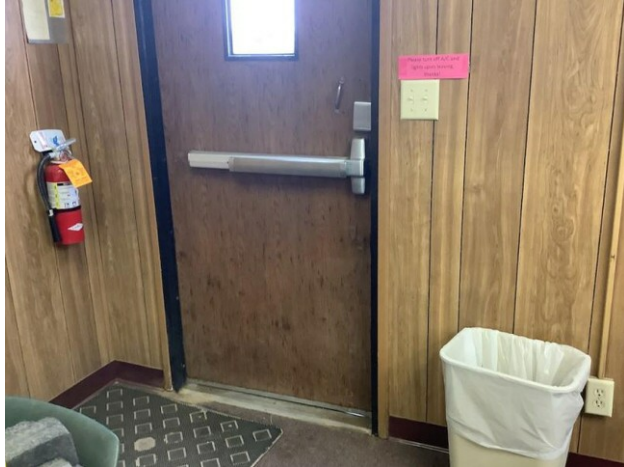
## Project 477E.2011 · Security and Safety Upgrades

The main campus includes an alarm, but the portables do not. The portable lacks a smoke detector.

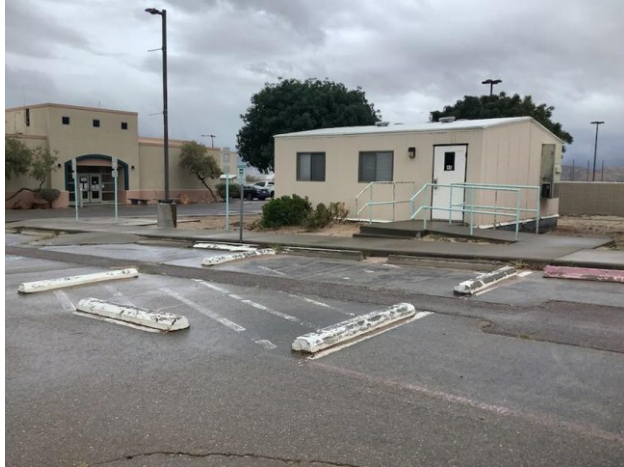
## Project 477E.2012 · Alternative Solution: Portable Replacement

Constructed to meet building codes from 1988 and dated by the district from 1996, the structure is past the average serviceable lifespan. The portable is heavily aged and worn. A replacement portable would be more energy efficient and space efficient, meet current building and safety codes, and meet ADA requirements. The cost includes the removal of the old portable.

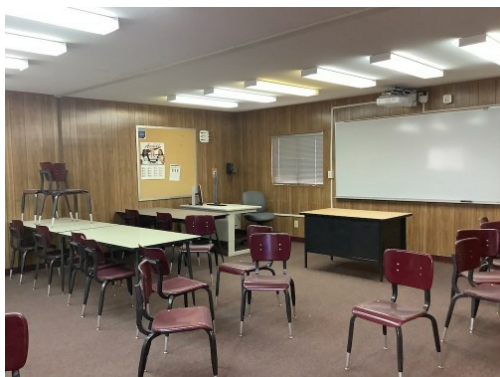
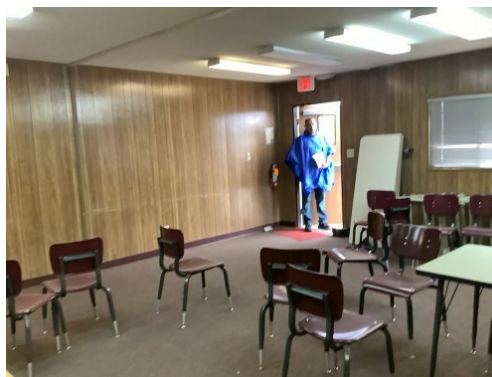
## Building Assessment

Portable 3 stands between portables 2 and 4. The portable serves as a single-room classroom and does not contain a restroom. The data plate states that the modular building was constructed to the 1988 Uniform Building Code and falls under Seismic Zone 1; however, Sunland Park is in Seismic Zone 2.

The prefabricated structure sits elevated from the exposed ground on a concrete masonry unit (CMU) stem wall. Other than a bent and mangled metal drip edge, it is in good condition. However, water runoff undermines the concrete footing on the stem wall and exhibits spalling. The stem wall extends out to provide access to a crawl space, which is covered with a loose-fitting metal lid.

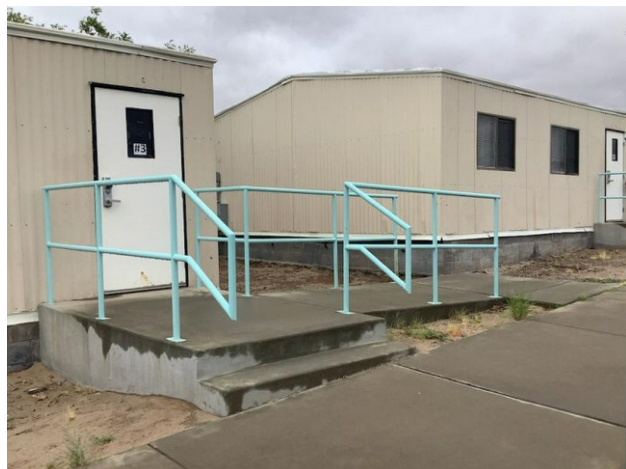
## Project 477F.2001 · ADA Compliance: Walkways

The concrete walkway components are in good condition; however, the metal pipe handrails lack extensions, the paint on the pipe is chipped and oxidizing, and the stairs lack tread nosing contrast.

A concrete sidewalk runs along the north entrance side of the portable. Concrete steps and a ramp rise to the entrance's landing. The concrete walkway components are in good condition; however, the metal pipe handrails lack extensions, the paint on the pipe is chipped and oxidizing, and the step treads lack contrast.

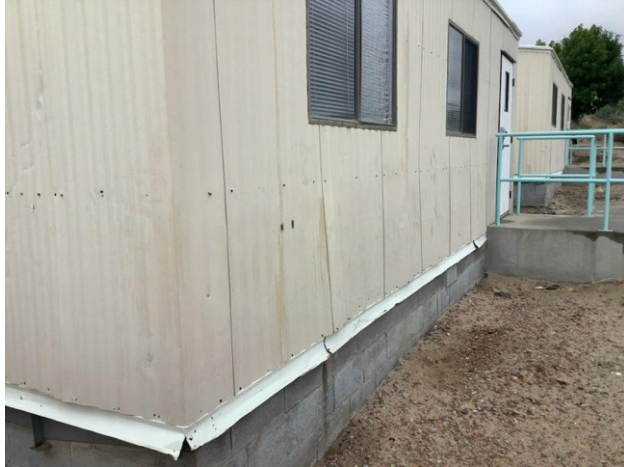
## Project 477F.2002 · Exterior Lighting Improvements

The entrance lacks lighting.

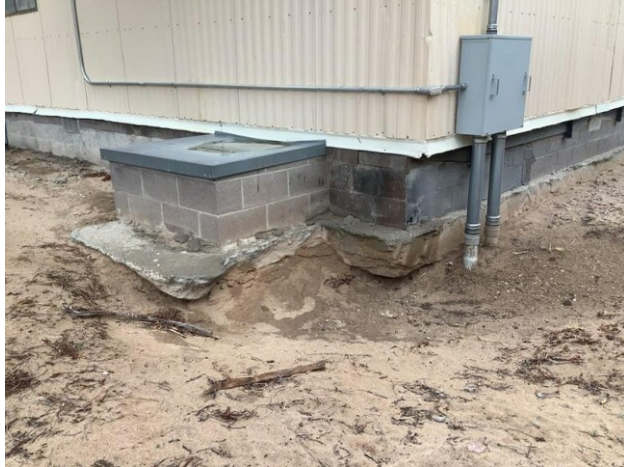
## Project 477F.2003 · Foundation Repairs and Drainage

The concrete masonry unit (CMU) stem wall has a bent, damaged metal drip edge. Water runoff undermines the concrete footing that the stem wall rests on. The concrete footing exhibits spalling.

Replace the metal drip edge. Patch the spalling concrete. Correct the drainage.

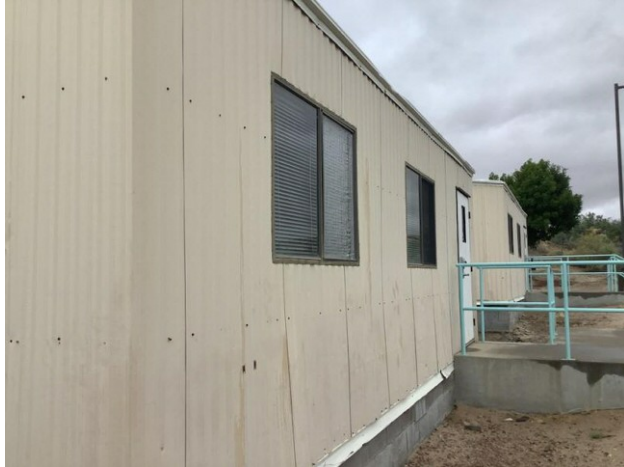
## Project 477F.2004 · Roof Replacement

The metal-panel pitched roof is in poor condition with dents, oxidation, and layers of aged and weather-damaged liquid roof sealant. The roof lacks gutters and roof drains. The fascia's drip edge is misaligned and bent, and it does not provide a continuous protective surface.

Replace the roof and install gutters, downspouts, drip edges, and splash blocks.

The metal-panel pitched roof is in poor condition with dents, oxidation, and layers of aged and weather-damaged liquid roof sealant. The roof lacks gutters and roof drains. The fascia's drip edge appears misaligned and bent, and it does not provide a continuous protective surface.

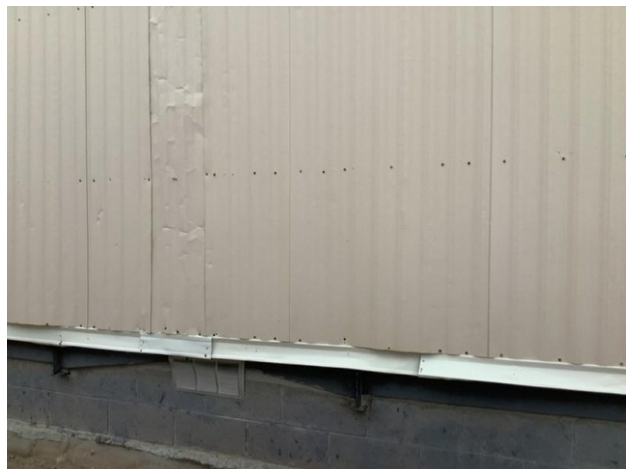
## Project 477F.2005 · Exterior Surface Improvements

The metal-panel sheathing exhibits significant denting, oxidation and rust. The sheathing is in poor condition. The adhesive vinyl numbers for building identification are cracking and peeling off.

Power wash the building. Replace damaged panels. Seal the gaps and paint the sheathing. Replace building identification.

The metal-panel sheathing exhibits denting, oxidation and rust. The sheathing is in poor condition. The adhesive vinyl numbers identifying the building are cracking and peeling off.

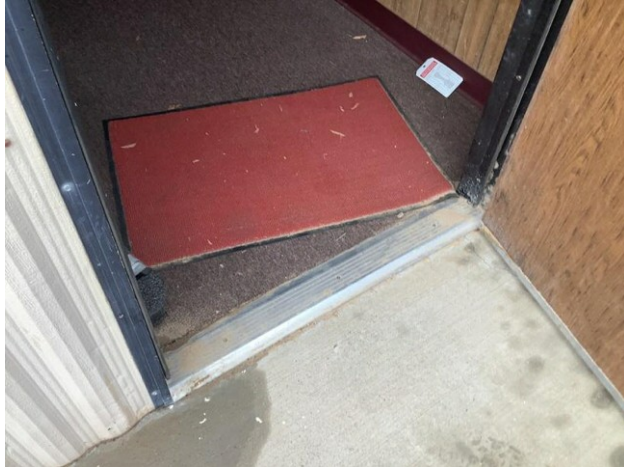
## Project 477F.2007 · Carpet Replacement

Aged carpet covers the floor and shows fiber breakdown, which is off-gassing odors. Damage from water and sand intrusion shows at the foot of the door, which is covered with a floor mat.

Replace carpet.

Aged carpet covers the floor and shows fiber breakdown, which is off-gassing odors. Damage from water and sand intrusion shows at the foot of the door, which is covered with a floor mat.

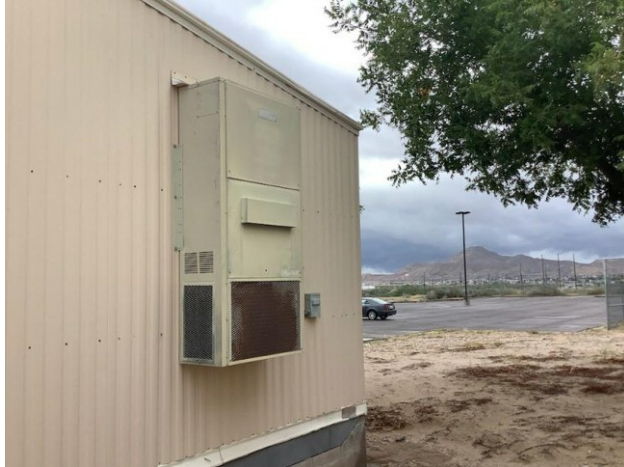
## Project 477F.2009 · Heating and Cooling Upgrades

An electric heat pump, which is original to the building and past its expected serviceable life, hangs on the exterior wall. The electric pump heats and cools the interior through a single wall vent. A manual thermostat controls the unit. The portable lacks mechanical ventilation; thus, opening the door is the only option for passive ventilation.

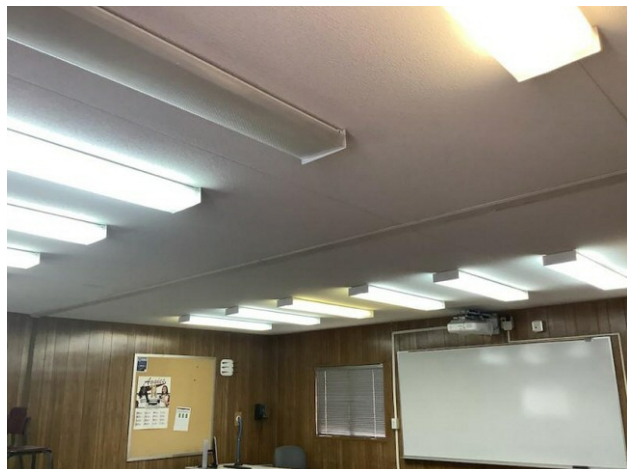
## Project 477F.2010 · Lighting Improvements

The aged, ceiling-mounted light fixtures have a variety of color-temperature tube lights, which range from yellow to blue. The fixtures produce an uneven light quality and illuminate the room's interior. One fixture is not functioning. Original toggle light switches hang near the door with a sign reminding users to turn off lights and the mechanical equipment.

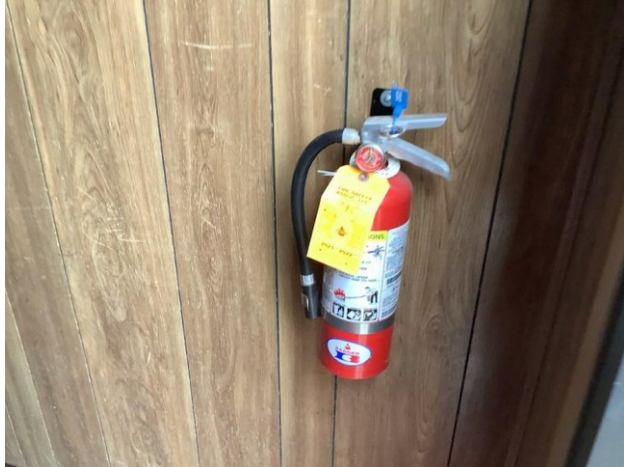
## Project 477F.2011 · Security and Safety Upgrades

The main campus includes an alarm, but the portables do not. The portable lacks a smoke detector.

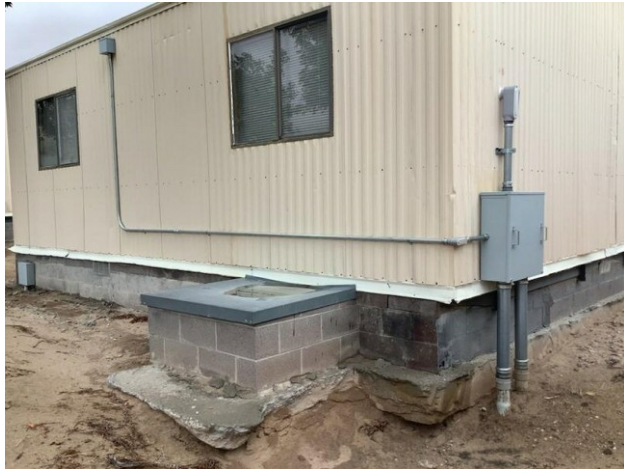
## Project 477F.2012 · Alternative Solution: Portable Replacement

Constructed to meet building codes from 1988 and dated by the district from 1996, the structure is past the average serviceable lifespan. The portable is heavily aged and worn. A replacement portable would be more energy efficient and space efficient, meet current building and safety codes, and meet ADA requirements. The cost includes the removal of the old portable.

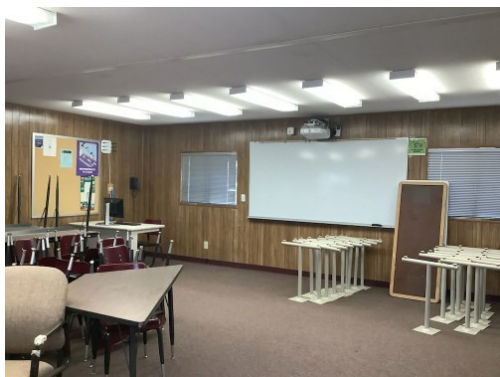
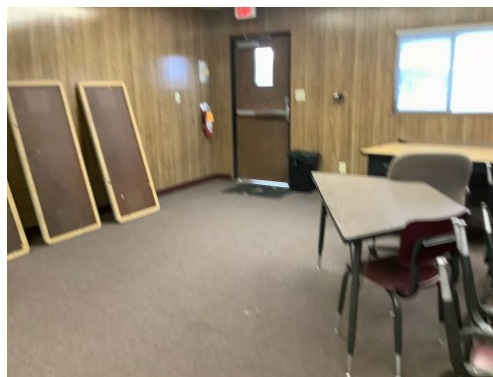
## Building Assessment

Portable 4 stands west of portable 3. The portable serves as a single-room classroom and does not contain a restroom. The data plate states that the modular building is constructed to the 1988 Uniform Building Code and falls under Seismic Zone 1; however, Sunland Park is in Seismic Zone 2.

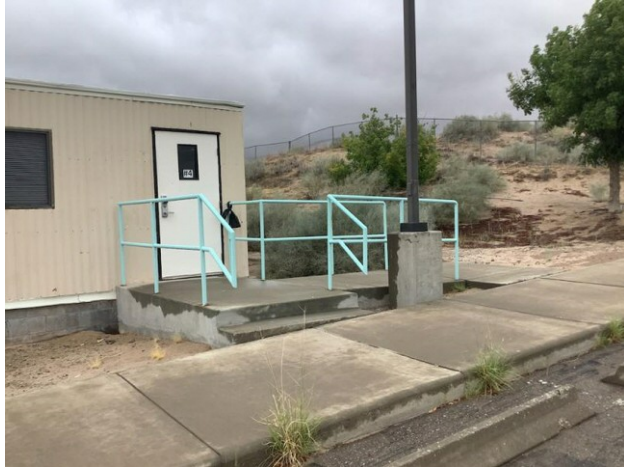
## Project 477G.2001 · ADA Compliance: Walkways

The concrete walkway components are in good condition; however, the metal pipe handrails lack extensions, the paint on the pipe is chipped and oxidizing, and the stairs lack tread nosing contrast.
