# DACC

Doña Ana Community College

# Facilities Master Plan

**FMP 2023-2030**

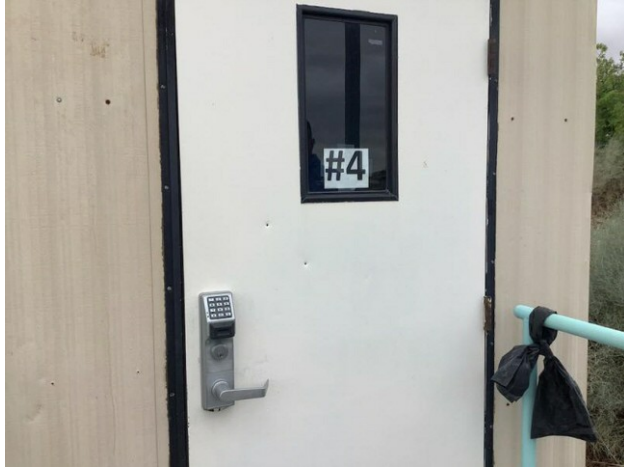
## Project 477G.2002 · Exterior Lighting Improvements

The entrance lacks lighting.

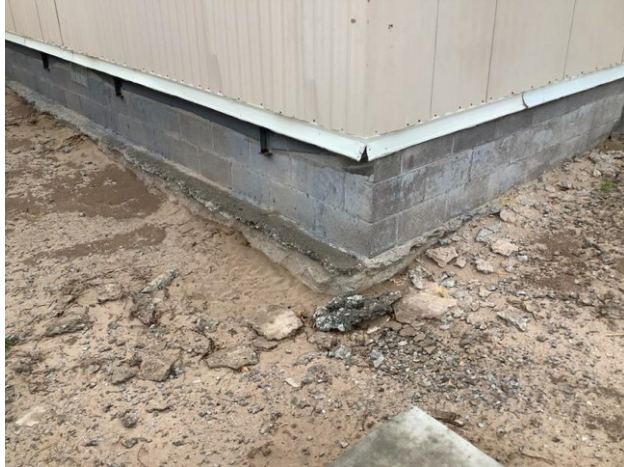
## Project 477G.2003 · Foundation Repairs and Drainage

The concrete masonry unit (CMU) stem wall has a bent, damaged metal drip edge. Water runoff undermines the concrete footing that the stem wall rests on. The concrete footing exhibits spalling.

Replace the metal drip edge. Patch the spalling concrete. Correct the drainage.

The prefabricated structure sits elevated from the exposed ground on a concrete masonry unit (CMU) stem wall. Other than a bent and mangled metal drip edge, it is in good condition. However, water runoff undermines the concrete footing on the stem wall and exhibits spalling. The stem wall extends out to provide access to a crawl space, which is covered with a loose-fitting metal lid.

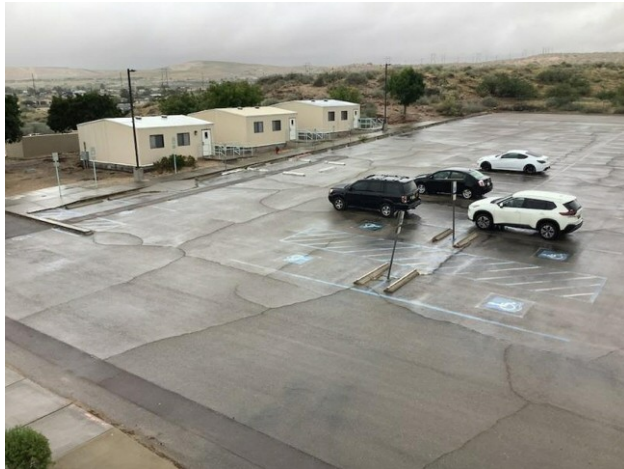
## Project 477G.2004 · Roof Replacement

The metal-panel pitched roof is in poor condition with dents, oxidation, and layers of aged and weather-damaged liquid roof sealant. The roof lacks gutters and roof drains. The fascia's drip edge is misaligned and bent, and it does not provide a continuous protective surface.

Replace the roof and install gutters, downspouts, drip edges, and splash blocks.

The metal-panel pitched roof is in poor condition with dents, oxidation, and layers of aged and weather-damaged liquid roof sealant. The roof lacks gutters and roof drains. The fascia's drip edge appears misaligned and bent, and it does not provide a continuous protective surface.

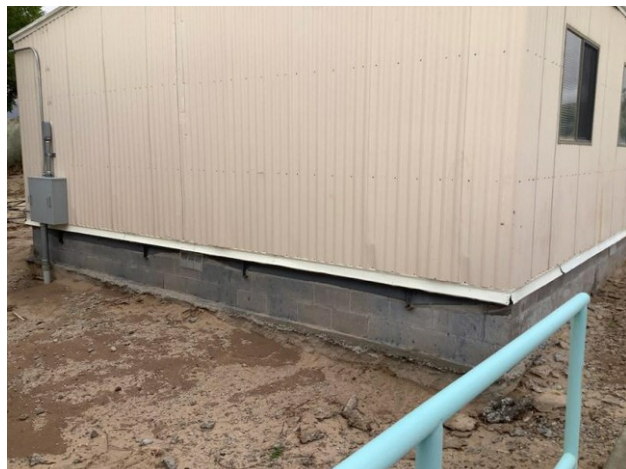
## Project 477G.2005 · Exterior Surface Improvements

The metal-panel sheathing exhibits minor denting, oxidation, and rust. The sheathing is in poor condition. The adhesive vinyl numbers for building identification are cracking and peeling off.

Power wash, seal gaps, and paint the sheathing. Replace building identification.

The metal-panel sheathing exhibits denting, oxidation and rust. The sheathing is in poor condition. The adhesive vinyl numbers identifying the building are cracking and peeling off.

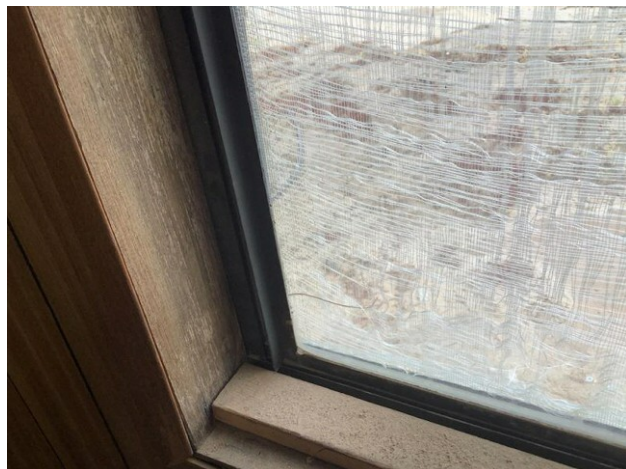
## Project 477G.2006 · Door and Window Upgrades

The metal-clad wood door is in poor condition with the cladding exhibiting dents, oxidation, and rust. Large gaps show between the door sweep and threshold, allowing sand and mud to accumulate inside the door. The single-pane, energy-inefficient windows are broken and do not slide in their frames. Glazing seals exhibit incorrect repairs and are filled with aging, peeling caulk. The interior wood sills and surrounds are weather-worn and cracked from sun damage and water intrusion; they are covered in layers of blown-in sand. Window screens are threadbare. Pull cords appear dry and weak, and they do not operate the venetian blinds. Interior door and window trim exhibit wear and damage

Repaint the door and frame. Install weather stripping and a threshold. Install energy-efficient windows, screens, and blinds. Replace the sills. Replace the interior door and window trim.

The metal-clad wood door includes a window, swipe card lock, panic bar, and door closer. The door is in poor condition with the cladding exhibiting dents, oxidation, and rust. Large gaps show between the door sweep and threshold, allowing sand and mud to accumulate inside the door.

Single-pane, energy-inefficient windows are broken and do not slide in their frames. Glazing seals show incorrect repairs and are filled with aging and peeling caulk. The interior wood sills and surrounds are weather-worn and cracked from sun damage and water intrusion and covered in layers of blown-in sand. Window screens are threadbare. Pull cords are dry, weak, and do not operate the venetian blinds.

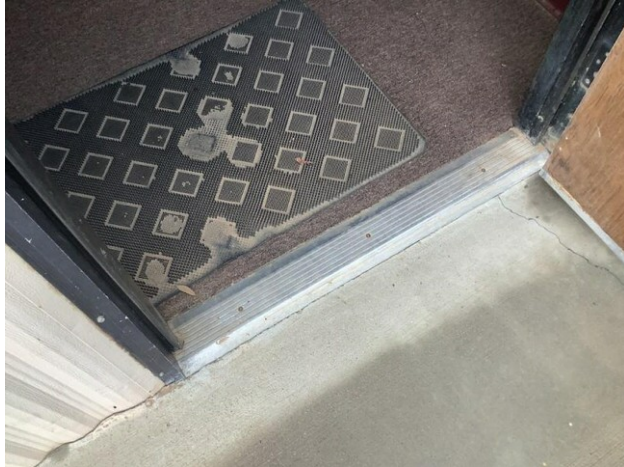
## Project 477G.2007 · Carpet Replacement

Aged carpet covers the floor and shows fiber breakdown, which is off-gassing odors. Damage from water and sand intrusion shows at the foot of the door, which is covered with a floor mat.

Replace carpet.

Aged carpet covers the floor and shows fiber breakdown, which is off-gassing odors. Damage from water and sand intrusion shows at the foot of the door, which is covered with a floor mat.

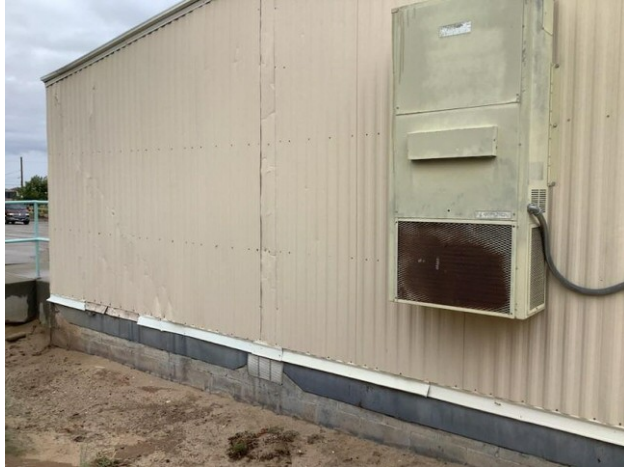
## Project 477G.2009 · Heating and Cooling Upgrades

An electric heat pump, which is original to the building and past its expected serviceable life, hangs on the exterior wall. The electric pump heats and cools the interior through a single wall vent. A manual thermostat controls the unit. The portable lacks mechanical ventilation; thus, opening the door is the only option for passive ventilation.

Replace the heat pump with an energy-efficient model and a programmable thermostat.

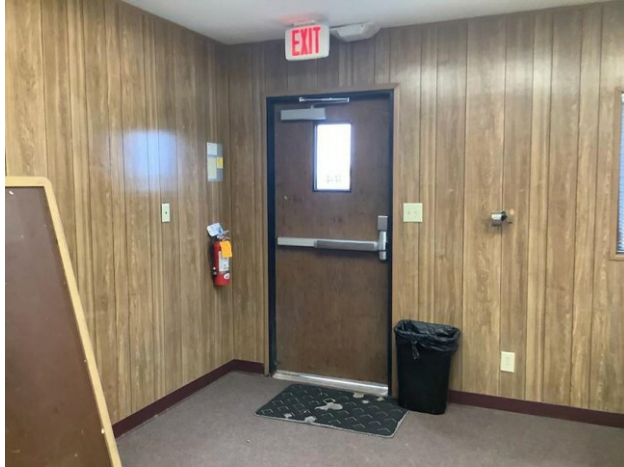
## Project 477G.2011 · Security and Safety Upgrades

The main campus includes an alarm, but the portables do not. The portable lacks a smoke detector.

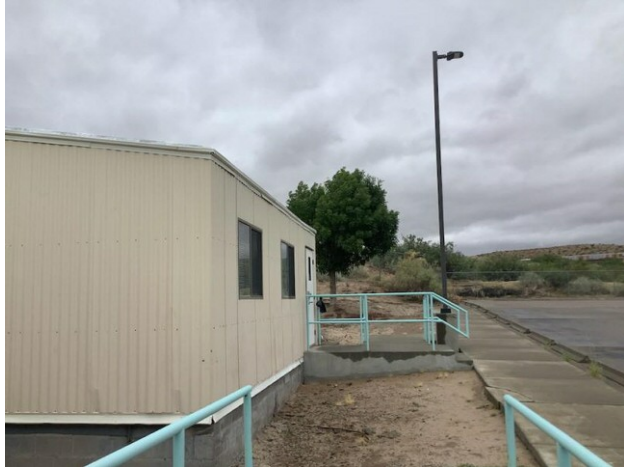
## Project 477G.2012 · Alternative Solution: Portable Replacement

Constructed to meet building codes from 1988 and dated by the district from 1996, the structure is past the average serviceable lifespan. The portable is heavily aged and worn. A replacement portable would be more energy and space-efficient, meet current building and safety codes, and meet ADA requirements. The cost includes the removal of the old portable.

Constructed to meet building codes from 1988 and dated by the district to 1994, the structure is past the average serviceable lifespan of a portable classroom. The structure is heavily aged and worn; however, the space can accommodate a variety of academic disciplines.
